**STRUCTURAL ASSESSMENT AND PROPOSALS FOR REPAIR,
CONSERVATION AND PRIORITIZATION OF URGENT
WORKS
FOR
FIFTEEN ARCHAEOLOGICAL MONUMENTS
IN
FINGAL COUNTY COUNCIL OWNERSHIP**

**Dermot Nolan & Associates
Historic Buildings Consultants
& Consulting Engineers
'Claremount'
Meath Road
Bray
Co. Wicklow
Tel: 01-276 2626
Email: dnolanconservation@eircom.net**

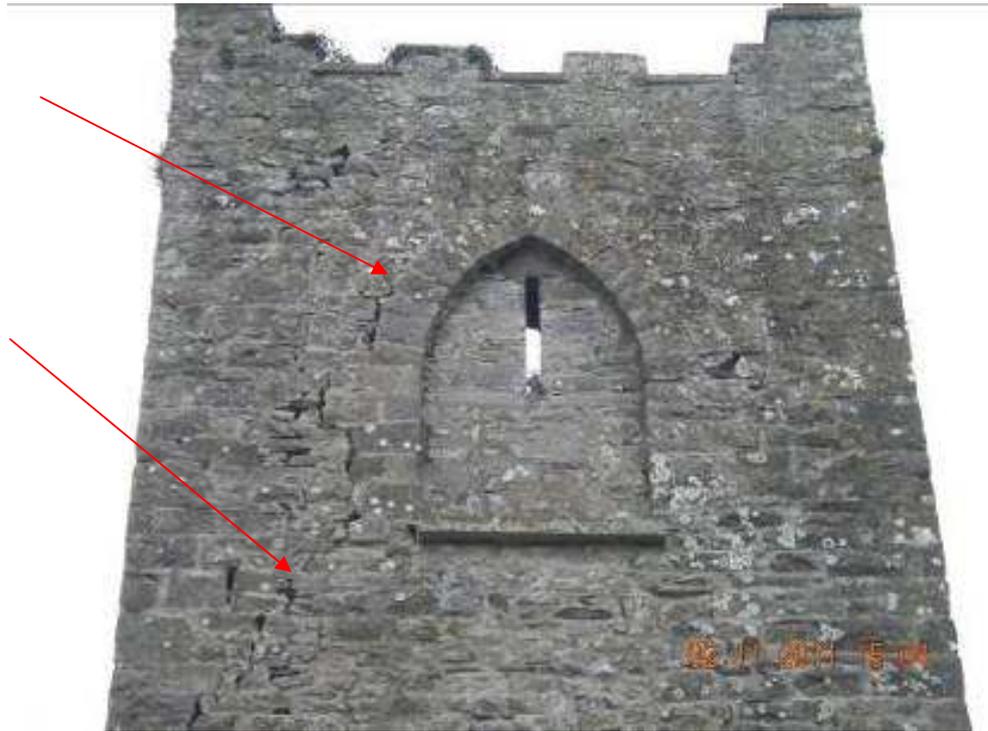
The tower walls appear to be damp and there is a covering of green mould on the interior walls. There is some masonry disintegration at high level on the west and east sides of the tower. There is vertical cracking for virtually the full height of the tower on the west side and a diagonal crack over the entrance door on the south side. These cracks may be connected and may be caused by subsidence at the south west corner. There is also cracking and voiding near the east end of the tower north wall. An area of wall below the string course on the east side of the tower requires to be pointed.

Note
cracking

North tower wall upper level

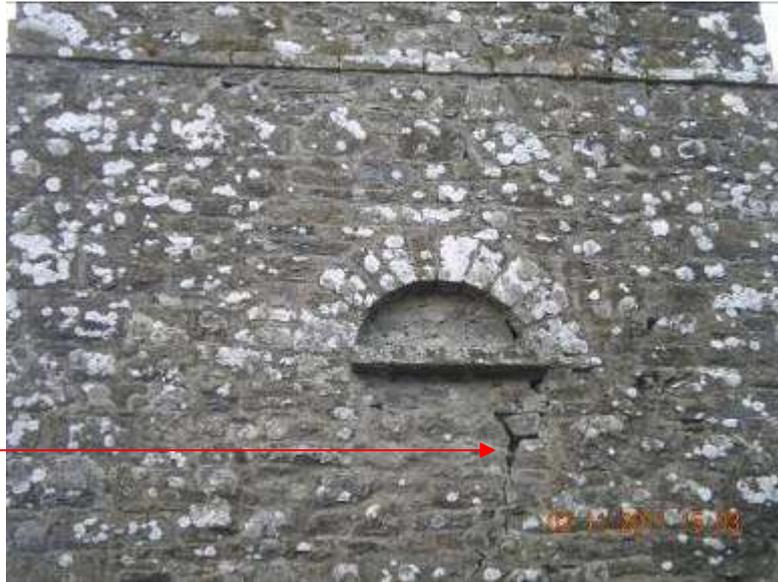
Most of the cracking and minor disintegration in the masonry is probably due to vegetation growing in the wall in the past. Where this occurred and the vegetation was removed or died off, the resulting disruption of pointing and mortar would have permitted ingress of moisture. This, in turn, can lead to washing out of mortar and voiding and disintegration of the masonry. The solution is to point the walls and to fill voids as far as possible. As noted above, the profile of the cracking at the south-west corner of the tower indicates possible foundation subsidence in this area.

Cracking

West wall of tower

- 5.1 An exploratory trial pit should be opened at the south-west corner of the tower to determine the subsoil conditions. The trial pit must be inspected by an engineer to determine what action might be required. The trial pit location (and that of any subsequent works) must be carefully chosen to avoid disturbing graves.

The outcome of this investigation may be a recommendation to underpin part of the tower foundation. Alternatively, or perhaps additionally, there may be a recommendation to install a 'French' drain around the tower. Where soil in the vicinity of a foundation becomes saturated it can become soft and cause subsidence. A 'French' drain can assist in drying the soil and preventing future saturation.

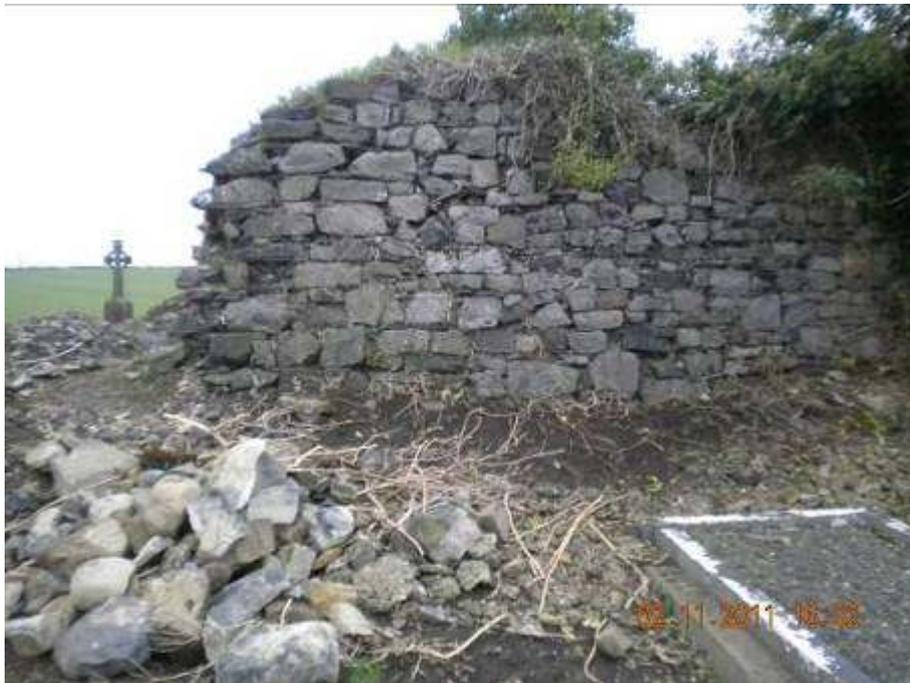
North end of the West wall (West face)

The remaining west wall is in poor condition, although ivy has been removed from the faces of the wall in the recent past. The following defects were noted:

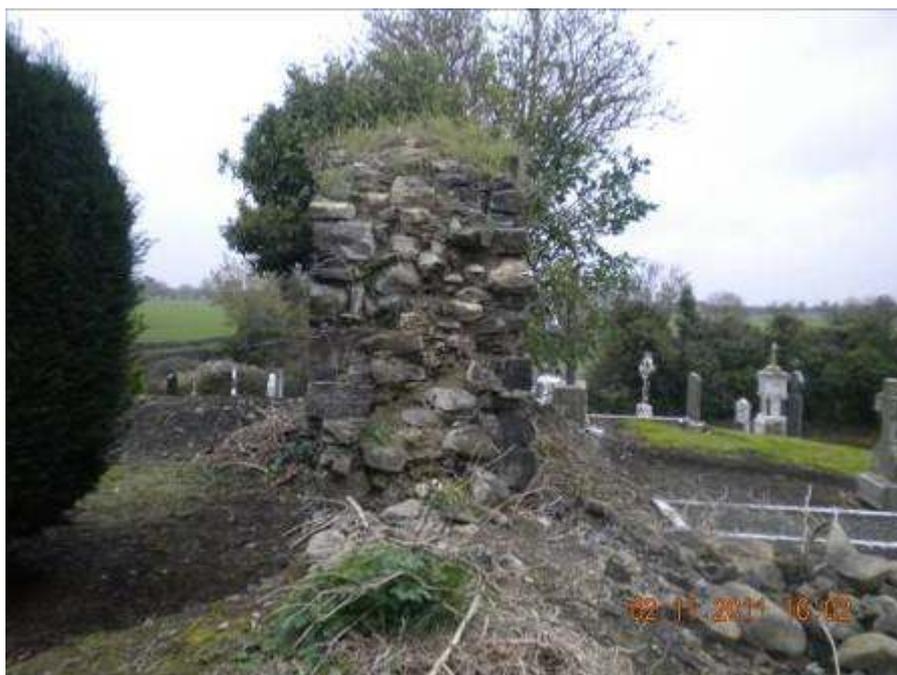
- a) Small trees are growing at the south end and causing serious disruption to the masonry.
- b) The north end is disintegrating and fallen stones lie at the foot of the wall.
- c) Vegetation is growing along the top of the wall and disrupting masonry.
- d) An area of wall face ca. 0.7 wide x 1.2 high has collapsed on the east side.
- e) The wall is out-of-plumb and leaning ca. 100mm towards the west.
- f) Fallen masonry has been moved and some of it is now grown over and covered by grass and earth.

North end of West wall (note the wall leans to the West)

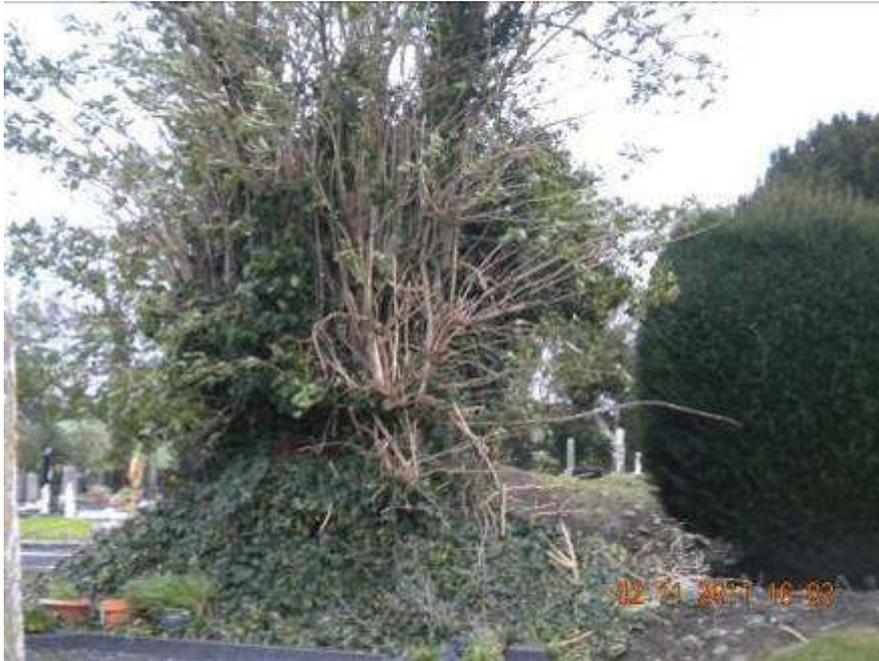
West end of West wall

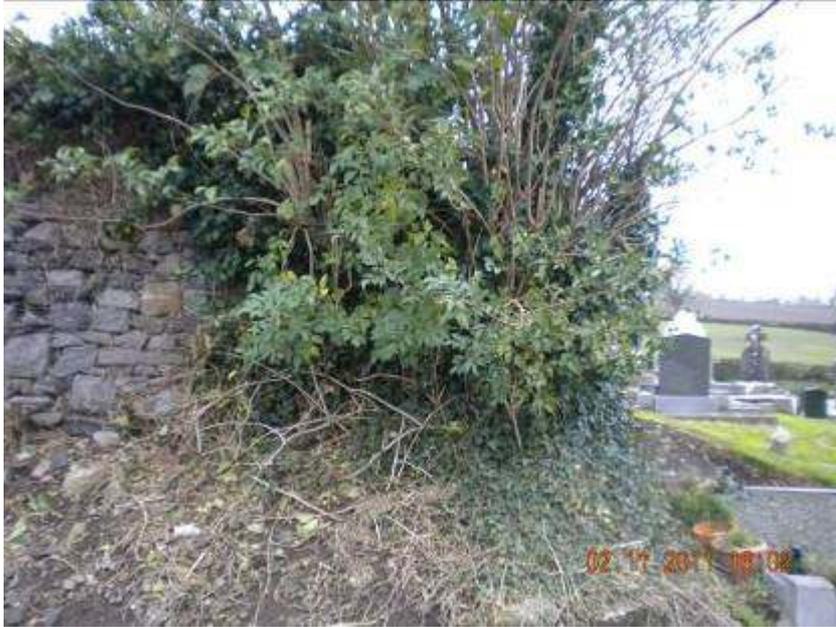
South end of West wall (West face)

- 5.2 All vegetation should be sprayed with biocide and carefully cut out. Vegetation should never be pulled from the masonry.
- 5.3 The damaged wall face should be rebuilt. The existing wall is Very roughly coursed with discontinuous courses. This pattern should be followed in reconstruction. There may be no original mortar left in the wall. In any event because of the obvious paucity of original material it would not be appropriate to remove a sample of the mortar for testing. The mortar used for re-building should be weak putty lime mortar with roughly graded sand.

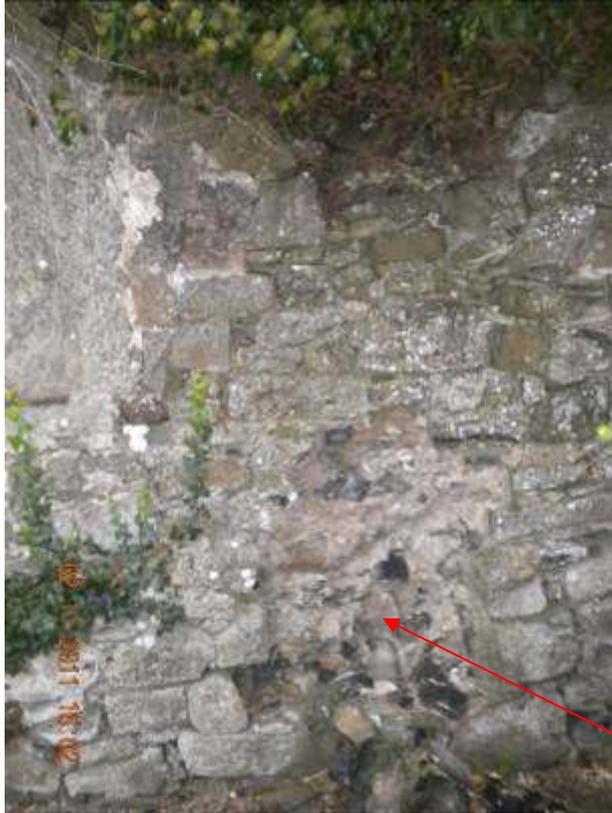
Area of collapsed masonry

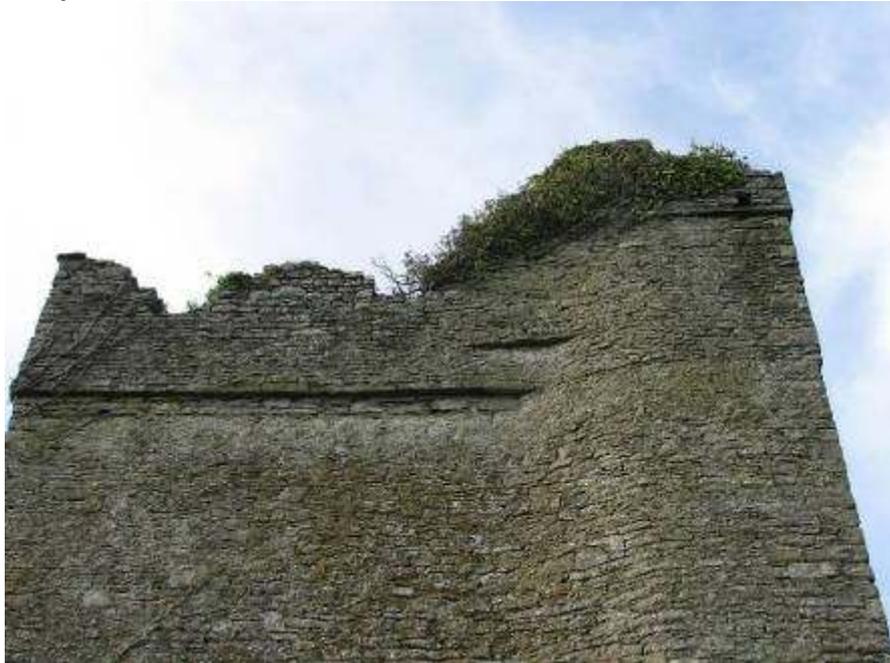
Battlements East Elevation

There is vegetation growing at high level on the battlements – particularly on the east and north side. The battlements have been degraded and have lost mortar on all elevations. Vegetation and possibly trees may be seen through the windows growing in the interior.

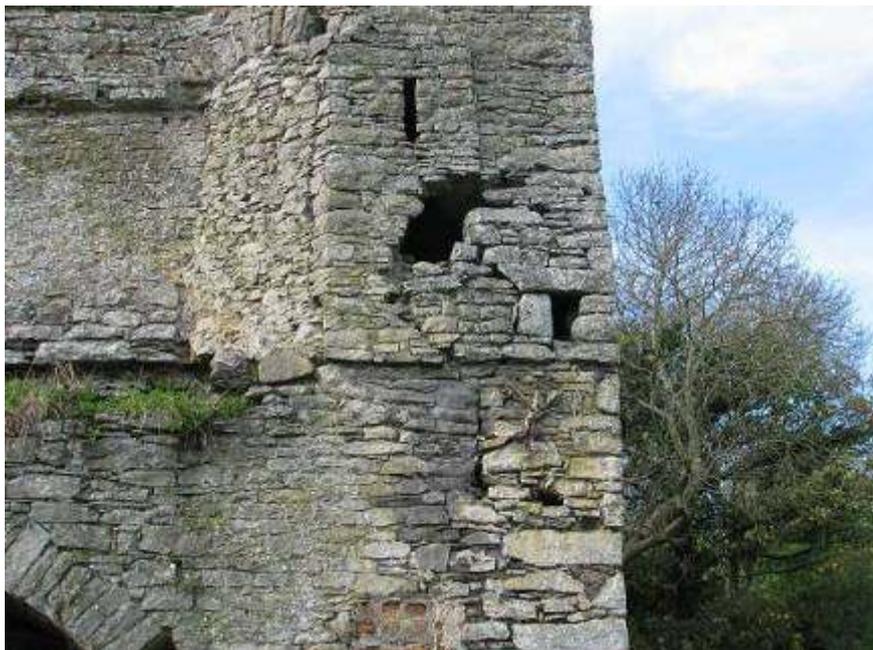
North-East corner bulge and hole – east side

On the east elevation there is a bulge in the wall of the northeast corner stairwell at first floor and disintegration of masonry with a substantial hole in the wall. Voussoirs are missing at the springings of the arch over the entrance into the former extension (now demolished). Subsidence has occurred at the southeast corner and a section of masonry has cracked and moved. There is an area of rough masonry at first floor level where the facing has been lost and this requires to be pointed and made good.

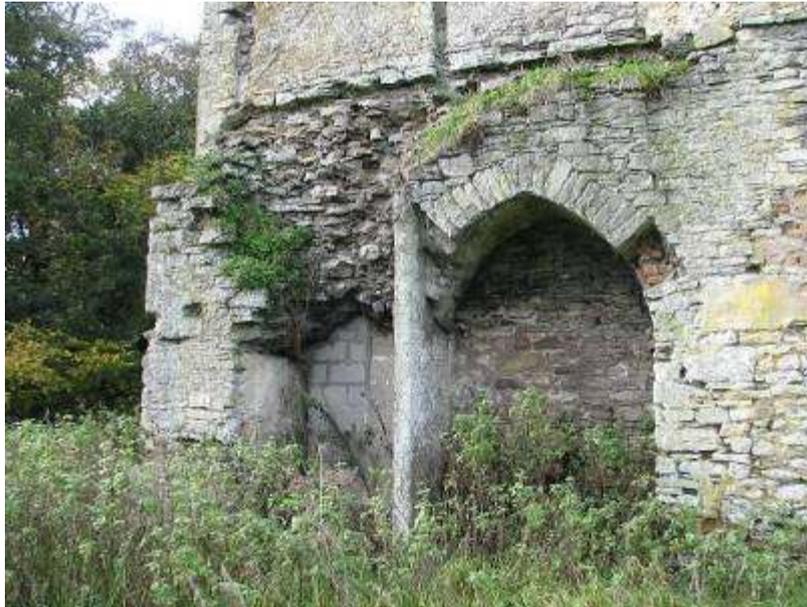
East wall – damaged arch springing and missing voussoirs

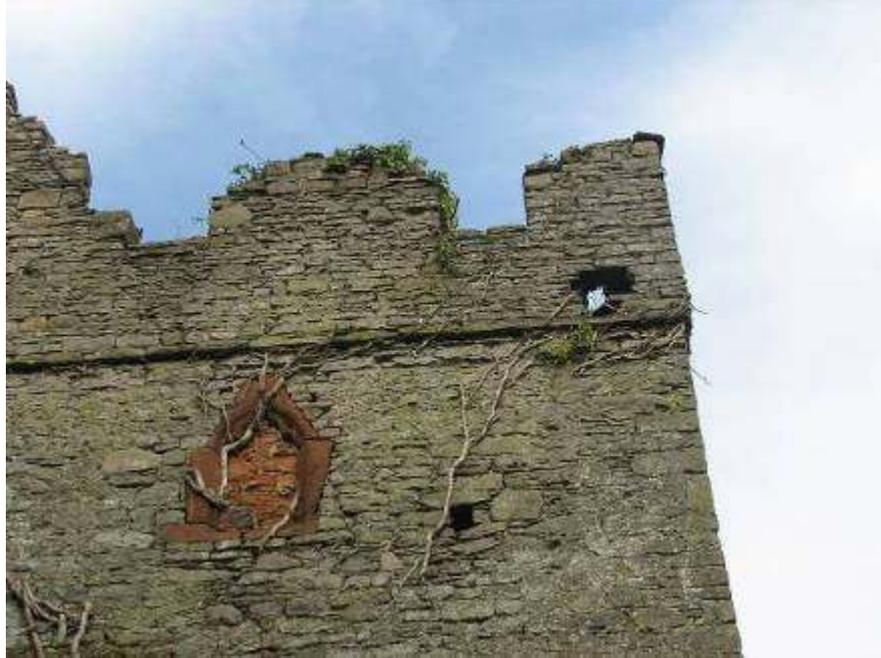
Hole in masonry at south-east corner

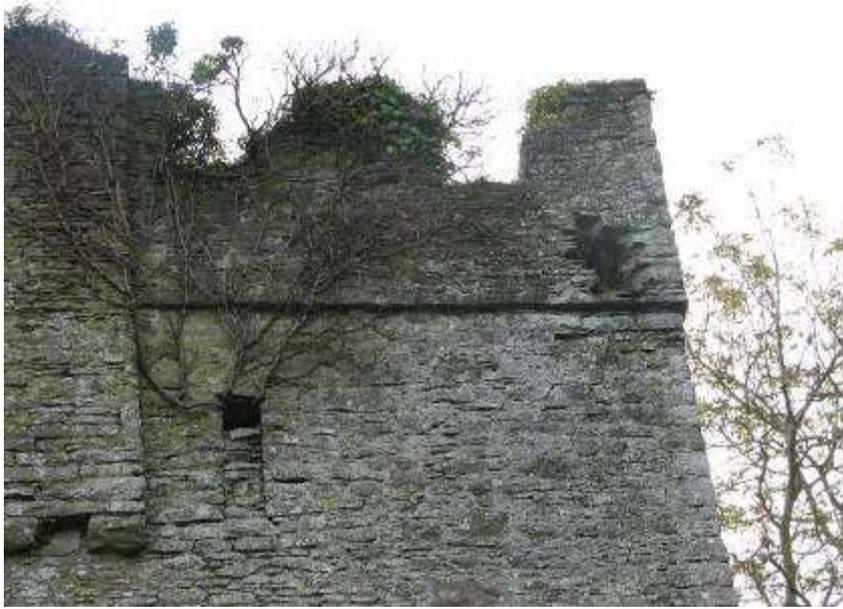
Hole in masonry at north-west corner

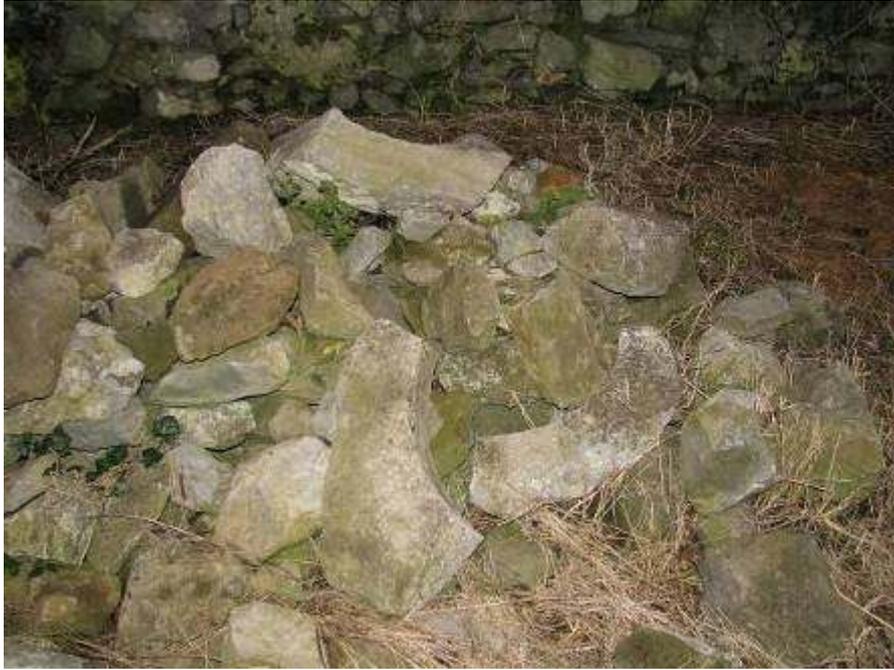
Rubble pile – note cut stones

- 5.5 The fallen and heaped stones should be collected and stored in the chancel area. Any pieces of cut stone should be identified and recorded and consideration should be given to storing them off site. The iron gate within the chancel should be closed and locked to provide some minimum protection to the stored masonry.

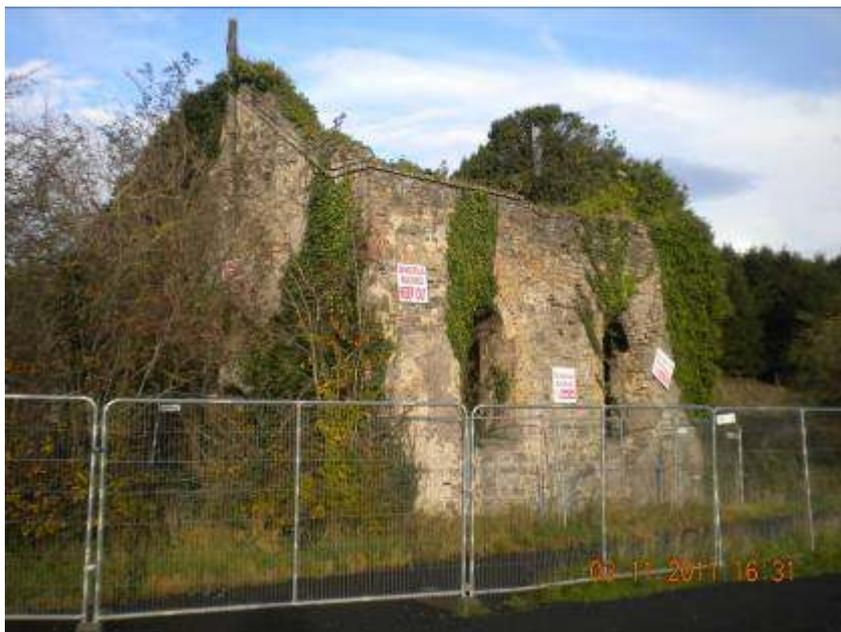
This structure is in very poor condition primarily due to the action of rampant vegetation. The brickwork lining in the window surrounds, the eaves course and on the barges has been severely damaged. Mortar has been washed out in many places and there are local bulges in the walls which may be evidence of interior voiding. As noted above, the west, east and north walls are obscured by vegetation at present and it is possible that there are serious structural defects in these walls. The plaster on the outsides of the walls has been almost completely lost.

Detail of brick barge

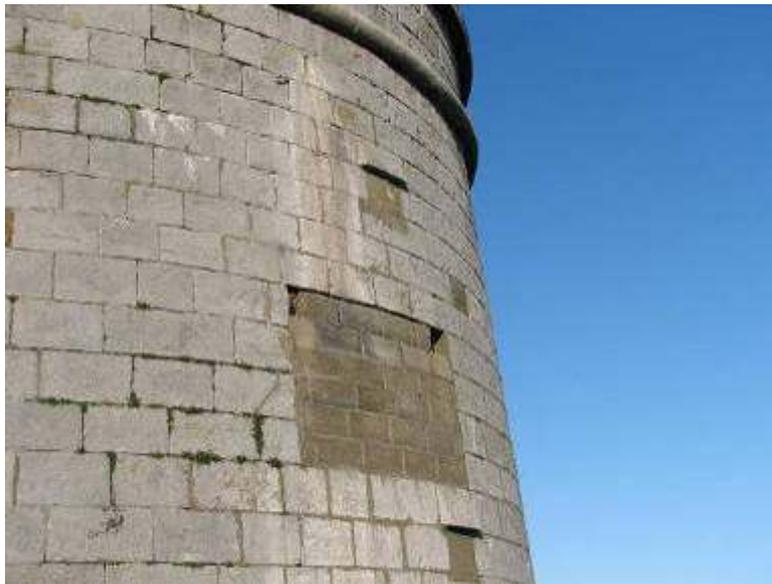
Detail of blocked up former openings

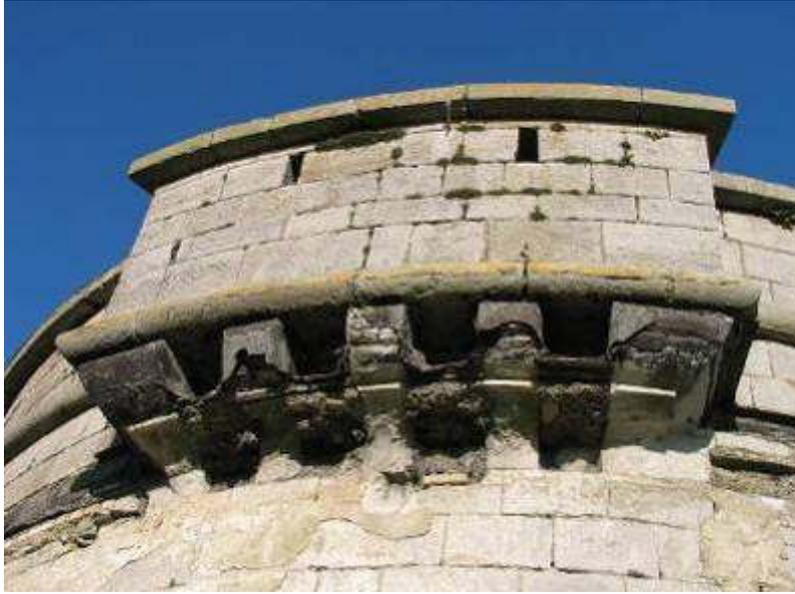
On the exterior there is no evidence of subsidence and no structural cracking was noted. However the brackets supporting the machicolation appear to have been damaged, probably when a structure was erected against the tower. There is extensive loss of mortar from the masonry joints. In some areas, the mortar has been replaced by inappropriate cement pointing, which may result in moisture retention in the masonry. At high level there is moss growing in the joints which is evidence of dampness in the wall. At low-level, mortar has been completely washed out of the joints. There appears to be virtually no ventilation of the interior.

Detail of machicolation with concrete infilling

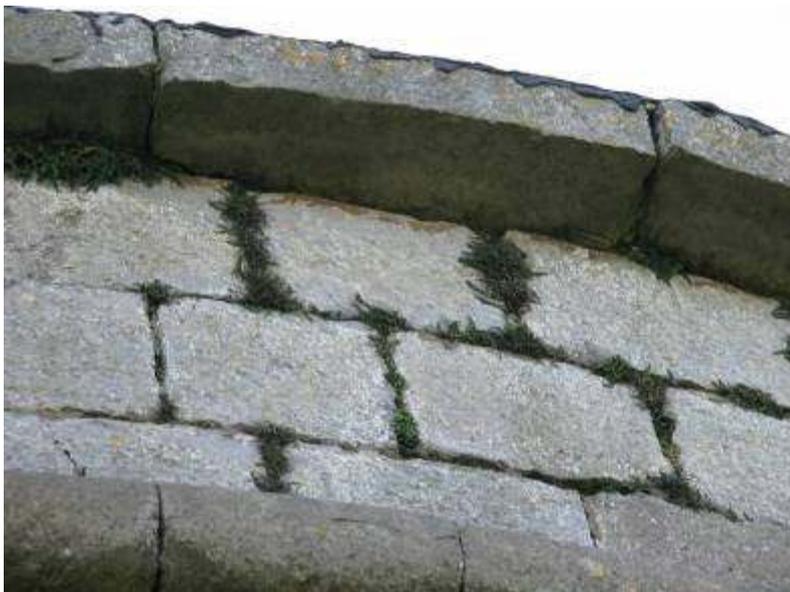
The condition of the wall tops and gun platform is not known as there was no access to the roof of the structure. The excessive dampness within the building is evidence that substantial re-pointing and waterproofing is required at roof level.

Evidence of water ingress at high level

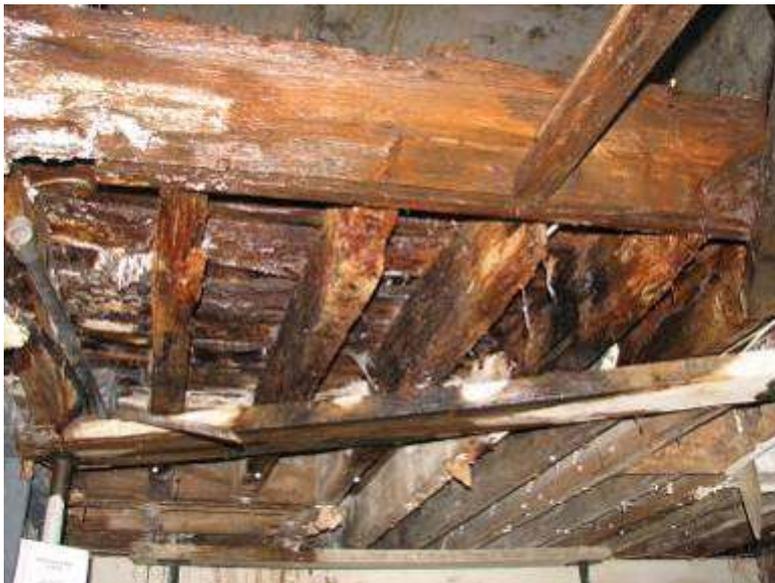
The interior of the building is very damp. The floors and walls are palpably wet and there are 'stalactites' suspended from all the soffits above the first floor. The timber elements in the building are very badly affected by wet rot which makes it unsafe to access the first floor as noted above. The first floor steel beams are badly corroded.

Ground floor – note rotted timber floor over

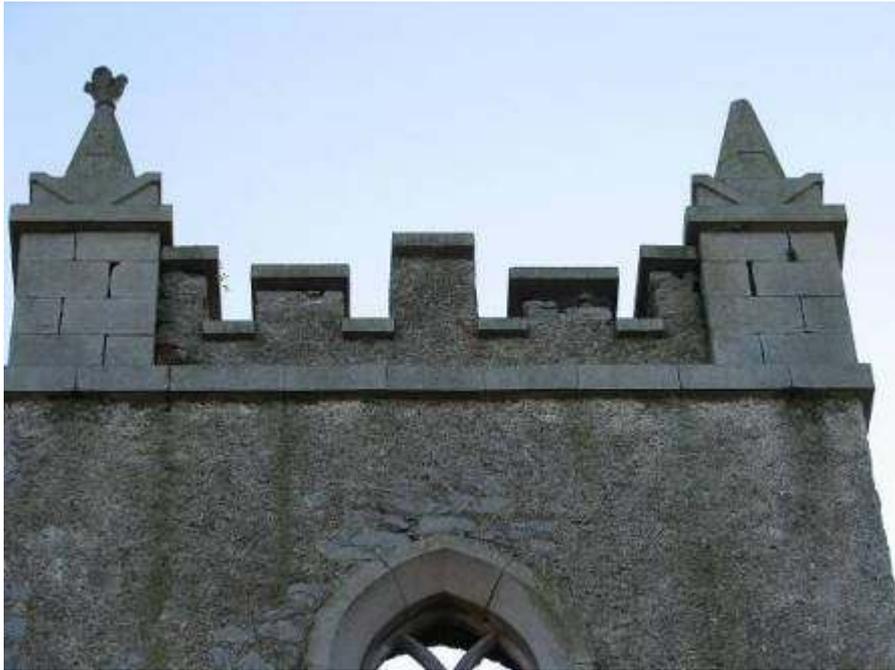
Parapet detail – east elevation

- 5.2 The parapet requires to be completely refurbished and repaired. This will require scaffolding the building on all sides and providing access to the inside faces of the parapet walls. Loose remnant timbers and lead flashings should be removed. The vegetation growing from the parapet should be sprayed with biocide and removed. Damaged and dislodged stones should be re-set. The parapets should be re-pointed and flashed. The pointing should be carried out using hydraulic lime (NHL 3.5) and fine sand in a 1 : 2.5 mix. All of the work should be specified by an experienced conservation professional.

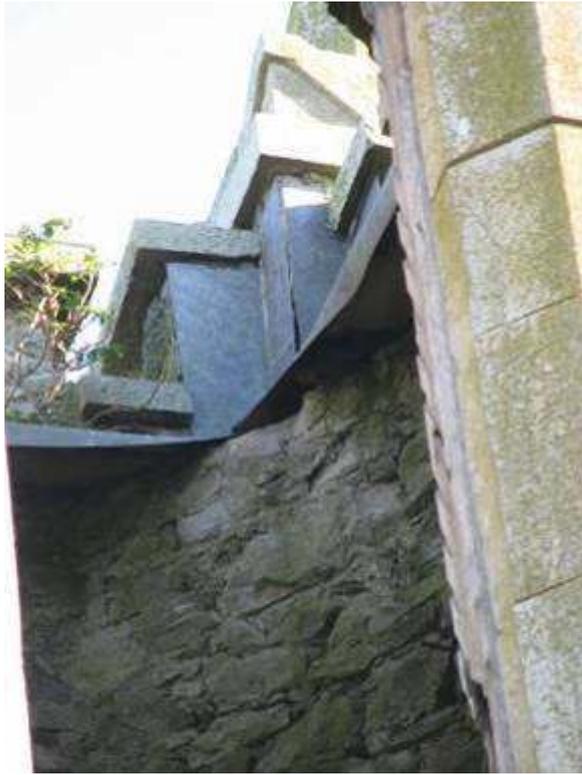
Detail behind parapet (note unsupported lead gutter lining)

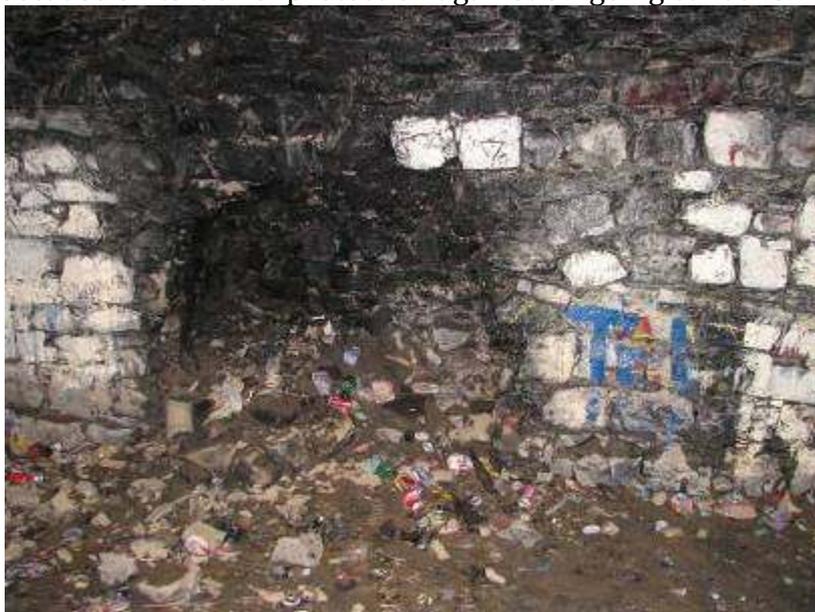
Undercroft – collapsed fireplace

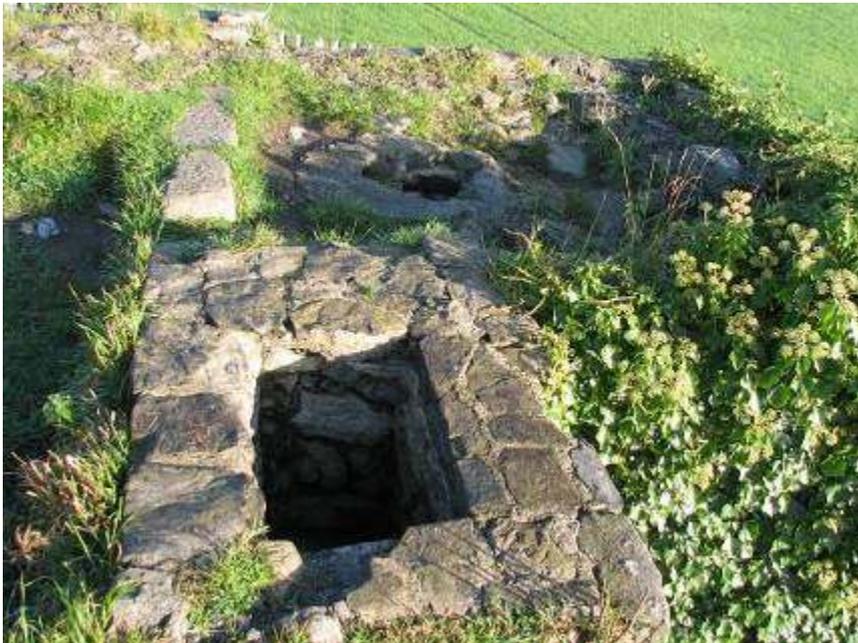
First floor east side – note truncated chimney and north-east tower

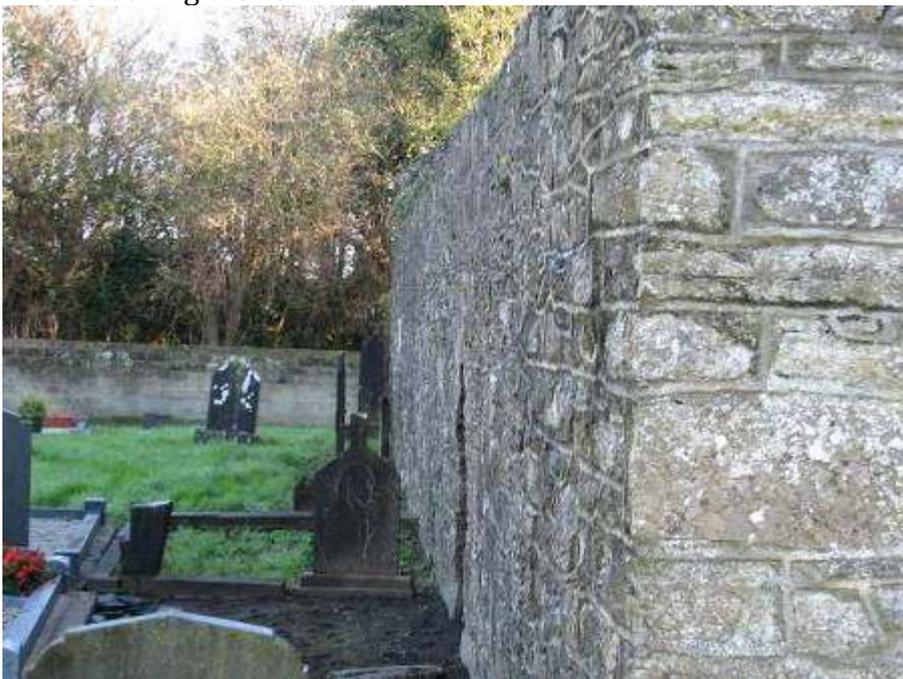
View along north wall (note bulging)

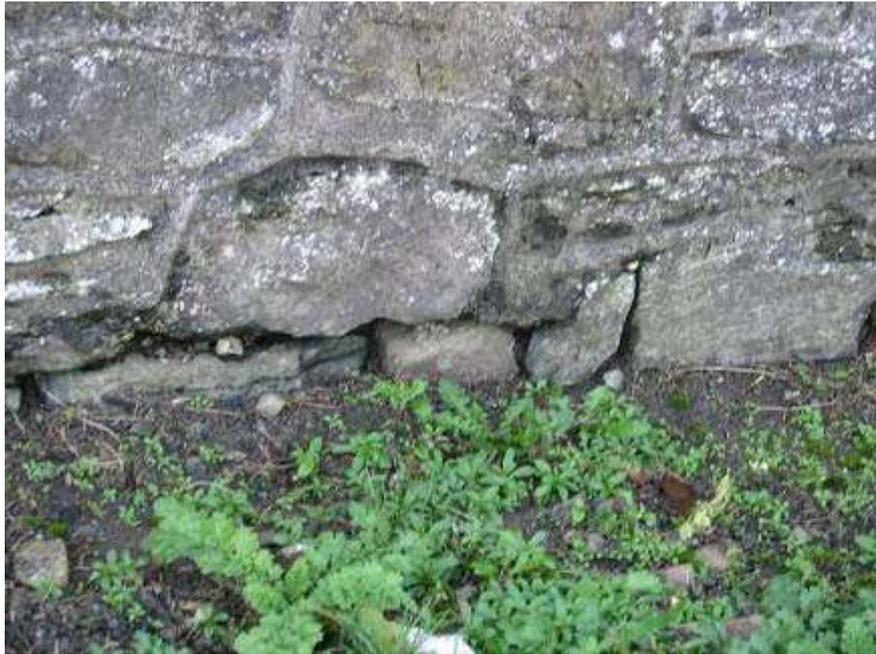
Mortar washout at the base of the north wall

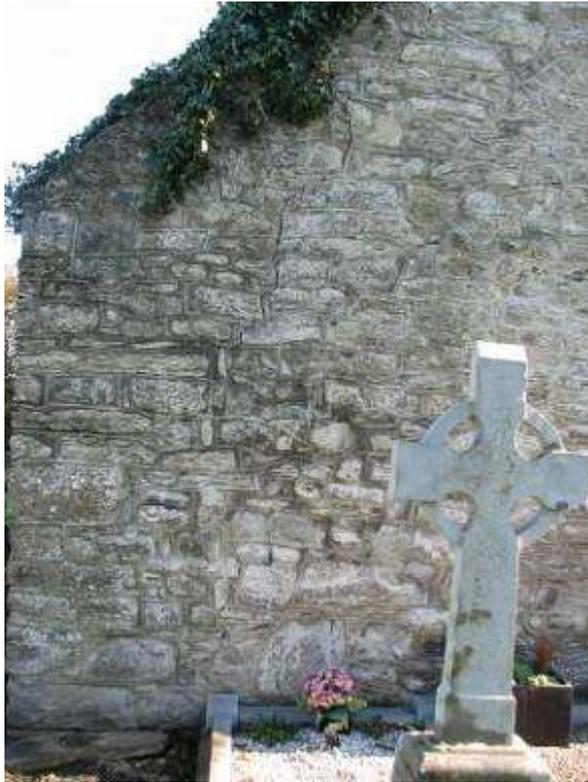
Cracking on east gable (note graves directly beside the wall)

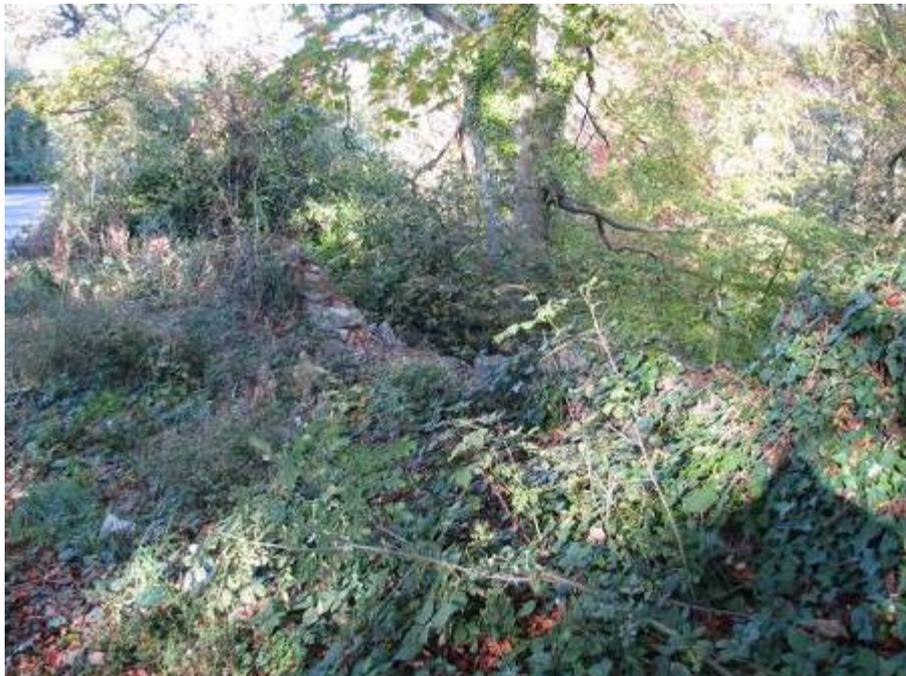
Collision damaged wall south-east of the bridge

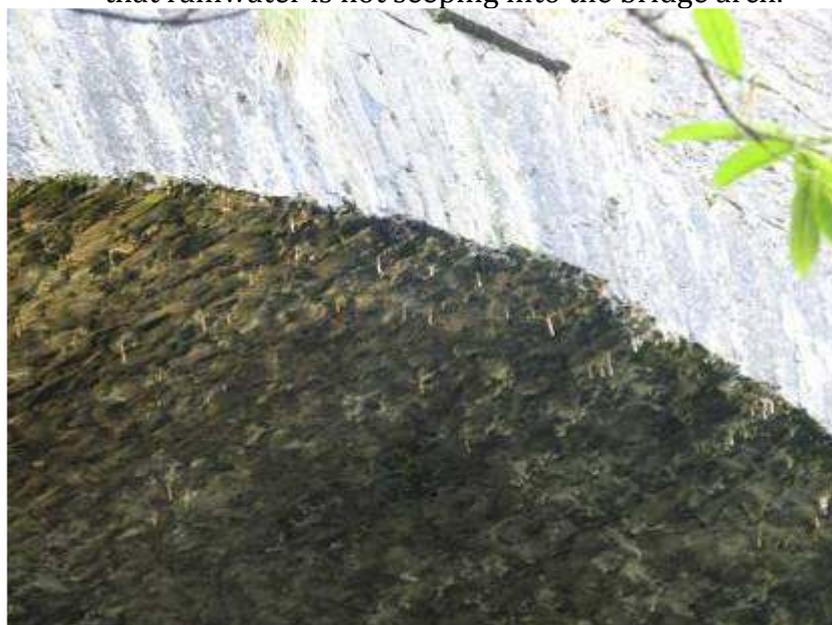
Lime 'stalactites' on bridge soffit

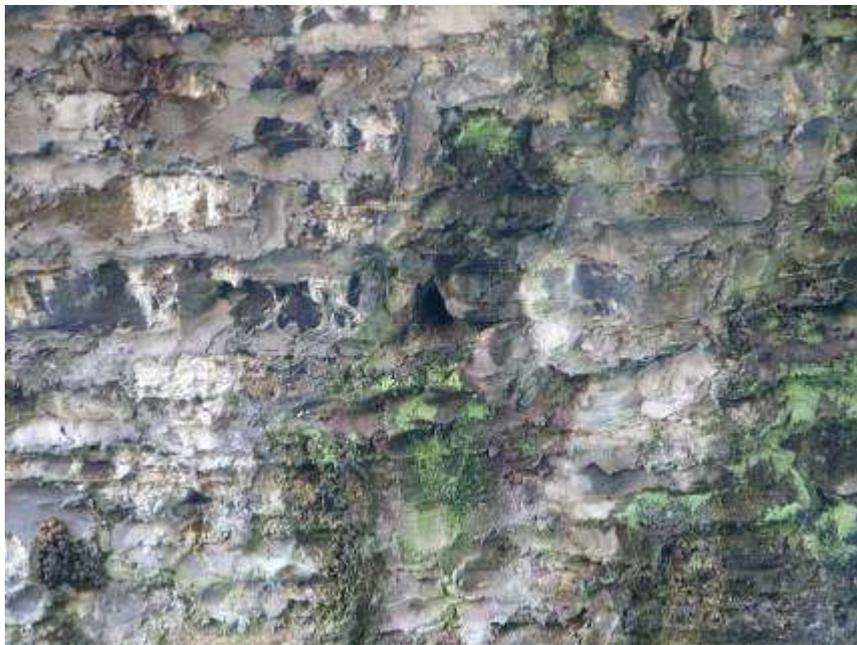
Possible hole in bridge soffit
