**Archaeological Excavation
Preliminary Report**

**Season 1: August-September 2015
Swords Castle
Swords
Co. Dublin**

**Consent no.: C450
Excavation ref: E004619**

By
Christine Baker
Community Archaeologist
Fingal County Council

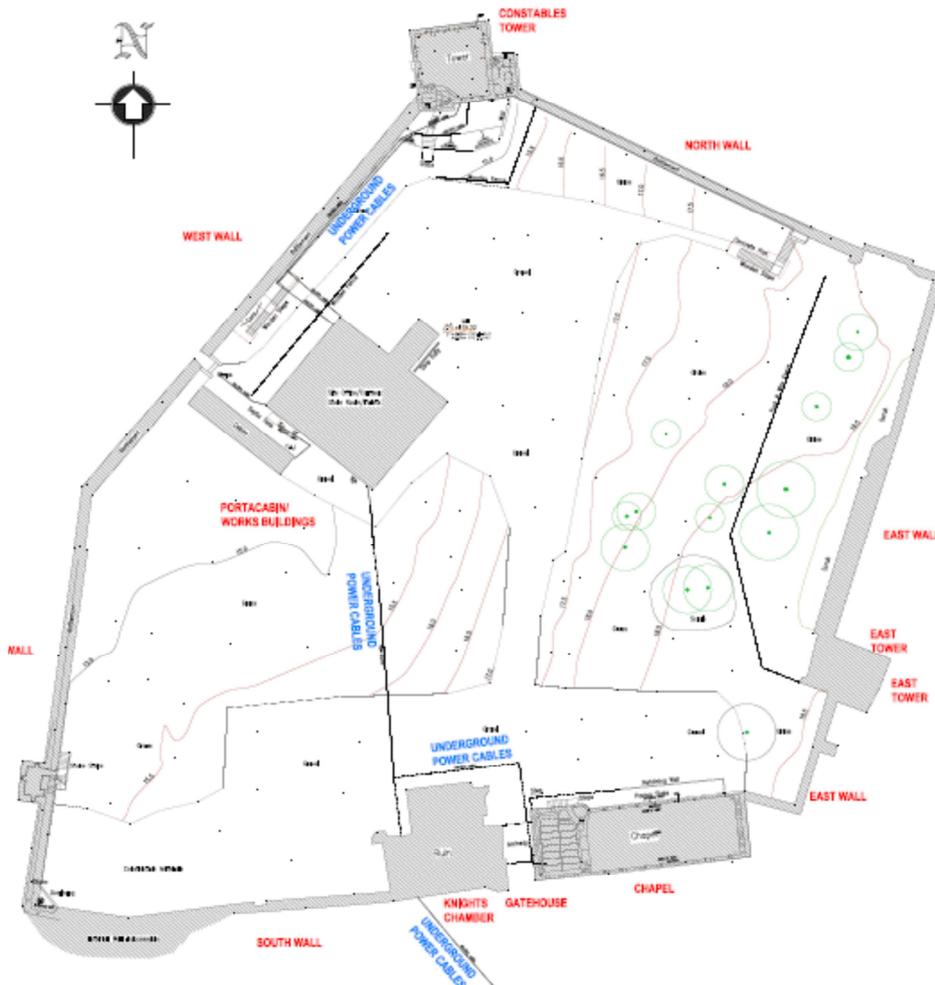
Fig. 2: Swords Castle-current site plan (incl. contours and known services)

There are well established apple trees on the higher ground to the east. The area to the south-west was previously used as an equipment compound and is currently under gravel. The access way and carpark is under compacted asphalt. The remaining open spaces within the site are under grass.

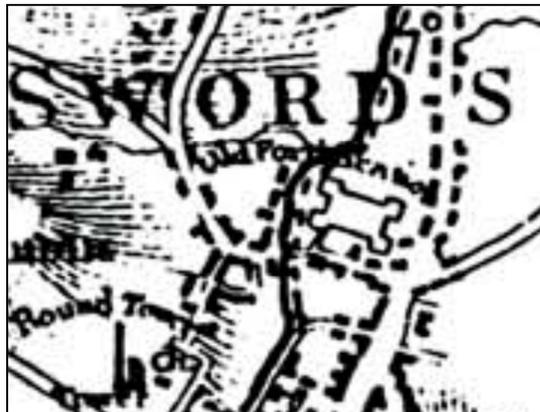
Fig. 7: Taylor 1816

John Taylor records little additional detail on his 1816 map of Swords and environs (Fig. 7). However, the castle is described as an 'old fortification' and is shown erroneously as a rectangular fort with four corner bastions and is aligned incorrectly with the Main Street.

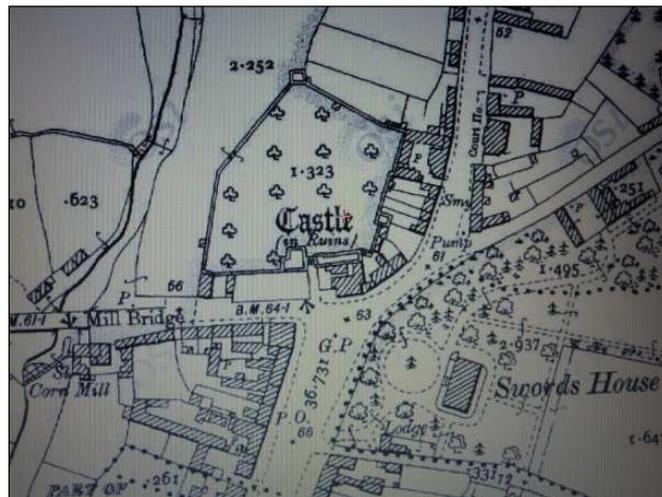
Fig.10 OS 25-inch 1906 revision

The OS 25-inch 1906 revision map (Fig. 10) shows a traditional orchard layout but the paths and borders have apparently gone or simply overgrown and not recorded. The open access from the rear garden of one of the houses of the 19th century terrace has been closed off.

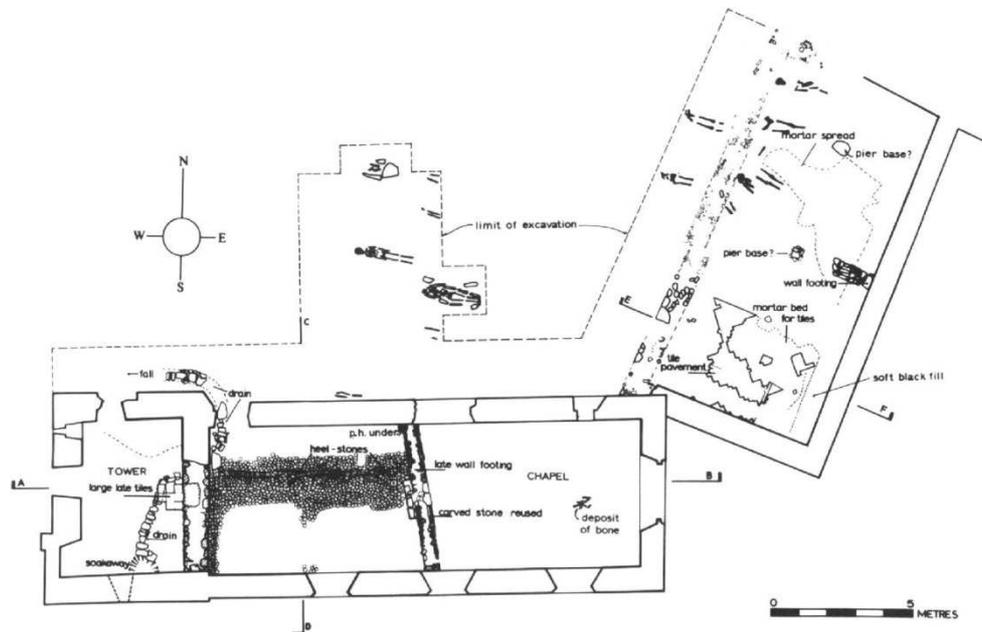
Fig. 11: Fanning's 1971 Excavation, (JRSAI 1975)

1971 (E101) Tom Fanning excavated the Chapel & Chamber Block located in to the south-east of the castle. A medieval tiled floor, a silver denier tournois dated to AD 1310 and skeletal remains were identified.

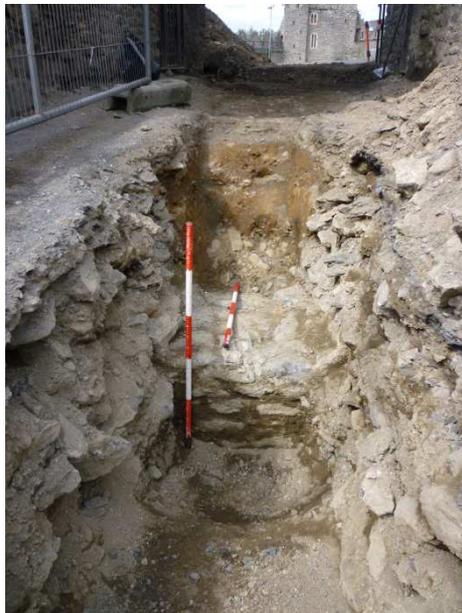
Plate 3: Monitoring undertaken by ADS Ltd., 2011

Immediately external to the gatehouse archaeological monitoring (C450/E4376) of services insertions in **2011** revealed two parallel walls running EW across the entrance.

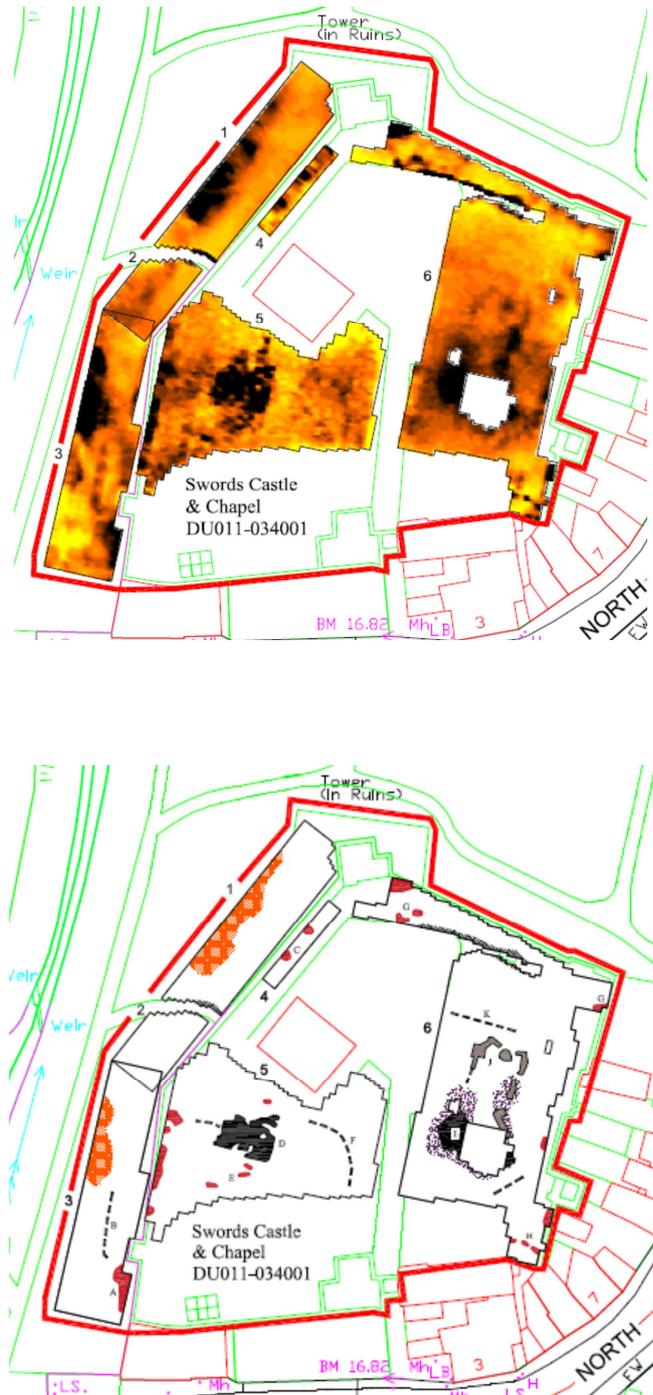
Fig. 14: Resistivity results and interpretation (Nicholls 2011)

Resistivity results indicated no evidence for a moat west of the wall of Swords Castle, although there is a suggestion of underlying material associated with the perimeter wall to the south-east. On the lower ground south of the extant portakabins a sub-rectangular response c.6m x 10m was identified. High resistance responses on the higher ground to the east indicate a grouping extending c.22m NS x 10m EW which may represent foundations associated with buildings (Nicholls 2011, 10-11).

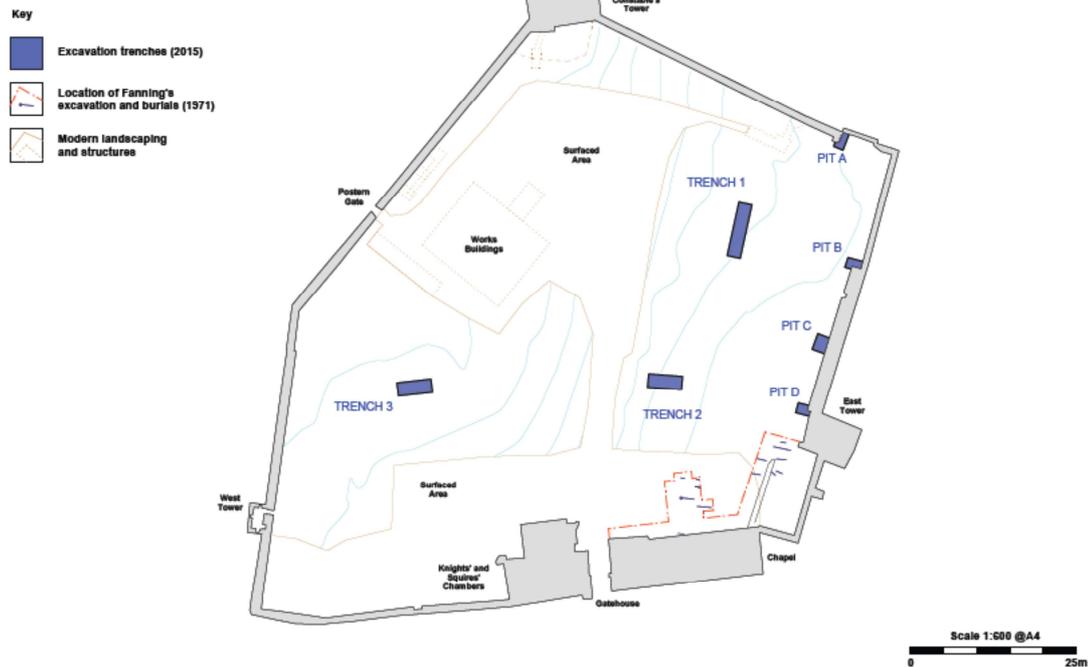
Fig.16 Layout of Trenches 1-3 and Pits A-D

Trench 3 was located on low ground to the west of the precinct in order to investigate an extensive geophysical anomaly. Trench 3 was aligned east-west, measured 5m x 2m and natural subsoil was identified at a depth of 1.1m.

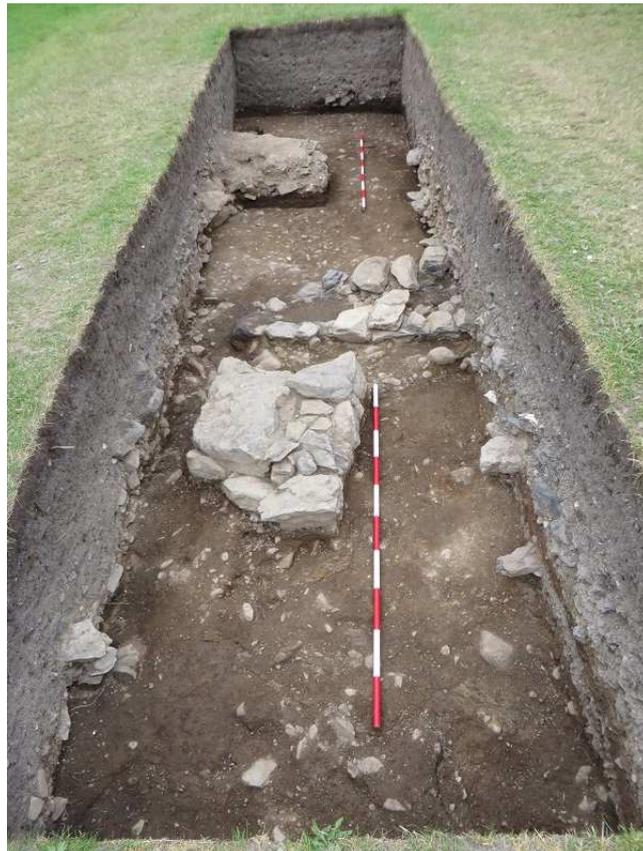
Plate 4: Trench 1, post-excavation, facing south

Natural subsoil was attained at 1.17m below ground level. Structural elements were identified within this trench. A wall (F14) and foundation trench were cut into natural subsoil. To the south of the wall were a series of medieval layer (F23, F8). North of the wall was a metalled surface (F45) with a stone setting (F44) overlain by a series of thin fishbone-rich medieval layers (F41, F42, F43). These layers were truncated to the north by a post-medieval pit (F38). All of this activity was overlain by a consolidation layer (F3), topsoil (F1) and sod.

A step for access was left unexcavated within the trench. Contiguous to the western limit, 1.65m south of the northern limit of the trench, the step measured 0.82m NS x 1m EW.

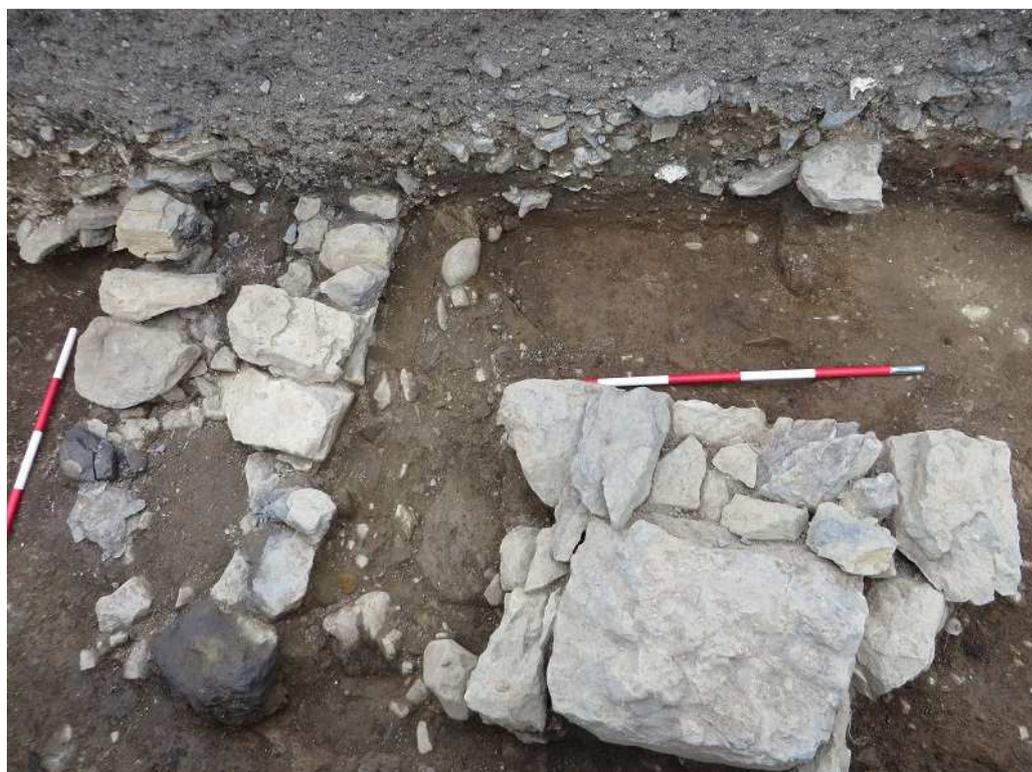
Plate 5: Walls F14 and F9 facing west

Located immediately north of wall (F14), Feature 17 was an area of wall collapse or demolition that extended for 2.25m NS. It comprised large angular boulders and stones of calp limestone and sandstone in a yellow brown matrix 0.35m in depth.

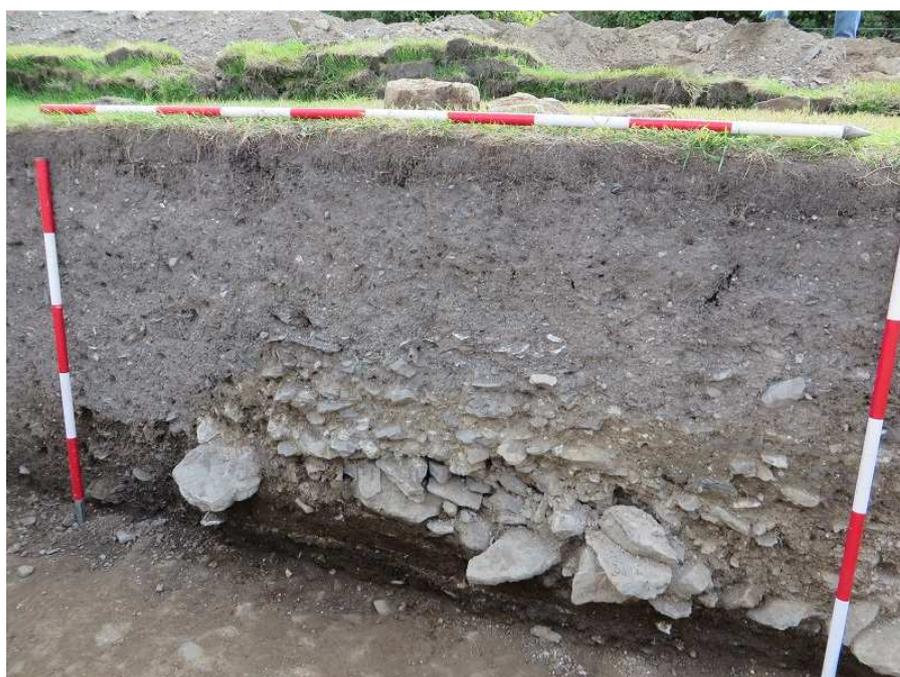
Plate 6: East-facing section, northern quadrant

There was a distinct differentiation between the layers and deposits to the south and north of medieval wall F14.

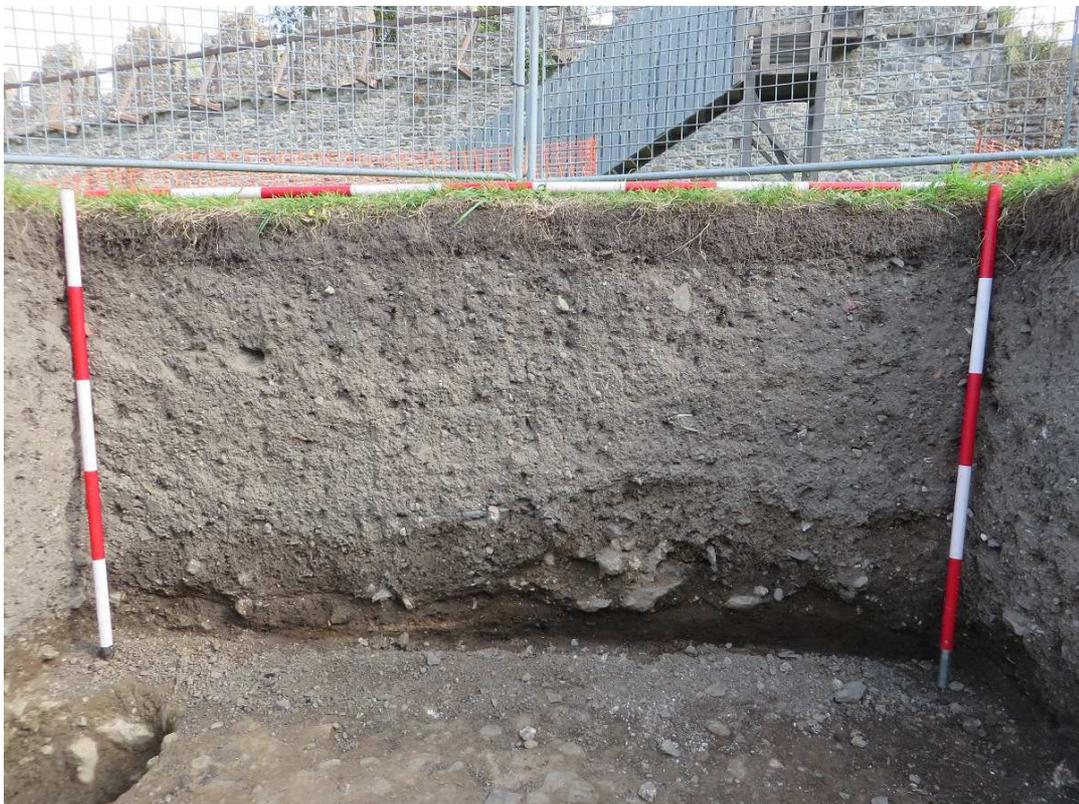
Plate 8: North facing section Trench 1, depicting Pit F38/F6

This was interpreted as a medieval pit truncated by post medieval pit F38/F6, although only the base of feature 39 was in evidence in the south-facing section. It appeared to be concave in section and was recorded as 0.86m NS x 0.68m EW and 0.30m in depth. It contained a friable dark brown silty fill with moderate charcoal, sea shell and animal bone inclusions. A sample (#15) was wet-sieved and is currently undergoing environmental analysis.

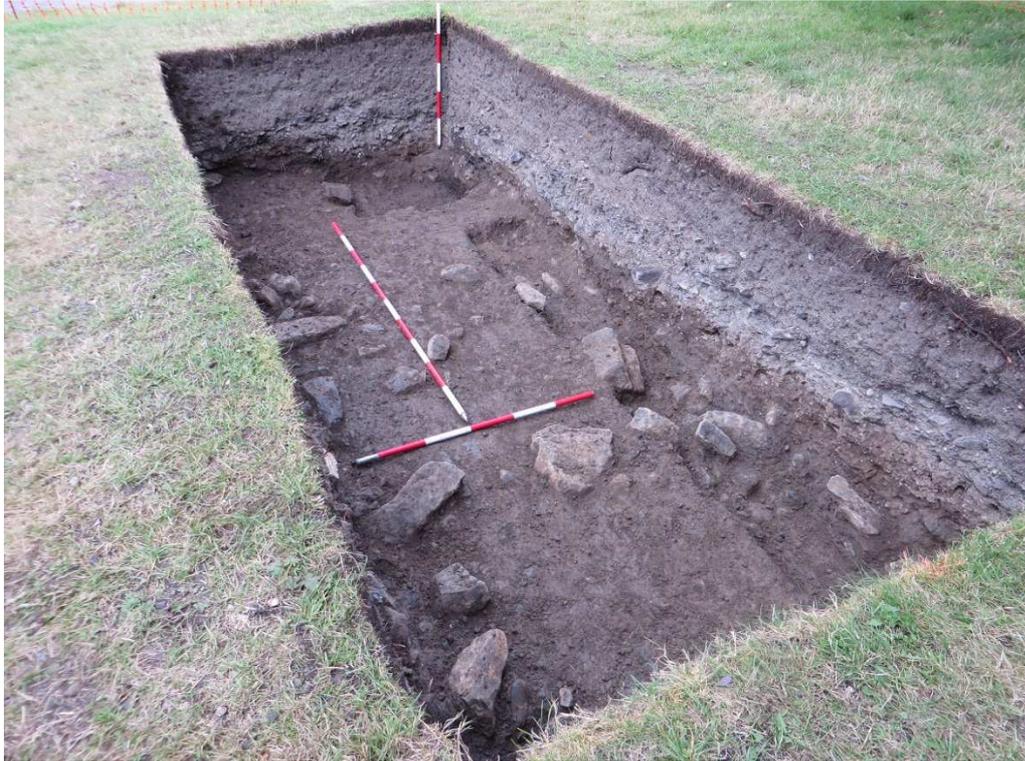
Plate 9: Trench 2 post-excavation, facing north-west

Natural subsoil was attained at 0.88m below ground level. It sloped down from east to west following the topography of the site. Cut into natural was a pit (F19) which was recut at a higher level (F11). Natural subsoil was overlain by a relatively sterile layer (F13) over which a roughly metallised surface (F5). This was overlain by a consolidation layer (F3), topsoil (F1) and sod.

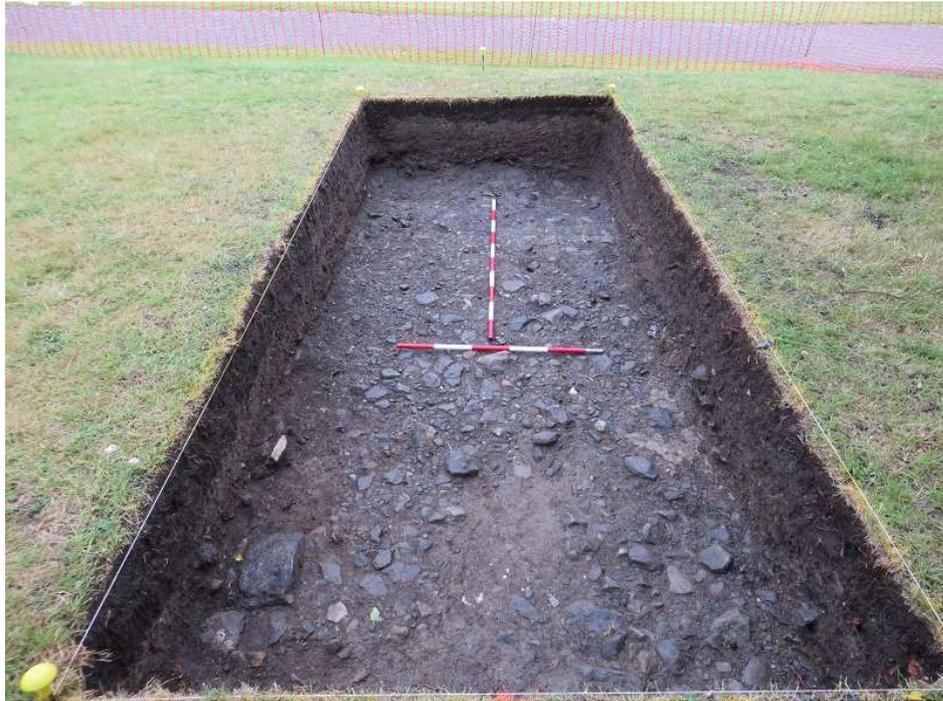
Plate 10: Roughly metallated yard surface F5, facing west

Feature 13 comprised soft mid-brown silty clay that measured from 0.13m to 0.28m in depth with occasional charcoal fleck inclusions. Small amounts of animal bone and sea shell were recovered from this layer. There was a single possible artefact retrieved from this layer, an usually shaped stone (E4619:13:1) which has been preliminarily interpreted as a shell opener. This layer was overlain by a deposit of mortar (F12) (0.6m NS x 0.4m EW x 0.12m d.) at the south western corner of the trench and a very thin concentration of charcoal (F10) (0.2m NX x 0.5m EW x 0.03m d.), located 2.2m west of the eastern limit of the trench.

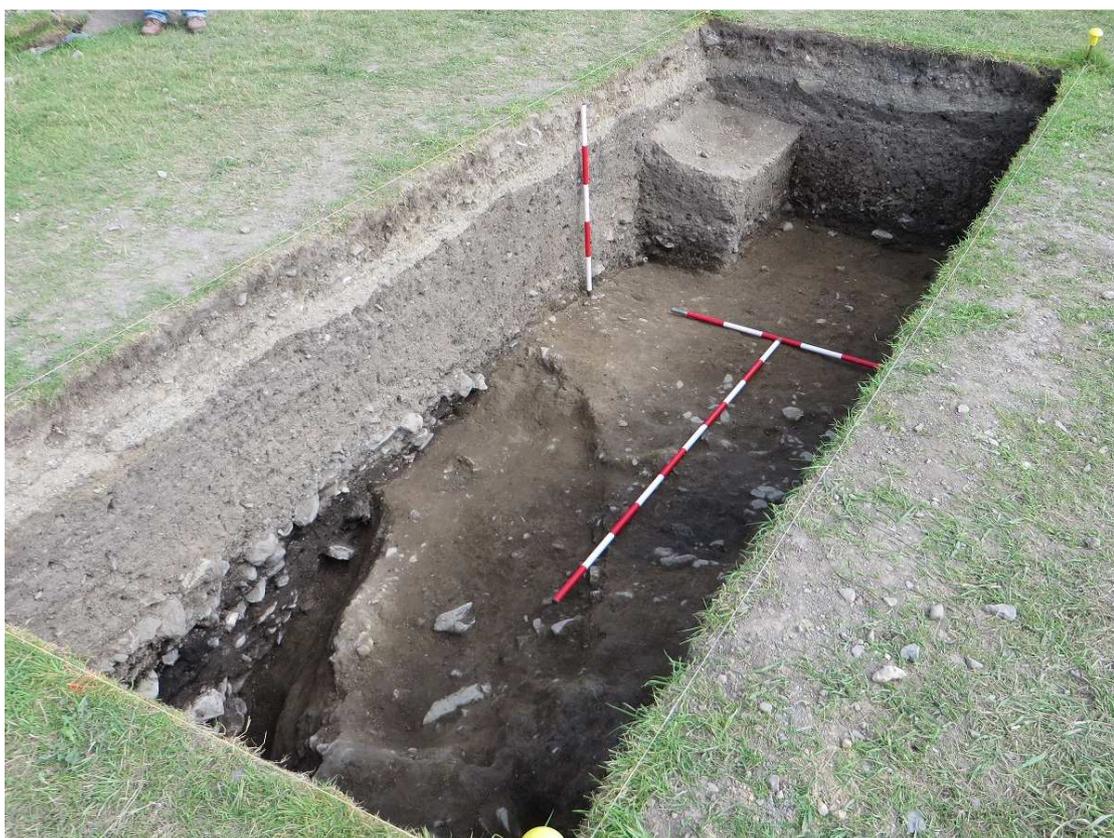
Plate 12: Trench 3, Post-excavation, facing north-east

Contiguous to the north-eastern corner south of the trench a step that measured 0.6m NS x 0.8m EW was left unexcavated in order to provide access.

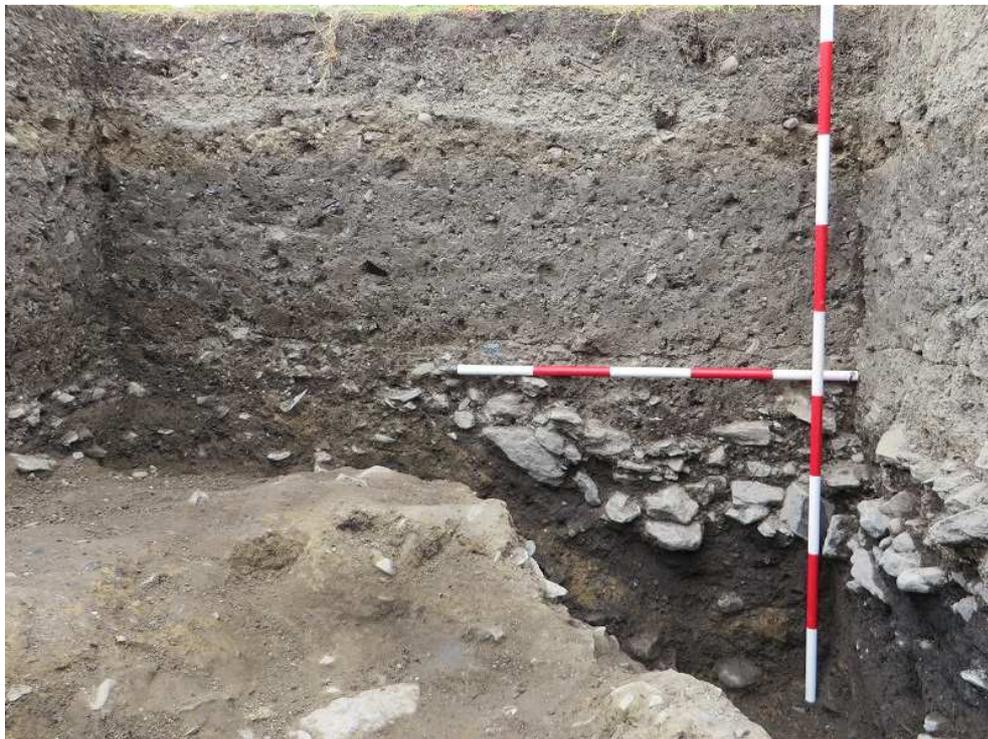
Plate 11: Pit F31 post-excavation, facing west

Cut into natural subsoil and through pit F31, this steep-sided medieval pit extends beyond the western and northern limits of Trench 3. Within the trench it measured 1m NS x 1.7m EW and was excavated to 0.6m in depth. The base was not attained as it was excavated to 1.8m below present ground level and health and safety concerns precluded further excavation. The pit contained four identified fills. The lowest fill consisted of mid-grey silt with medium stones (< 0.02m diam.) and frequent charcoal inclusions. A sample (#21) was wet sieved and is currently undergoing environmental analysis. Above this was the redeposited layer F29. Feature 29 consisted of a firm yellow-orange mottled clayey silt deposit that infilled pit F31 and extended southwards over pit F33. It had a maximum depth of 0.15m tapering away to the south. A human seventh cervical vertebra (Linda Lynch pers. comm.) was recovered from this deposit.

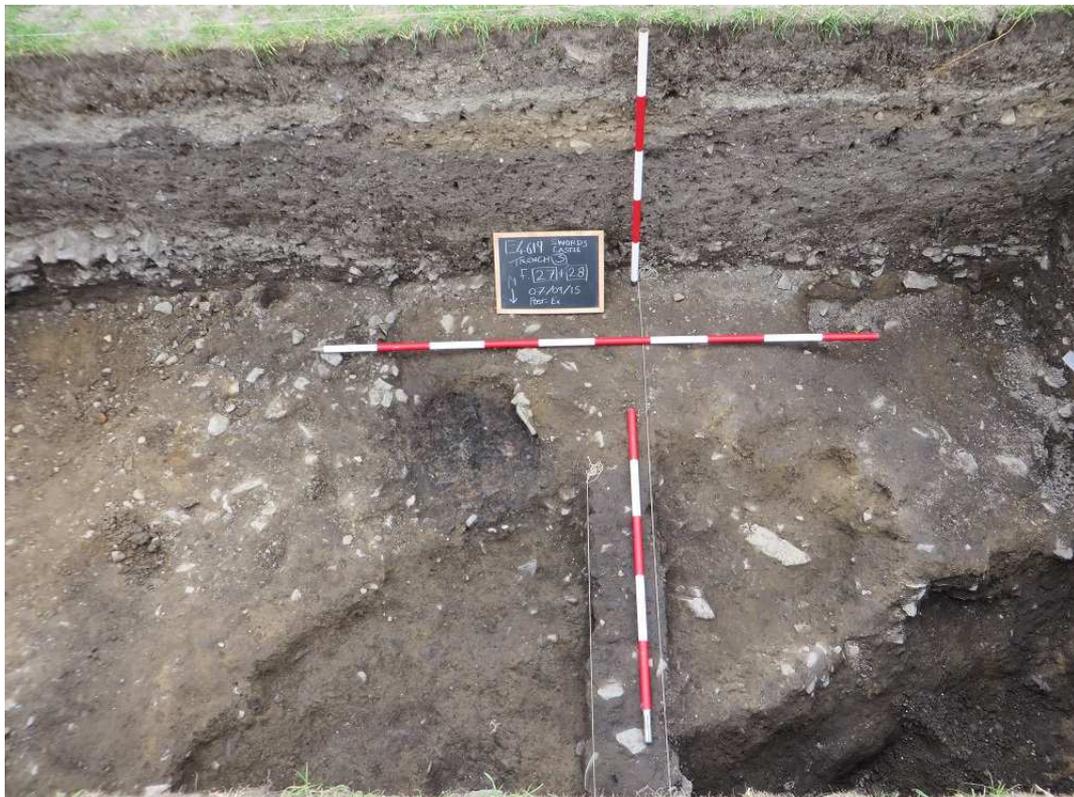
Plate 14: Pit F28 and hearth F27, facing south

Lying on top of metallised surface F50, Feature 46 was a sub-circular spread of loose charcoal that measured 0.35m in diameter and 0.03m in depth. There was no sign of in situ burning and this feature may represent spread from nearby hearth F27.

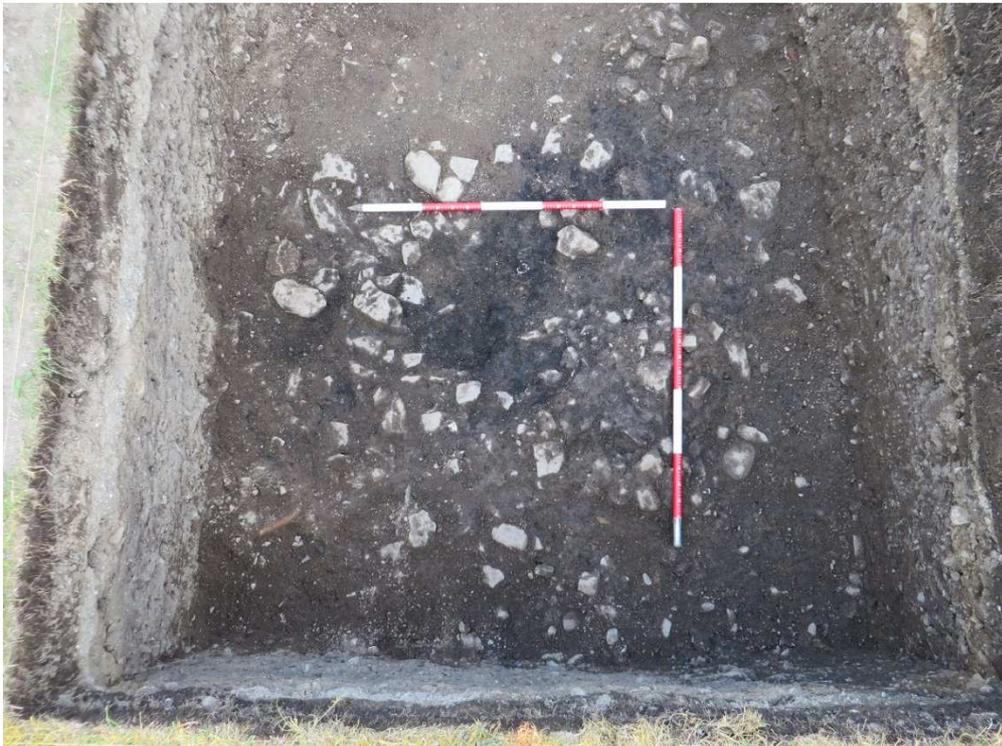
Plate 16: Stone surface F18, pre-excitation, western quadrant Trench 3

Located to the east of Trench 3, delineating layer F21, this feature consisted of a concentration of larger stones (0.1m-0.2m diam.) in a low linear, dome-topped bank. At its apex it measured 0.3m in height tapering downwards. Aligned NE/SW feature 20 measured 1.5m x 1.4m and consisted of stones in a light mid-brown firm clayey silt matrix. Animal bones including small mammal/bird bones and fishbones and sea shell were retrieved. Artefacts recovered from this layer include medieval pottery, a lead weight and iron nails. This layer was abutted by layer F18, both of which were overlain by topsoil F1.

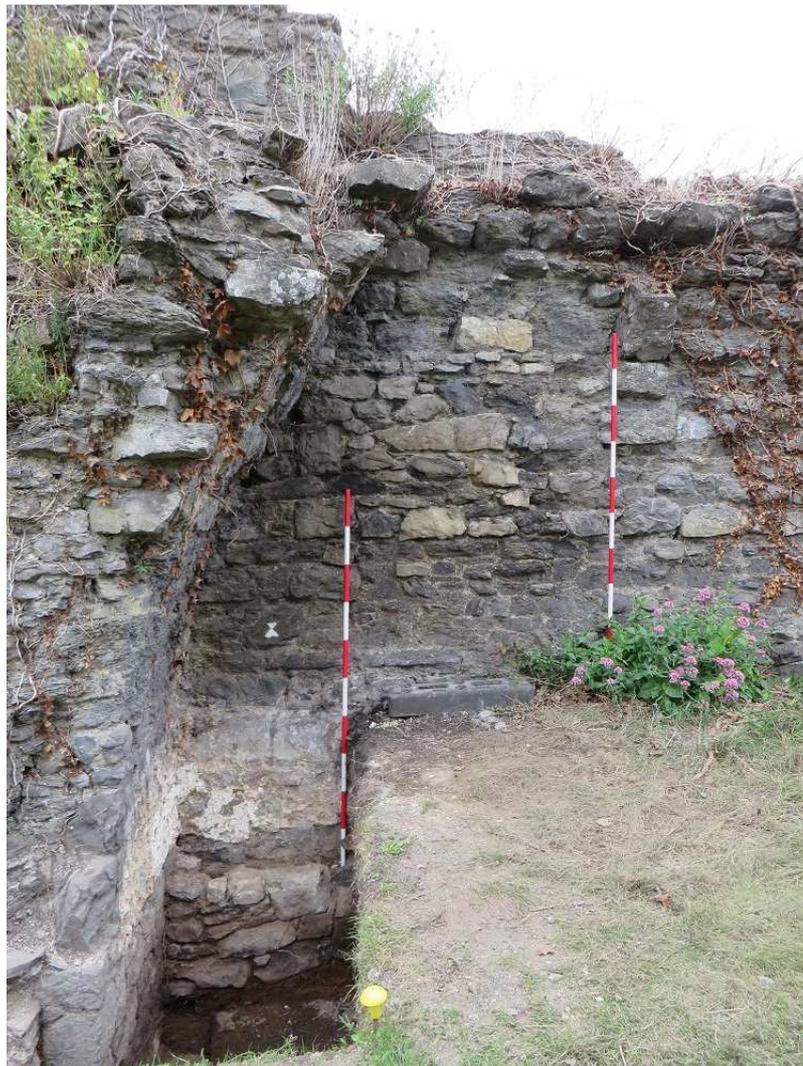
Plate 17: Pit A, post-excavation, facing north

Located at the western junction of the curtain wall and a possible mural tower in the north-eastern quadrant of Swords Castle precinct, Pit A measured 2.4m NS x 1.5m EW. The remnants of an arch extending from the northern perimeter wall and an adjacent NS wall to the west were visible prior to excavation. Pit A was excavated to a depth of 1.2m below present ground level, where excavation ceased due to health and safety issues.

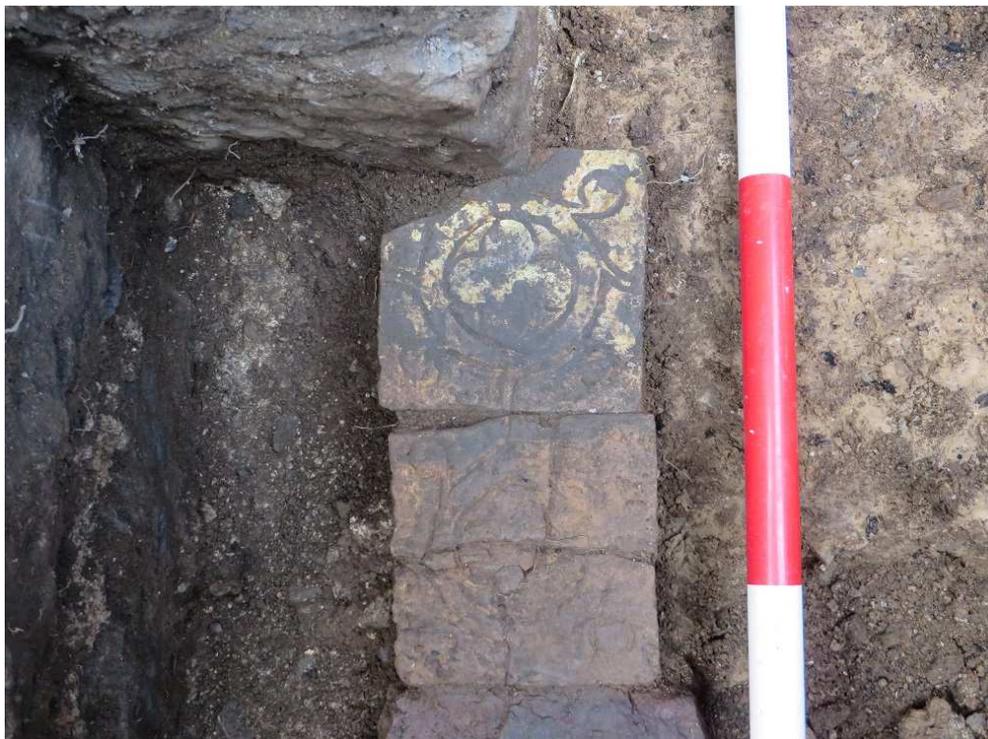
Plate 18: Medieval floor tiles, clay F47 visible to the east

The lowest layer uncovered within Pit A consisted of very compact light yellowish brown clay. Feature 47 extended for the full extent of the pit. It was cut by the insertion of wall F49 to the west. A sondage (0.55m NS x 0.38m EW) was excavated along the internal façade of the arch of the mural tower. The depth of clay F47 was 0.2m in depth here and overlay the foundation wall of the building mortar. As it extends southwards this layer becomes less substantial, measuring 0.08m in depth. Two apparently *in situ* medieval floor tiles immediately overlay feature F47 contiguous with the cut for wall F49.

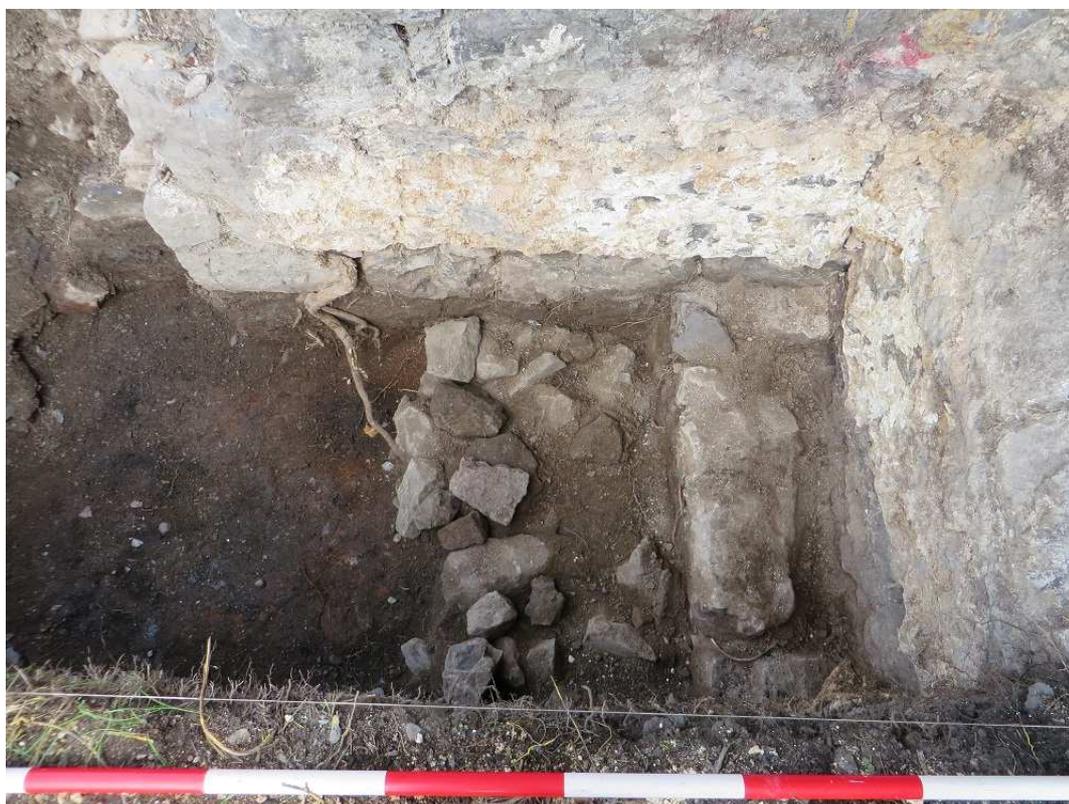
Plate 19: Stone dump F25 and wall F48, facing west

Positioned to the north of Pit A, this clay-bonded wall was identified 0.7m below the present ground surface. F48 measured 0.5m in height and extended 0.35m south of the northern castle wall. Comprising large and small stones F48 encompassed a space (0.67m EW x 0.15m NS) filled with loose brown clay, between its northern façade and the castle wall. Set on red/brown burnt layer F26, there was no cut apparent. A dump of stone F25, extended southwards for 0.61m from the southern façade of F48.

Feature 24 comprised a substantial layer 0.5m in depth of purple slate fragments and mortar in a gravelly brown clay matrix. It abutted stone dump F25 to the north and was sealed by topsoil. A sherd of medieval pottery, unburnt animal bone, and seashell were recovered from this layer.

48	Pit A	Clay-bonded comprising large and small stones F48 encompassed a space (0.67m EW x 0.15m NS) filled with loose brown clay, between its northern façade and the castle wall.	0.35m NS x 1m EW; 0.5m in height	F26/F30	F2					
49	Pit A	NS wall extending southwards from the extant arch of mural tower. Consists of large mortar-bonded blocks of cut calp limestone. The basal 0.4m of the inner façade of F49 was heat-affected due to the presence of burnt stone and material abutting it. A foundation cut measuring 0.15m east-west was visible, cut into clay deposit F47, the fill of the wall foundation was loose mortary material. It was not excavated.	0.8m NS; 0.5-0.72m in height	?	F24					
50	T3	Metalled surface of compact small rounded and sub-angular (0.01m-0.04m diam. and 0.1-0.15m) stones pressed into natural	2.3mEw x 1m NS and 0.05m deep	Natural	F27					
51	T1	Deposit identified in SE end of the trench; mid brownish grey silty clay of friable compaction with inclusions of charcoal and small pebbles.	2.8m NS x 0.7-1m EW and 0.08m-0.10m deep	F23	F8

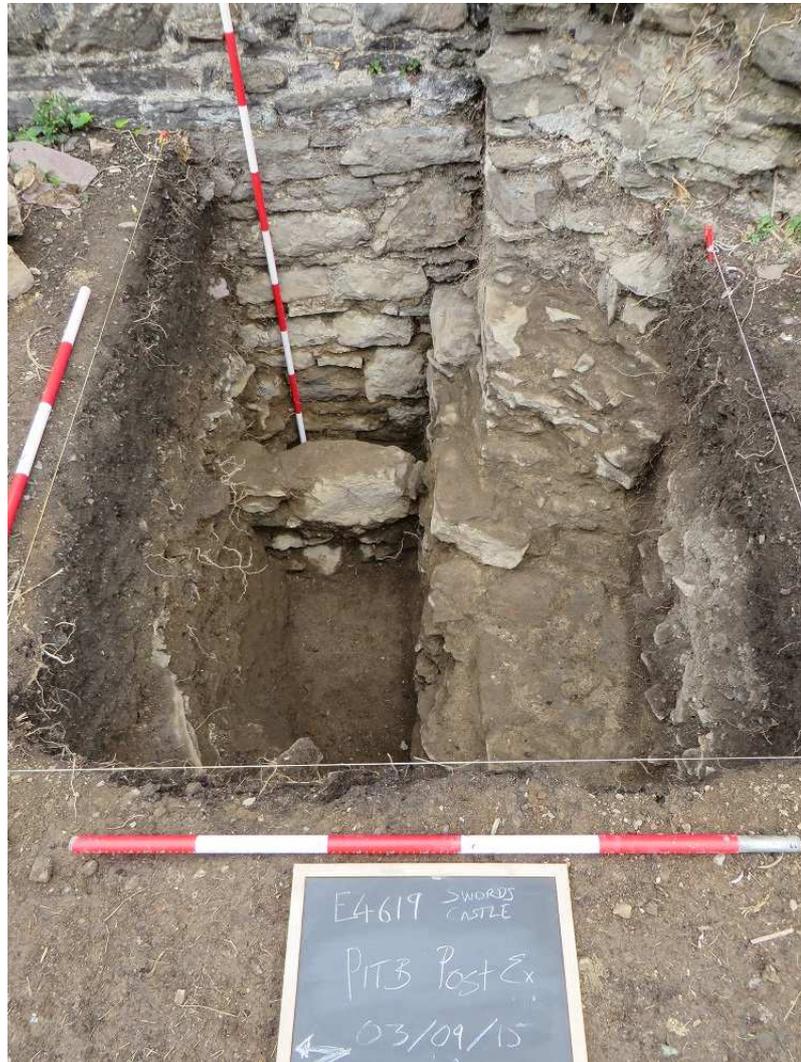
Plate 20: Pit B post-excavation , facing west

Located at the northern junction of the curtain wall and the gable ruin of the eastern range of Swords Castle precinct, Pit B measured 1.5m NS x 2m EW and was excavated to a depth of 1.4m below present ground level.

Excavation at the junction of the towering east gable and the curtain wall established that a wall extended westwards from the gable, although the extent of the structure has yet to be established. A small north-south wall at foundation level of the eastern gable building wall appears to have been used as a retaining wall while construction of the curtain wall was undertaken. Later interference was apparent, internal to the curtain wall and eastern gable, resulting in truncation of the structural remains.

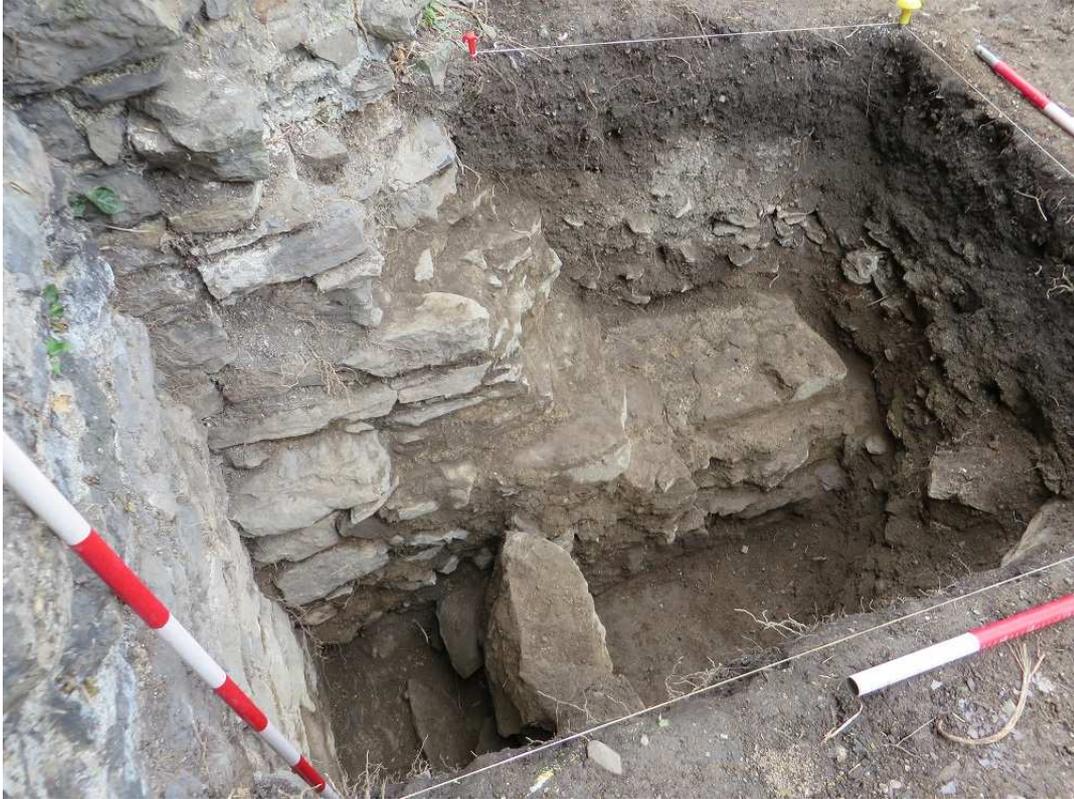
Plate 21: Wall F36, facing south

This wall extends westwards from the gable and was exposed for 2m. The upper portion of the wall had been truncated 0.9m west of the inner façade of the gable wall. The foundation levels of wall F36 consisted of 3/4 courses of clay bonded rough stone(average 0.12m diam.)which stands to a height of 0.47m. The upper course of the foundation of this wall was

topped by a mortar layer into which a course of cut stone (0.3-0.37m diam.) was placed, 0.11m from the northern edge of F36. Above this the wall consisted of mortar bonded cut calp limestone.

36	Pit B	EW building wall; Foundation levels consist of 3/4 courses of clay bonded rough stone (average 0.12m diam.); Upper course of the foundation of this wall topped by mortar layer with course of cut stone (0.3-0.37m diam.) 0.11m from the northern edge.	2m NS; 0.47m in height	Natural	F55					
37	T1	Late medieval layer-mid reddish brown silty sandy clay of friable compaction with inclusions of moderate amounts of charcoal, burnt clay. Concentrated in N end of the trench	4m NS x 2m EW and 0.07-0.10m deep	F41	F3	19 sherd medieval pottery; iron piece; flint chunk	2 bags animal bone; 1 crustacean; 1 fishbones; 1 small mammal/bird bones	Seashell		
38=F6	T1	See F26		F43	F1		1 small bag animal; 1 bird/small mammal; 1 fishbone	Seashell		
39	T1	Medieval layer; Cut by later pits F6/F38. Only the base in evidence consisting of a moist dark brown silty clay of friable compaction that contained charcoal.	0.86m NS x 0.68mEW and 0.32m in depth.	F45	F38		1 small bag animal; 1 bird/small mammal; 1 fishbone	Seashell		Sample #15 wet sieved

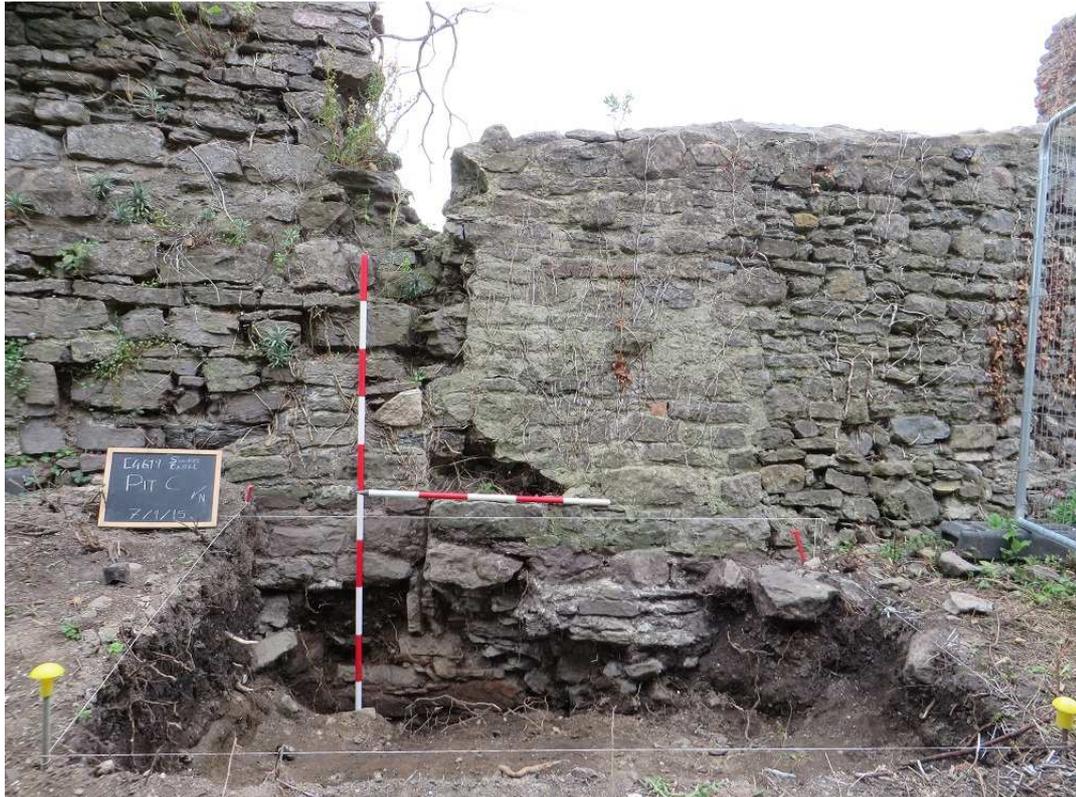
Plate 22: Pit C post-excavation, facing west

Located at the southern junction of the gable ruin of the eastern range and the 'curtain wall' of Swords Castle precinct, Pit C measured 2.5m NS x 1.5m EW and was excavated to a depth of 1m below present ground level. This involved the removal of c.0.4m of dark brown root rich garden soil with modern detritus onto a compact fill light brown onto backfill material that consisted of small stones, stone collapse, slate and modern material, similar to Feature 5 in the nearby Pit B. The unstable nature of the curtain wall in this area precluded further excavation.

On excavation it became clear that there had been extensive modern interference with both the 'curtain wall' and the southern quadrant of the gable ruin. Two courses of the original curtain wall were identified at the base of the excavation. Over this there had been at least three separate phases of rebuilding and attempted repair, resulting in a step out (0.11m in width) constructed from re-used curtain wall stone.

Within Pit C there were several attempts at repair towards the base of the garden wall and specifically at the junction of the gable ruin obscuring the relationship between the two. However two courses of what appears to be the original curtain wall were identified below this. Later interference internal to the curtain wall and eastern gable apparent in Pit B, also extended through Pit C.

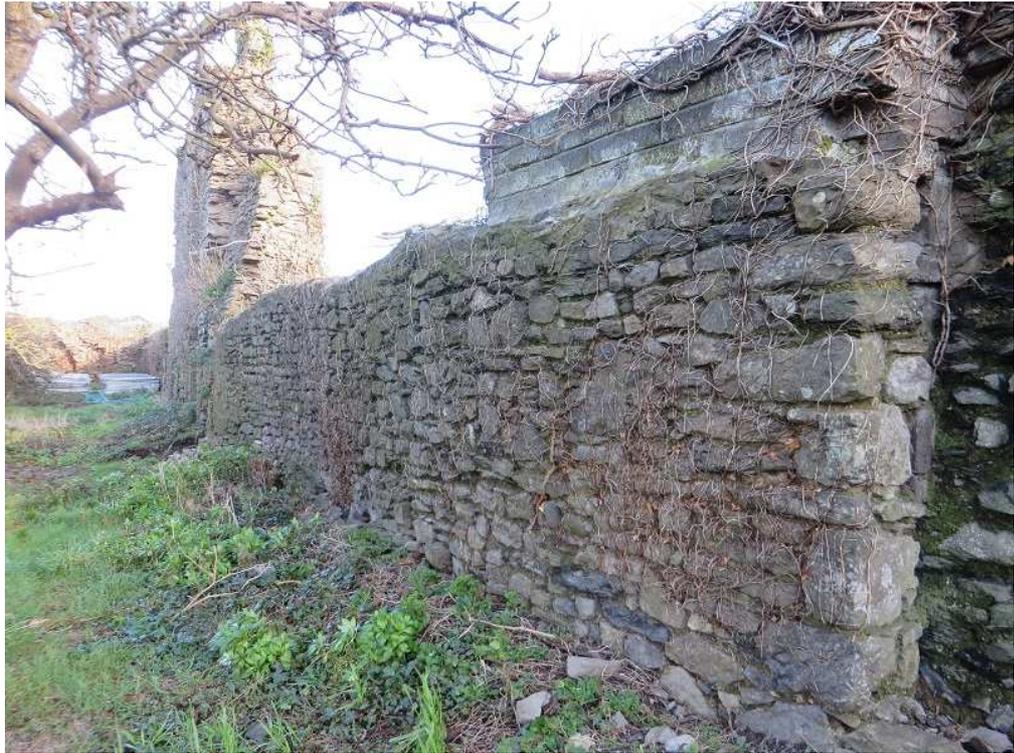
Plate 23: Rebuilt wall section facing north

The section of wall c.11m in length between the extant gable ruin and the eastern mural tower has been rebuilt. It stands 2m over ground level and consists of relatively small stones 0.12-0.25m in diameter which contrasts with the original curtain wall stones which average 0.4m in diameter. This rebuilt section has been subject to attempted repair most obviously a 1.36m NS block immediately adjacent to the gable wall, which had been cemented and contains red brick.

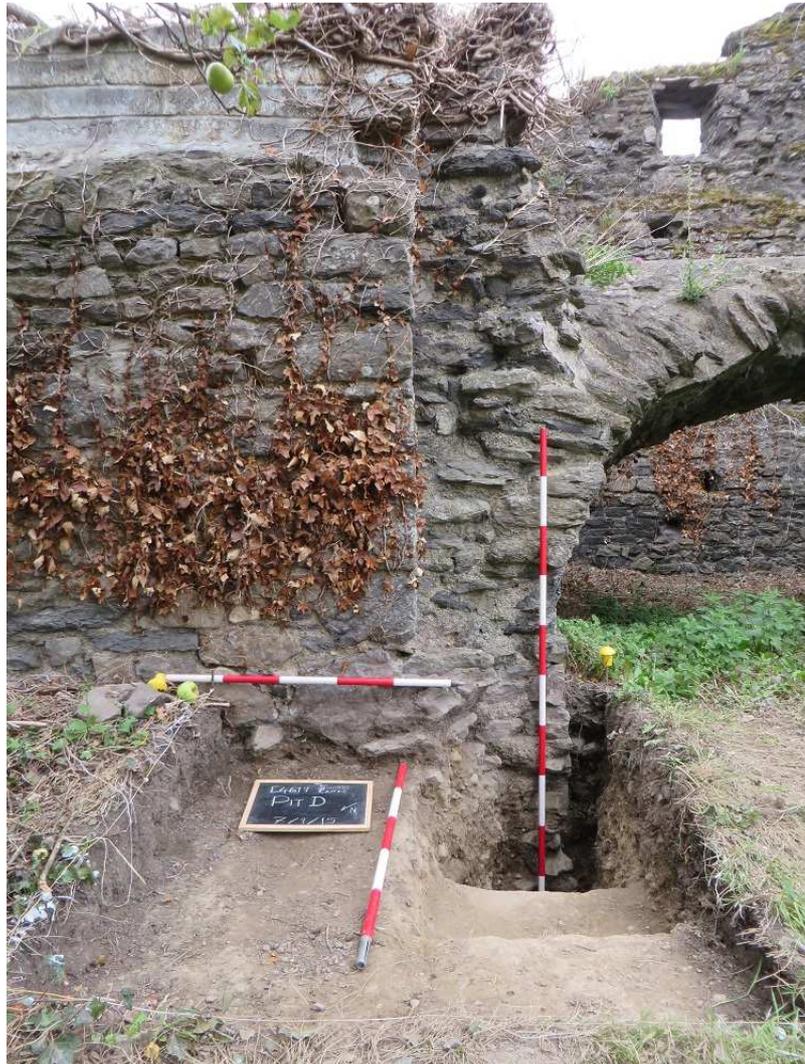
Plate 24: Pit D post-excavation, facing west

Located at the southern junction of the curtain wall of the eastern range and the arch of the east tower of Swords Castle precinct, Pit D measured 1.5m NS x 2.1m EW. and was excavated to a maximum depth of 1m below present ground level. This involved the removal of garden soil to a depth of 0.4m over the extent of the trench onto a compact yellow brown subsoil. This established the base of the 'curtain wall' in this location. There was also a distinct termination.
