**Archaeological Excavation
Preliminary Report**

**Season 1: August-September 2015
Swords Castle
Swords
Co. Dublin**

**Consent no.: C450
Excavation ref: E004619**

By
Christine Baker
Community Archaeologist
Fingal County Council

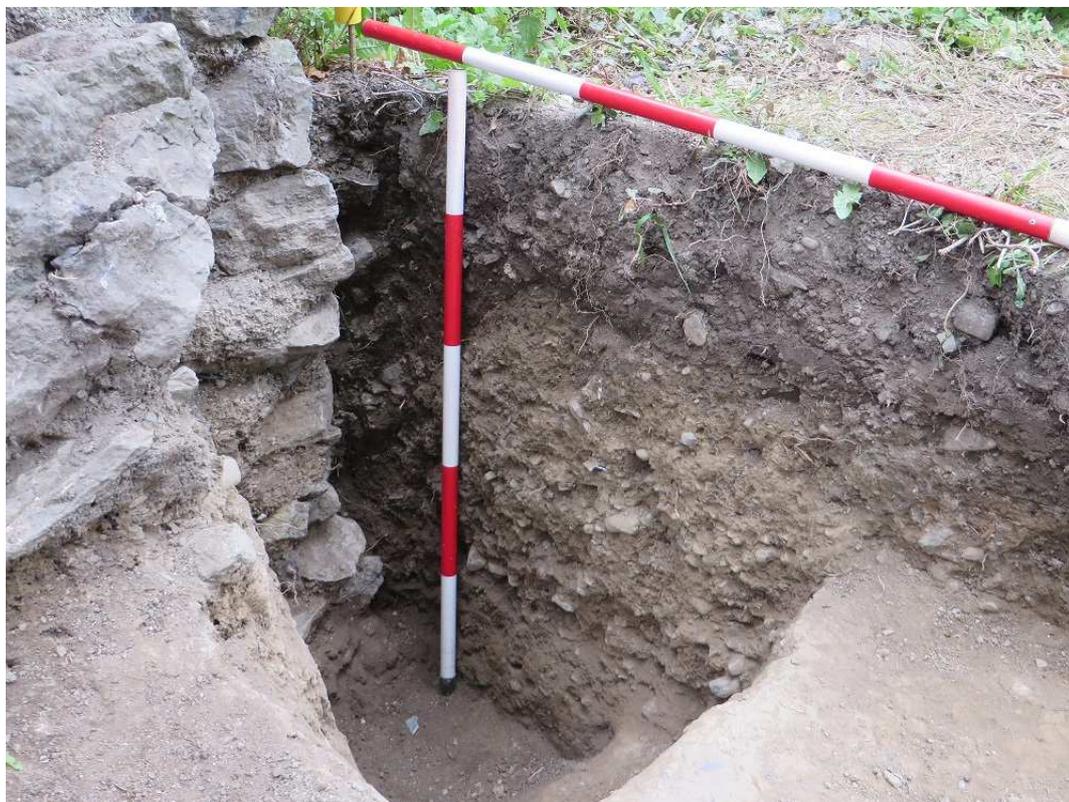
Plate 25: Sondage within Pit D, facing south-west

A sondage 0.75m NS x 1.25m EW was excavated at the southern limit of the curtain wall contiguous with the northern arch down to natural subsoil. The foundation of the arch measured 0.9m in height and consisted of mortared stone becoming increasingly rubble-like towards its base. The cut for the arch measured 0.3m east-west at the top narrowing to 0.1m at the base. It was filled with loose mid brown silty clay with moderate small stone inclusions.

There were three distinct layers identified within the sondage in Pit D.

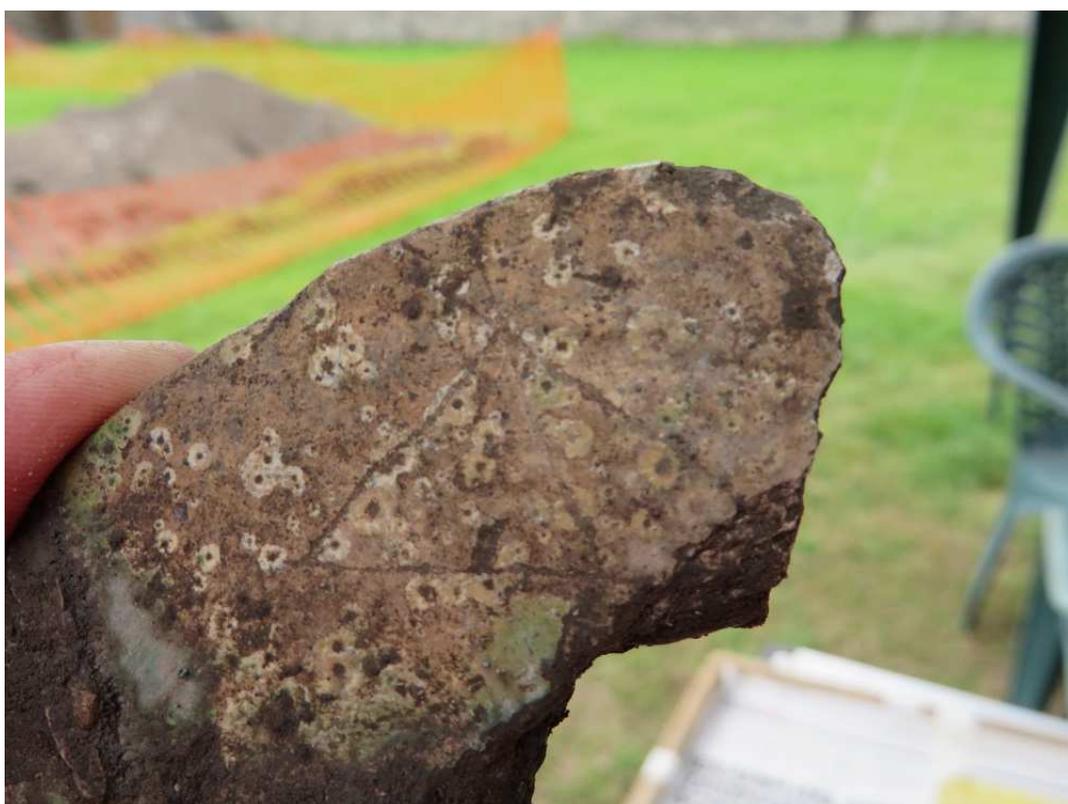
Plate 27: A basal sherd of Saintonge with a possible maker's mark was recovered from the base of a medieval pit F28 in Trench 3
