**Archaeological Excavation  
Preliminary Report**

**Season 3: August-September 2017  
Swords Castle  
Swords  
Co. Dublin**

**Consent no.: C450  
Excavation ref: E004619**

By  
Christine Baker  
Community Archaeologist  
Fingal County Council

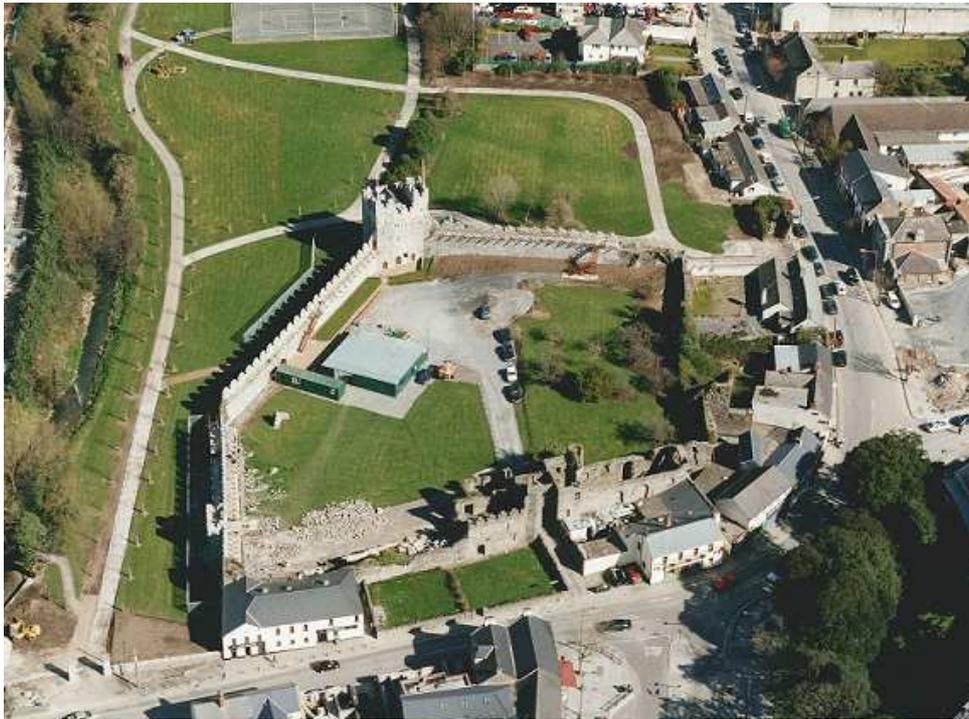
*Plate 1: Aerial Photograph c.2001*

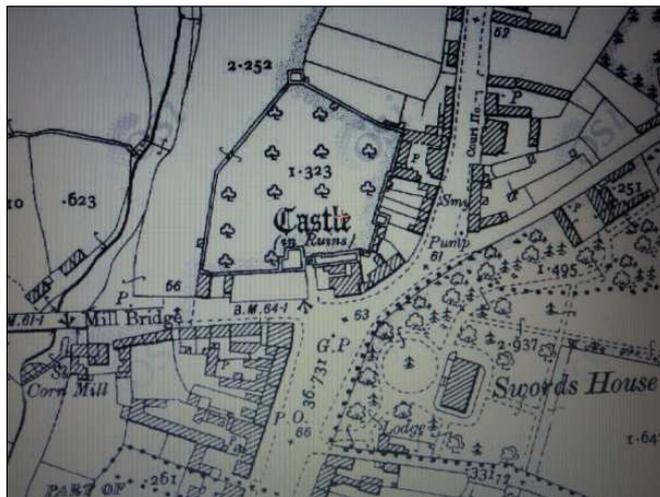
The OS 25-inch 1906 revision map (Fig. 10) shows a traditional orchard layout but the paths and borders have apparently gone or simply overgrown and not recorded. The open access from the rear garden of one of the houses of the 19<sup>th</sup> century terrace has been closed off.

Fig.9 OS 25-inch 1906 revision

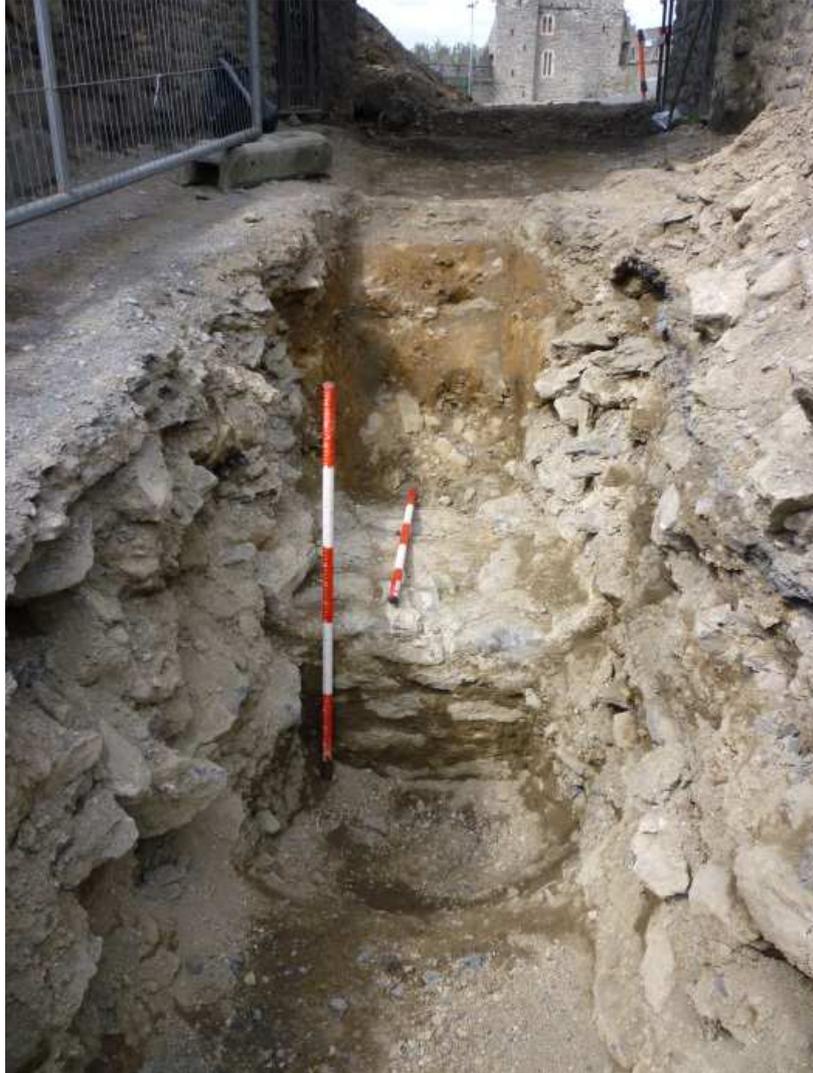
In addition unlicensed archaeological monitoring of service insertions took place in 1996/97. Immediately external to the gatehouse archaeological monitoring (C450/E4376) of services insertions in **2011** revealed two parallel walls running EW across the entrance.

*Plate 4: Monitoring undertaken by ADS Ltd., 2011*

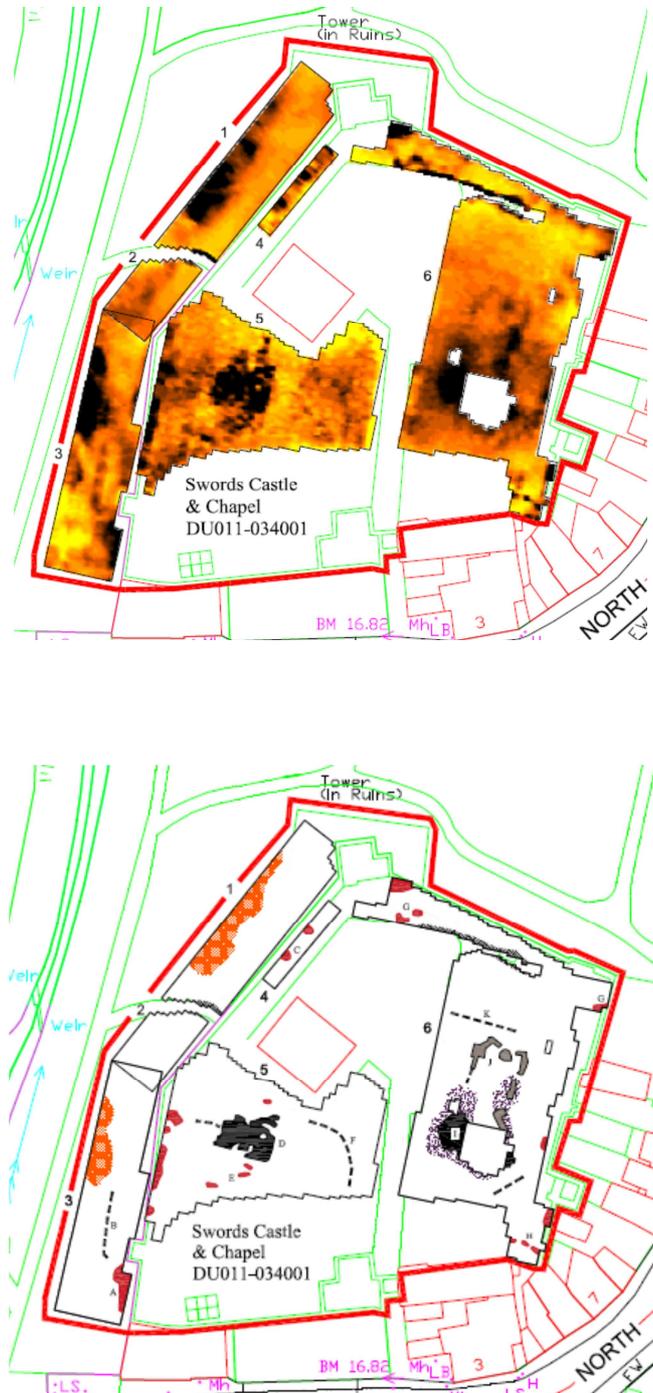
Fig. 12: Resistivity results and interpretation (Nicholls 2011)

Resistivity results indicated no evidence for a moat west of the wall of Swords Castle, although there is a suggestion of underlying material associated with the perimeter wall to the south-east. On the lower ground south of the portakabins a sub-rectangular response c.6m x 10m was identified. High resistance responses on the higher ground to the east indicate a grouping extending c.22m NS x 10m EW which may represent foundations associated with buildings (Nicholls 2011, 10-11).

In addition a geophysical survey was undertaken by Target Survey (Licence no. 11R0038) as part of the Swords Conservation Plan. The survey consisted of resistivity (of an area totalling 0.4ha) internally and external to the west wall of the castle, and GPR (survey totalling 0.14ha.) both internally and for a small section externally south of the Knights and Squires.

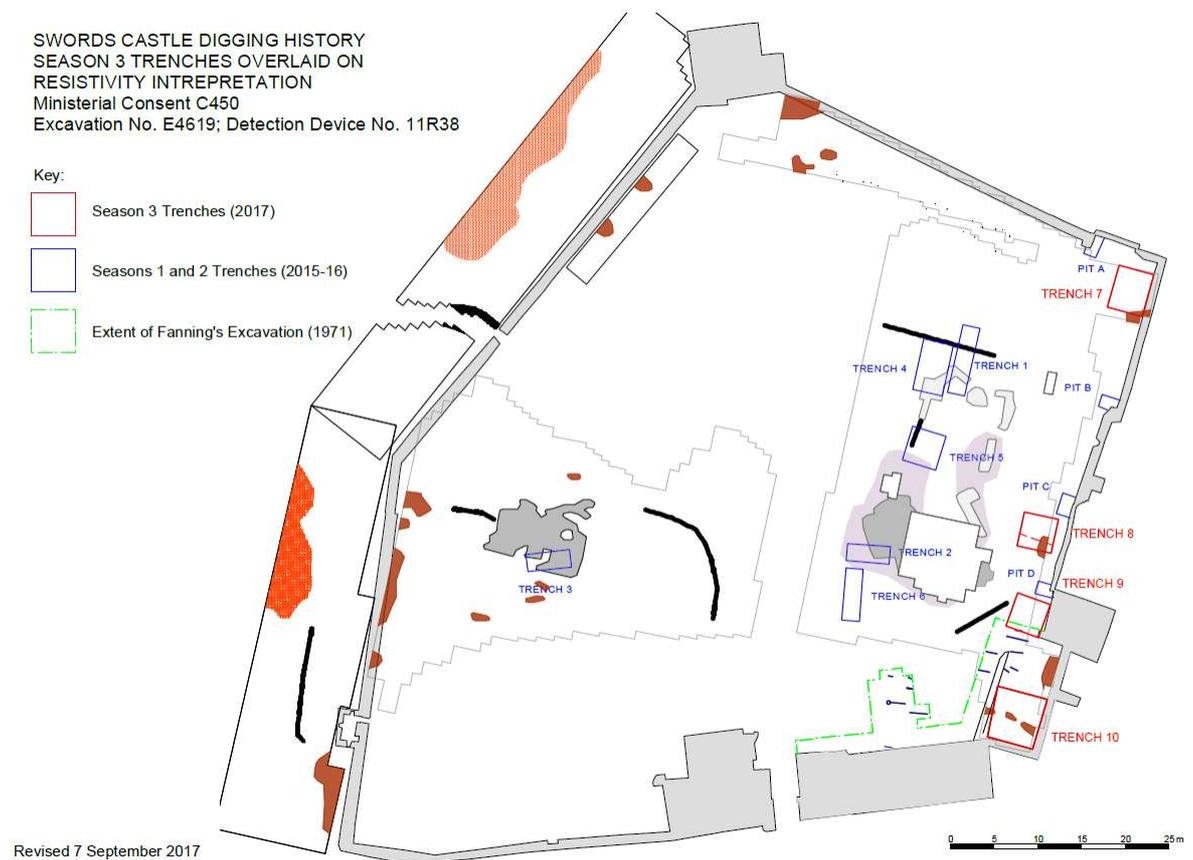
Trench 10 measured 6m NS x 5.5m EW and was located over the remains of the medieval tile pavement identified by Fanning in 1971.

*Fig.14 Layout of Trenches 7-10 in conjunction with Season 1&2 Trenches 1-6*

Trench 9 (4m x 4m) targeted the area immediately west of the East Tower in order to investigate the confluence of the 'missing' west wall of the East Tower and the limit of burials identified by Fanning. Due to the recovery of burials this trench was excavated to a maximum of 0.64m below current ground level.

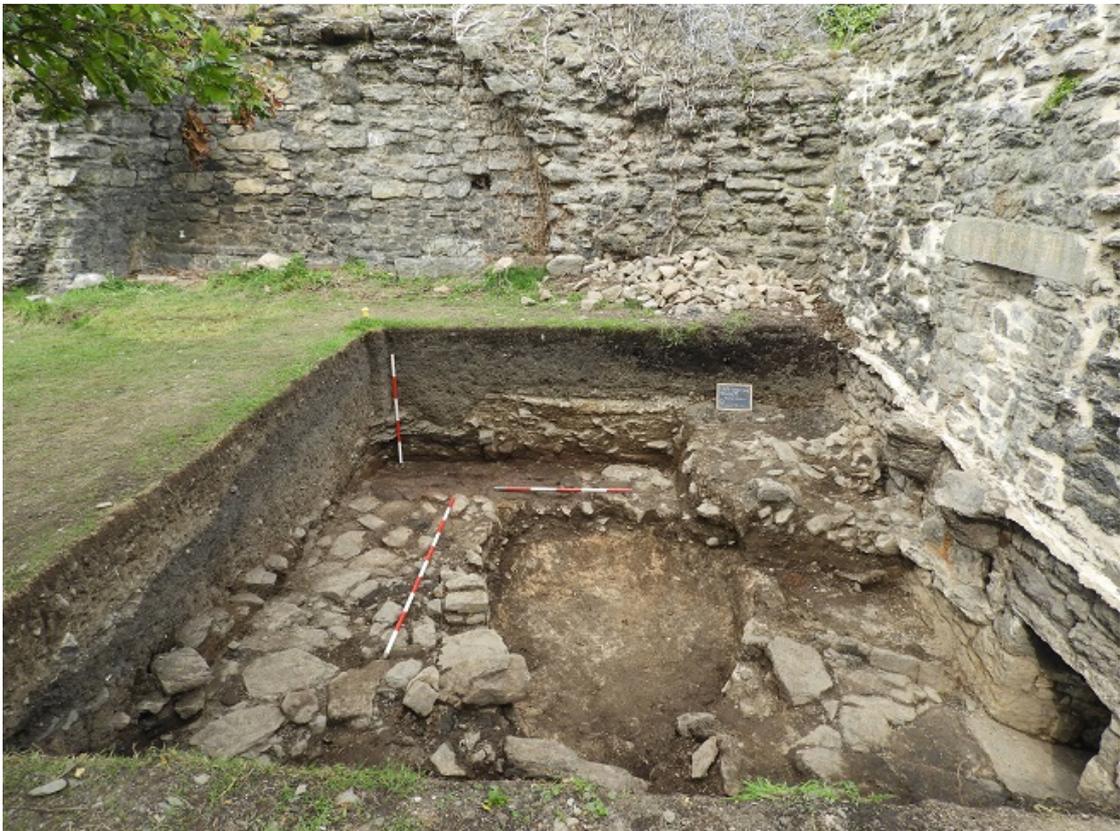
Excavation ceased at c.1m below present ground level at the level of a flagged floor which was overlain by a series of occupation layers (F126). These layers had been truncated by the construction and use of a kiln (F143). The later activity within this trench relates to the steps (F110) and a path (F111) leading to the doorway that had been inserted into the perimeter wall during the 19<sup>th</sup> century. There was evidence for waste burning beneath the topsoil (F1) and sod.

*Plate 5: Trench 7, post-excavation, facing north*

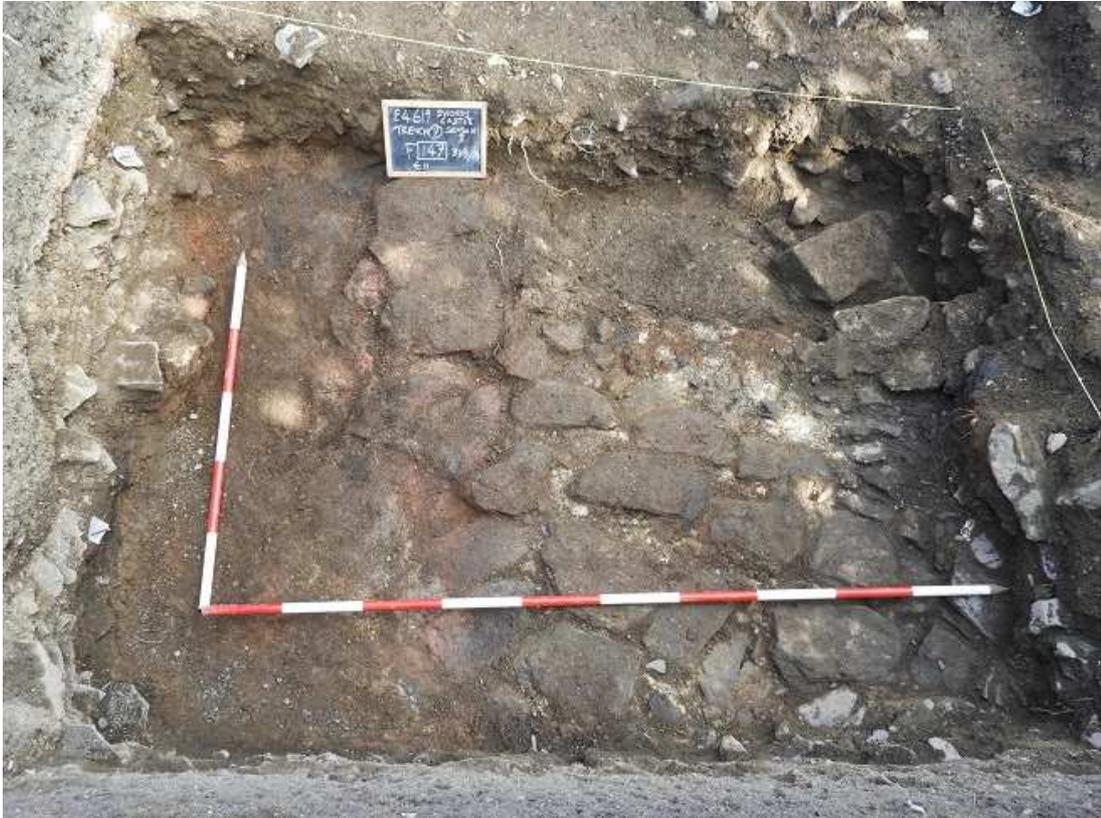
west. The southern edge was less clear but was defined by a change to smaller, uneven and non-level stones. Although likely contemporary with the flagged floor to the south (F145) there was a different usage in this area indicated by the nature of the stones which were heat-affected, and the overlying deposits.

*Plate 6: F147, mid-excavation, facing east*

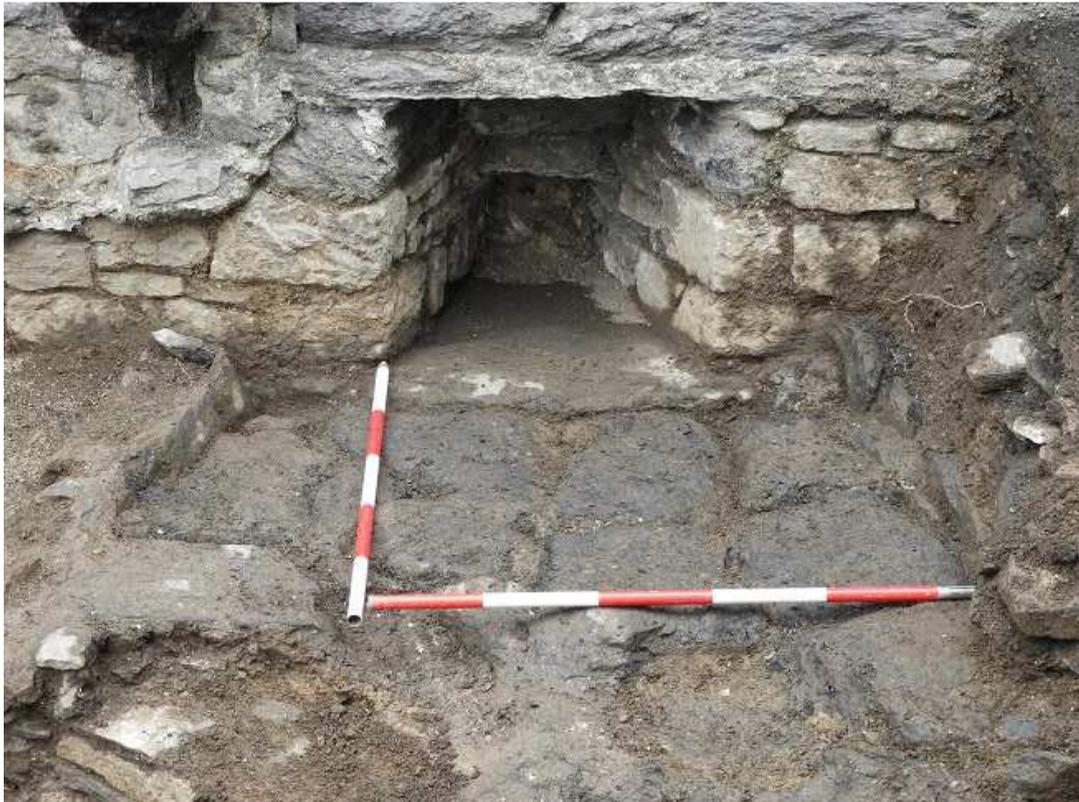
Two slabs that constitute the floor drop gently from west to east by 0.5m over 0.7m. These base slabs are beneath the sidestone and the easternmost appear to represent a continuation of the F145 surface. There is no obvious point at which this feature was inserted into the eastern wall and it may represent an original feature which implies that flagged surface F145 represents ground level at time of the construction of the curtain wall in this area of the precinct.

*Plate 7: F145 and F149, post-excavation, facing east*

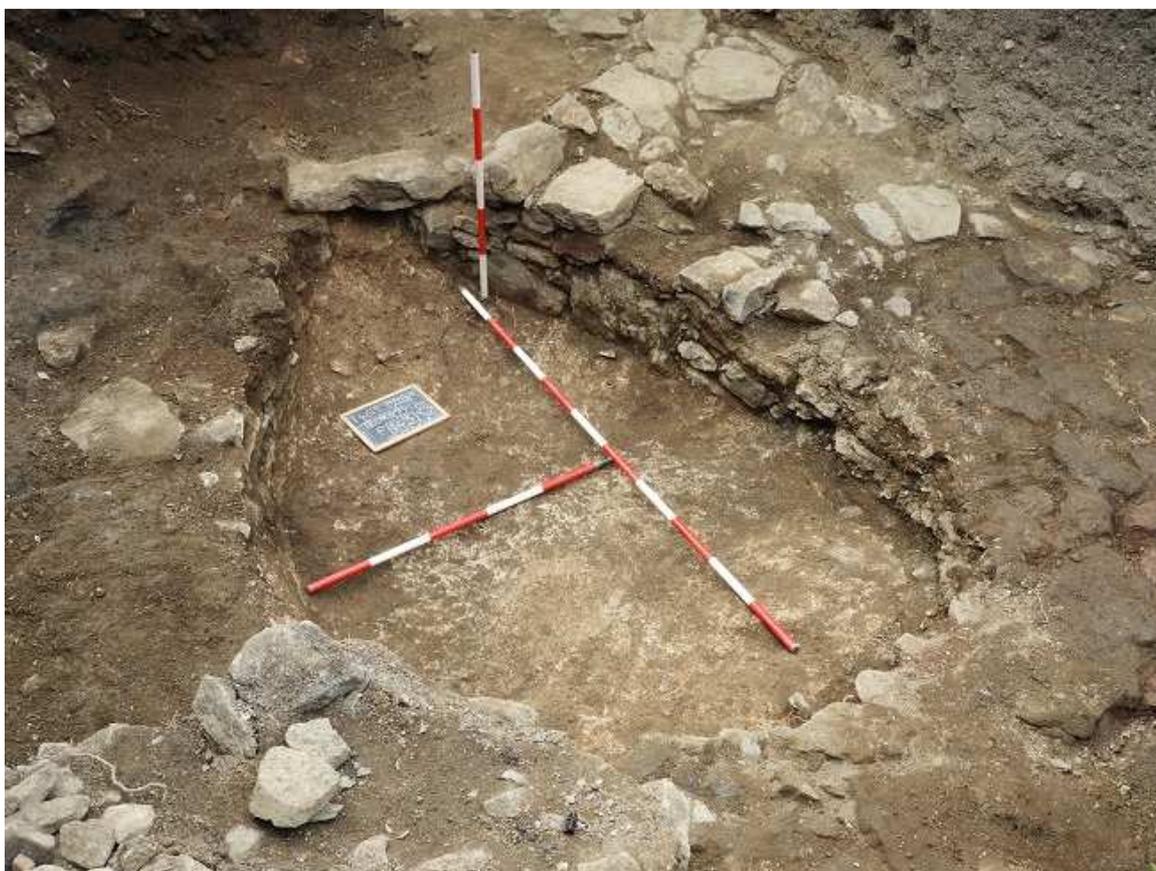
The northern bowl of kiln consisted of a tapering oval defined to north and east by an earth-cut face rendered with mortar and to the south and west by a mix of large and medium stones in a random rubble bond (0.5m NS x 2m EW; 0.5-0.6m in height). The rough coursed layer of stone at the south-west edge included several large stones (0.5m x 0.3m h.) but with no indication of shaping. The stone walling appears to be 0.4m-0.5m thick max approaching the flue mouth giving an overall extended width of 2m against a maximum internal width of 1.6m at the widest point. The base of the bowl was a hard white mortar (F143:1) which dipped gently down from the sides to create a smooth central surface. It is noticeable finer sand mortar and whiter than the coarse deposit overlying it at northern end. Curiously there is no real indication of burning/heating of the mortar surface but as it was left in situ it is possible that it represents a final clean use and earlier layers of burnt material lie beneath.

*Plate 8: F143 kiln bowl, facing south -west*

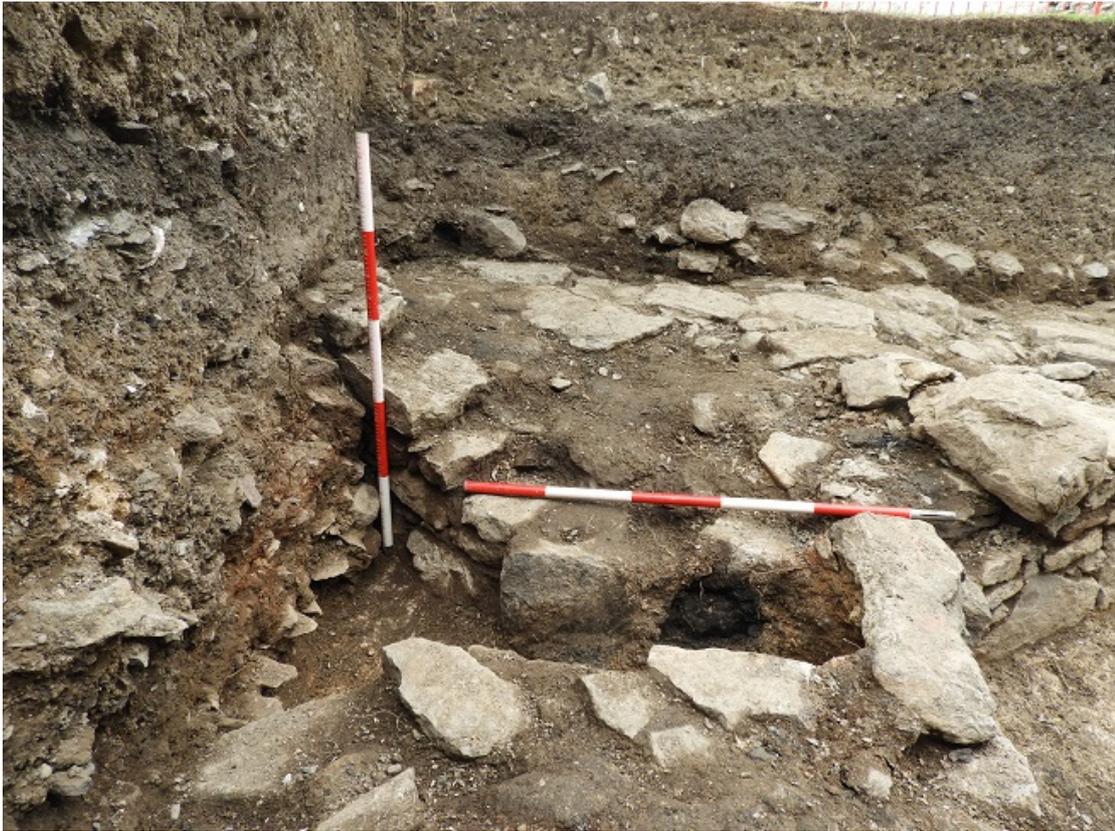
The flue comprised a fine orthostatic flue (0.9m NS x 0.3m EW; 0.3-0.35m) with sidewalls generally made of a single upright (2-3 in a row on each side) and with one surviving lintel at north end. Two infill deposits were noted; the basal fill (F161:2) was almost pure charcoal apparently representing a single large timber set transversely across the flue. The upper fill (F161:1) was an ashy mixed deposit mixed with mortar which almost filled the flue entirely.

*Plate 9: Flue (F161) and southern bowl (F162), facing west*

The southern kiln bowl or fire-pit comprised a finely made stone walled chamber or bowl. The walling was best preserved on the western side where it has up to four courses closely set up to 0.3m in thickness; In contrast to the flue (F161) the walling at the chamber was coursed stone rather than orthostatic. No mortar was identified between the stone but was exposed on the upper surface at both sides; Two fills were noted; the lowest fill (F161:1) was stony dark friable clayey silt. It was not fully excavated (due to time constraints) but appeared to overlie a layer of mortar similar to F143. The upper fill (F162:2) was loose reddish clayey silt and sand, 0.2m in thickness and dished in profile, with occasional small stones and frequent charcoal inclusions. A single sherd of medieval pottery was recovered from this feature.

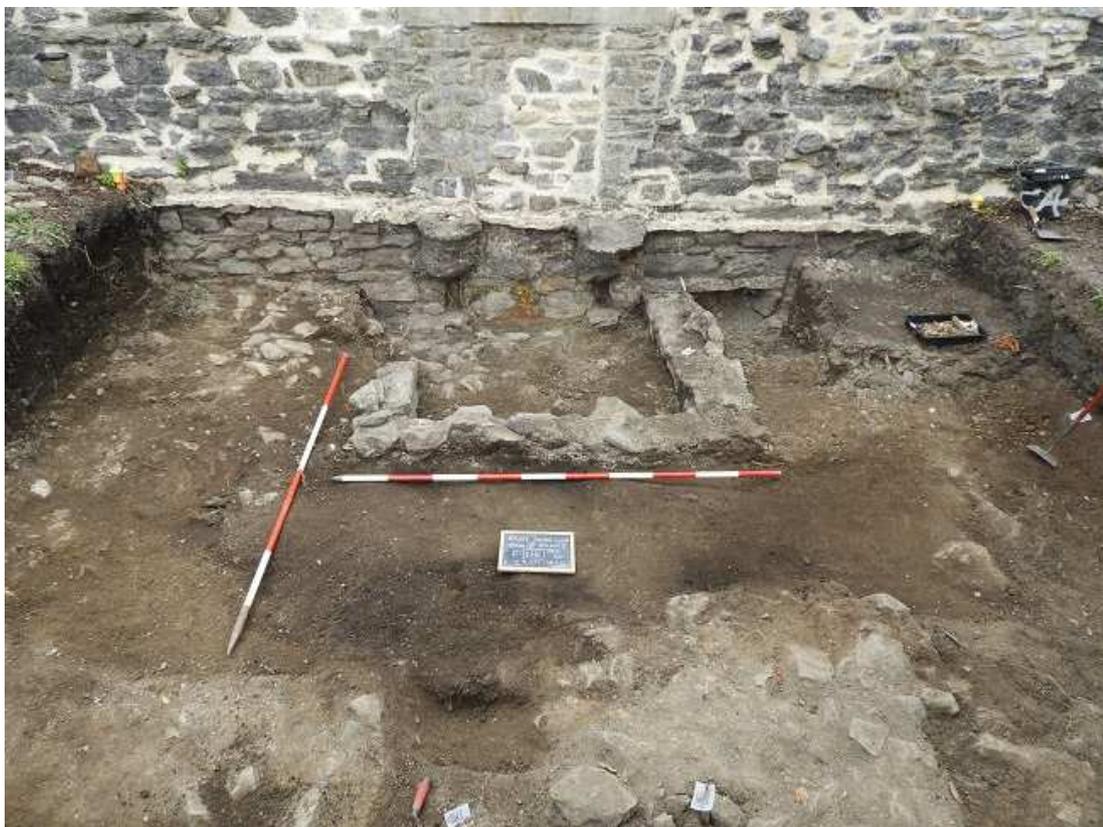
*Plate 10: F115 pre-excavation, facing east*

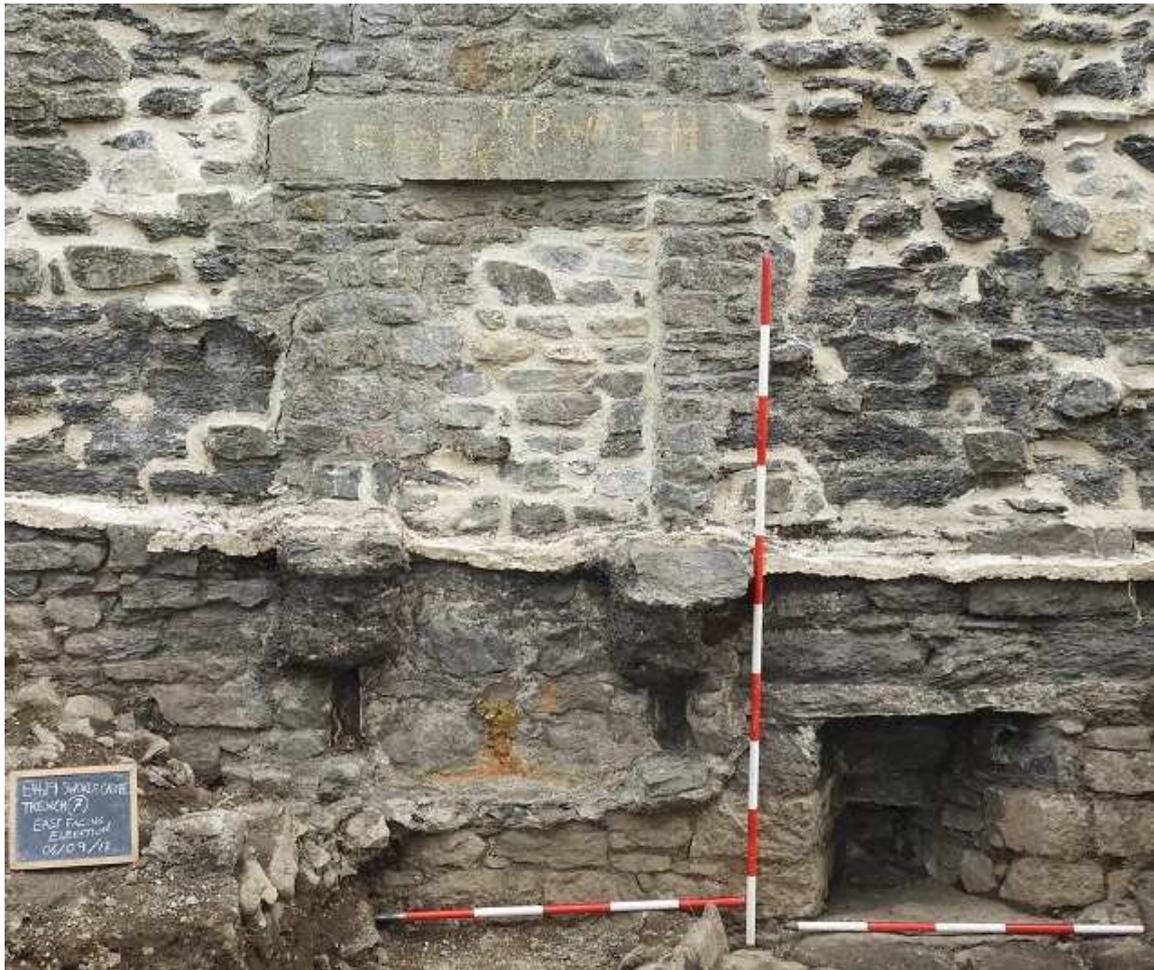
*Plate 11: F175, blocked doorway, facing east*

This feature is the blocked-up doorway in East wall; Inserted into the curtain wall in the nineteenth century this doorway is topped by a concrete lintel (above which there has been replaced stone 0.45m in height) and is defined at its base by F110:3 which formed the mortared threshold of the doorway, a total of 1.8m in height. Above ground the doorway is defined by mortared limestones in fill (0.9m in width) within semi-defined limestone jambs on each side (1.4m max width), at the base of which are two protruding stones sitting on large lumps of concrete. Below ground level (0.5m in height) there are two rectilinear voids (0.25m in height; 0.1m in width) indicating rotted out wooden door jambs. The line of mortar from the 2016 Enabling Works (Phase 1) is visible just below current ground level.

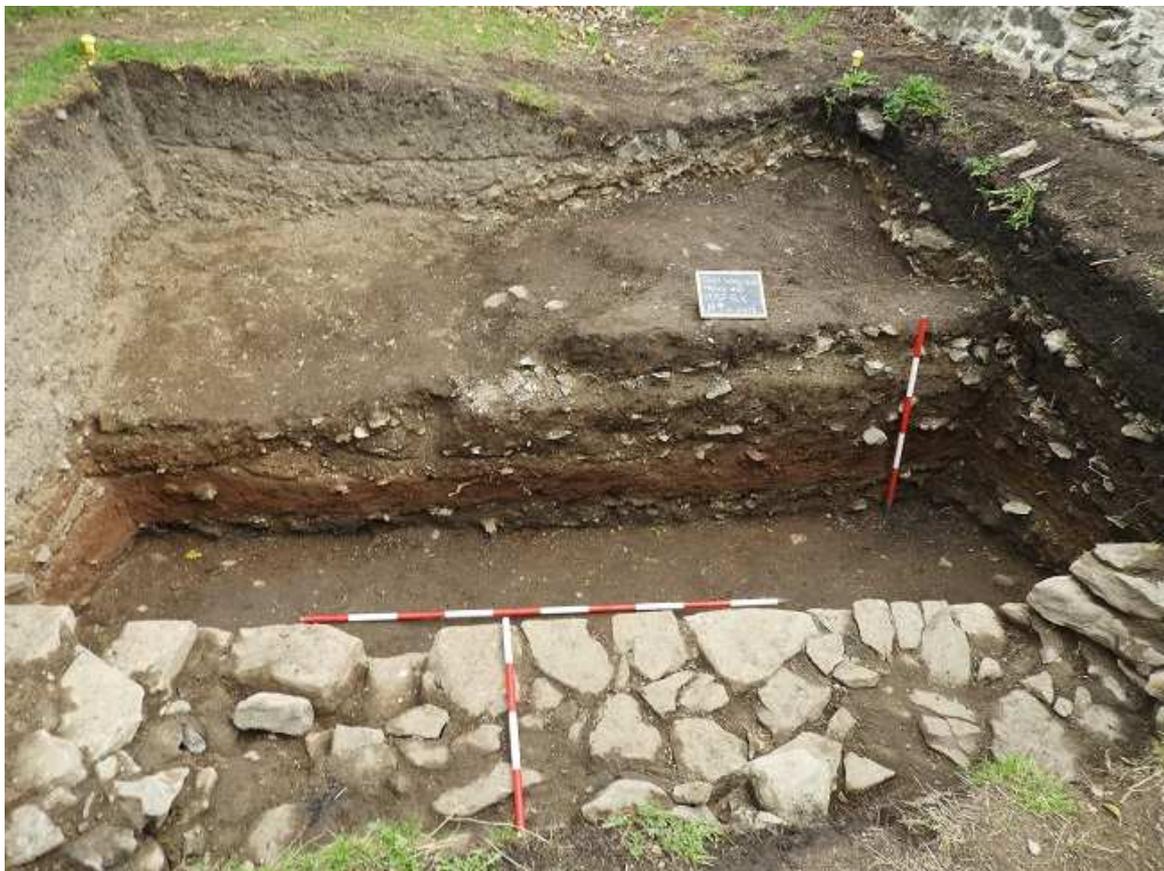
Natural subsoil was attained at 1.42m below ground level within a single east-west sondage excavated through the centre of this trench. Above natural was a large wall (F123) abutted by a build-up of occupation and demolition layers. Relatively modern disturbance had taken place across the top of the wall.

*Plate 12: Trench 8 post-excitation, facing north*

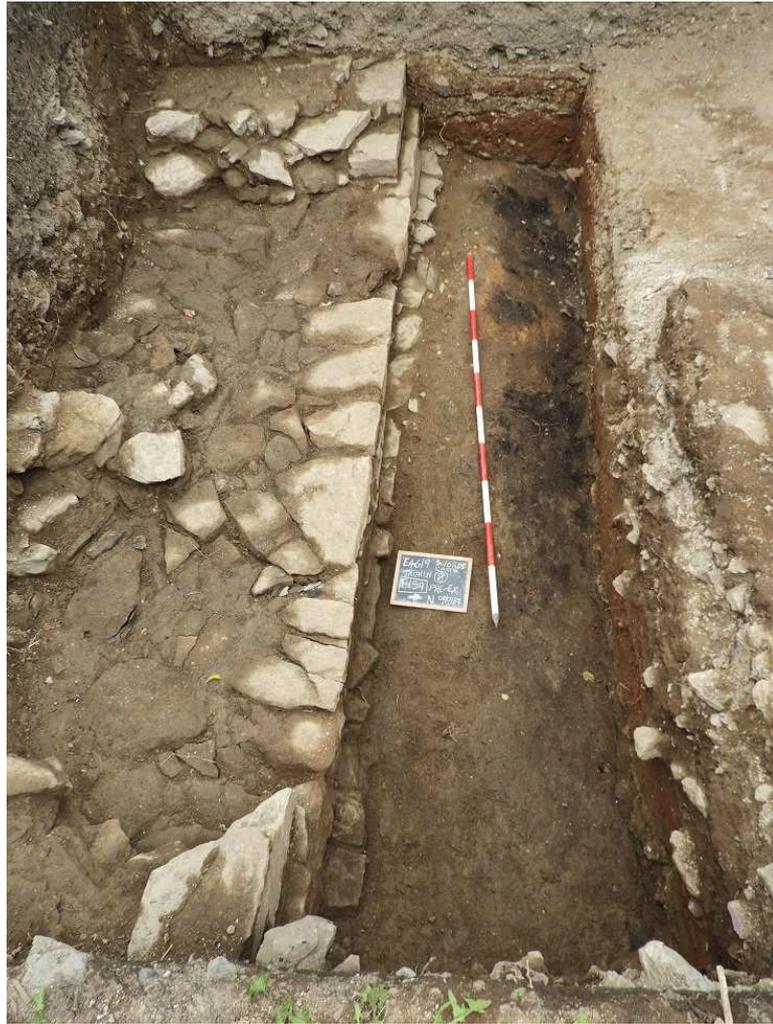
The substantial medieval limestone wall (1.5m in width) was aligned NNE/SSW. The wall was standing to a maximum height of 0.7m at its eastern end, although it averaged 3 courses. The foundation course was uneven and extended from 0.07m-0.16m north of the wall face. It consisted of small stones (average 0.15m diam.) and 0.1m in height. It appeared to overlay natural subsoil directly and there was no obvious cut and the ground level slopes away to the north. The wall consisted of mortar-bonded large stones (0.23m-0.36m diam.) interspersed with smaller infill stones. The top of the wall was uneven, having been truncated by later activity (F171). This resulted in a surviving wall height of 0.56m at the west end and a higher central area (1.2m EW x 0.6m NS) along the southern baulk. Given its position it may be the southern wall of the 'Great Hall' or a possible perimeter wall.

Plate 13: Wall F123 post-ex and layer F159 pre-ex, facing west

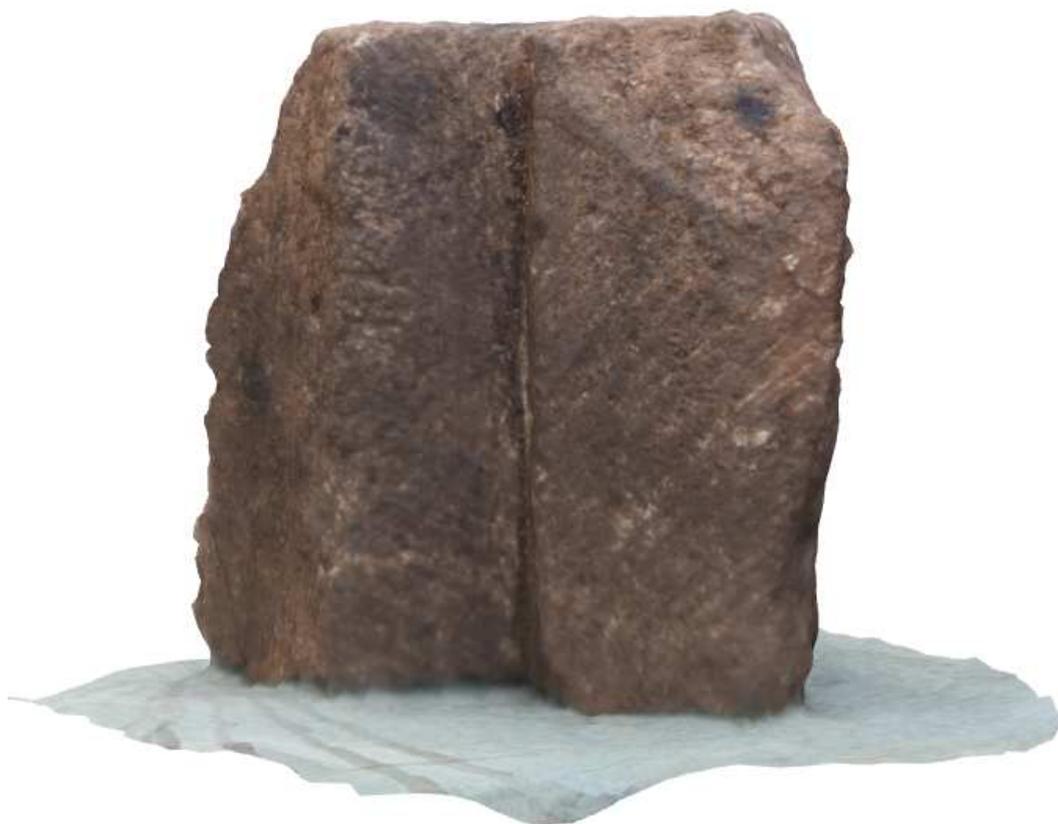
Overlying both F159 and F169 was F152 (4m EW x 1m-1.2m NS) loose grey stony sandy mortar with moderate animal bone, slate and angular stone inclusions. It was interpreted as building debris. An architectural fragment (chamfered stone with an indent that possibly formed door or window frame; striations still visible on carved surfaces. Carved at one end and truncated at other-possibility of having been burnt 0.1m in height; 0.1m in max diameter 0.5m in minimum) was recovered from this deposit as was a wedge shaped fragment of Dundry stone (0.08m in height; 0.085m in max width 0.15m-0.055m; tool marks visible one end face). Iron nails, medieval pottery and tile were also recovered from this feature.

*Plate 14: Architectural fragment, photogrammetric model, courtesy of Mick Mongey*

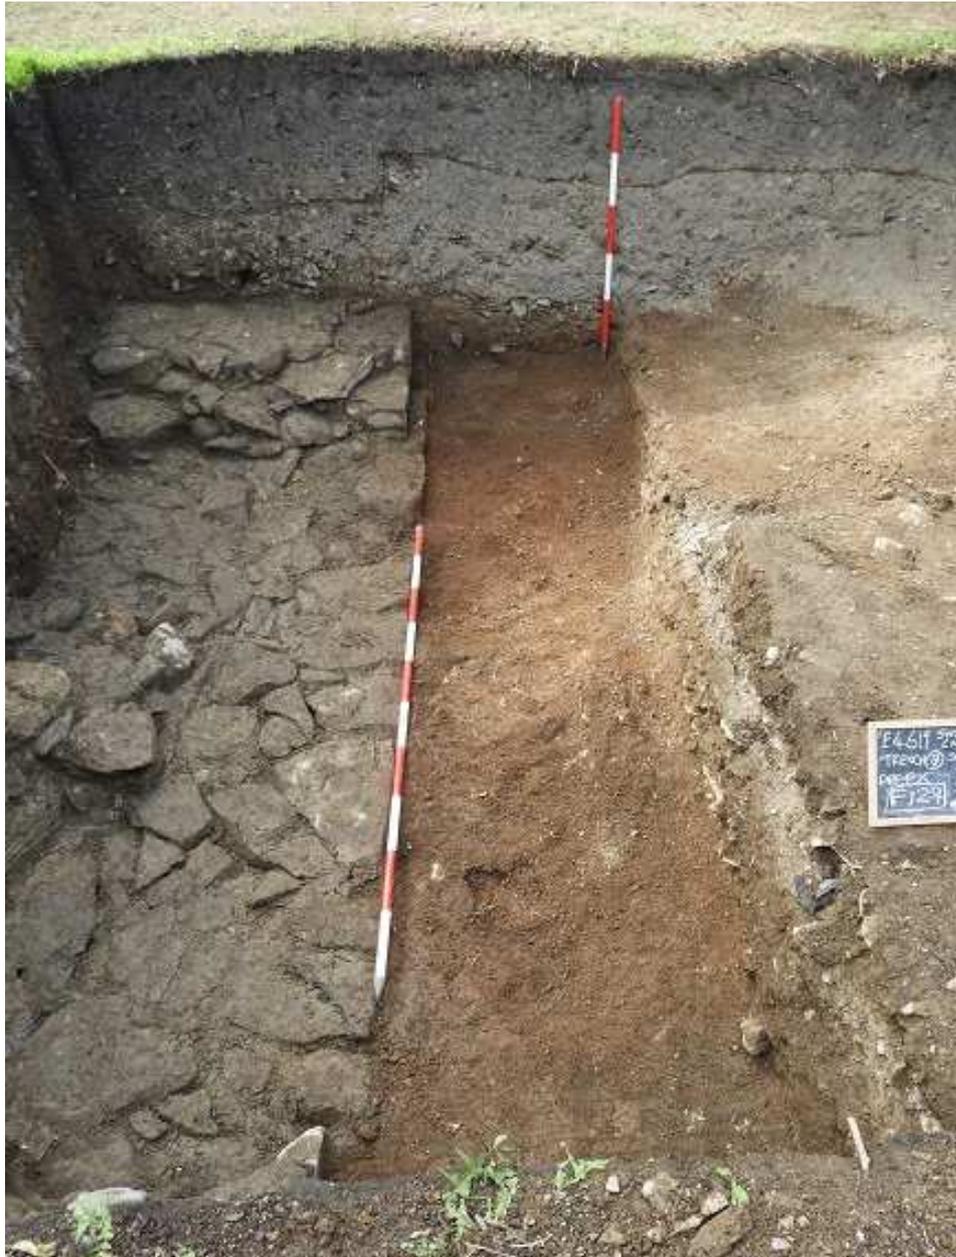
*Plate 15: Wall F123 mid-ex and layer F129 pre-ex, facing west*

Overlying F160 was a band of heat-affected soil (4m EW x 1.2m NS). Feature F129 consisted of loose friable, reddish brown sandy silt with frequent animal bone, occasional small angular stone inclusions and mortar flecks. F129 sloped down from south to north (0.02m-0.28m in depth). Slates, plaster fragments, iron nails and medieval pottery was recovered from this feature. An environmental sample (#57) was wet-sieved and is currently undergoing analysis.

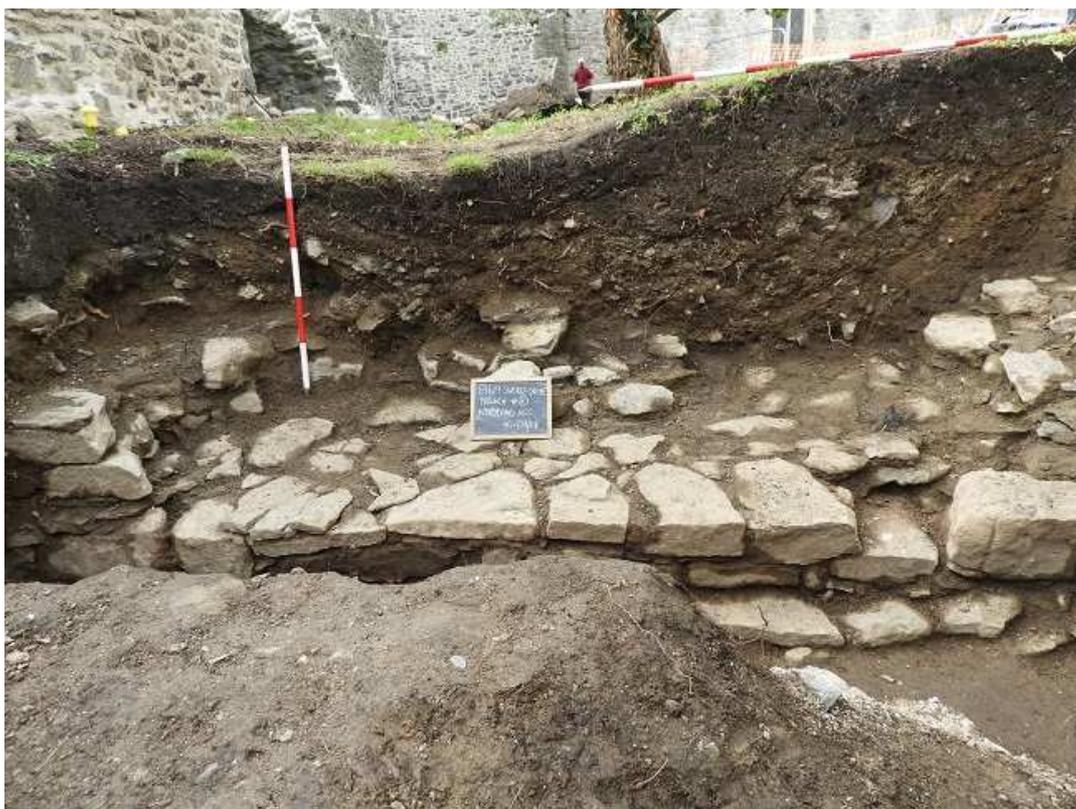
*Plate 16: Trench 8, Modern truncation over F123, facing south*

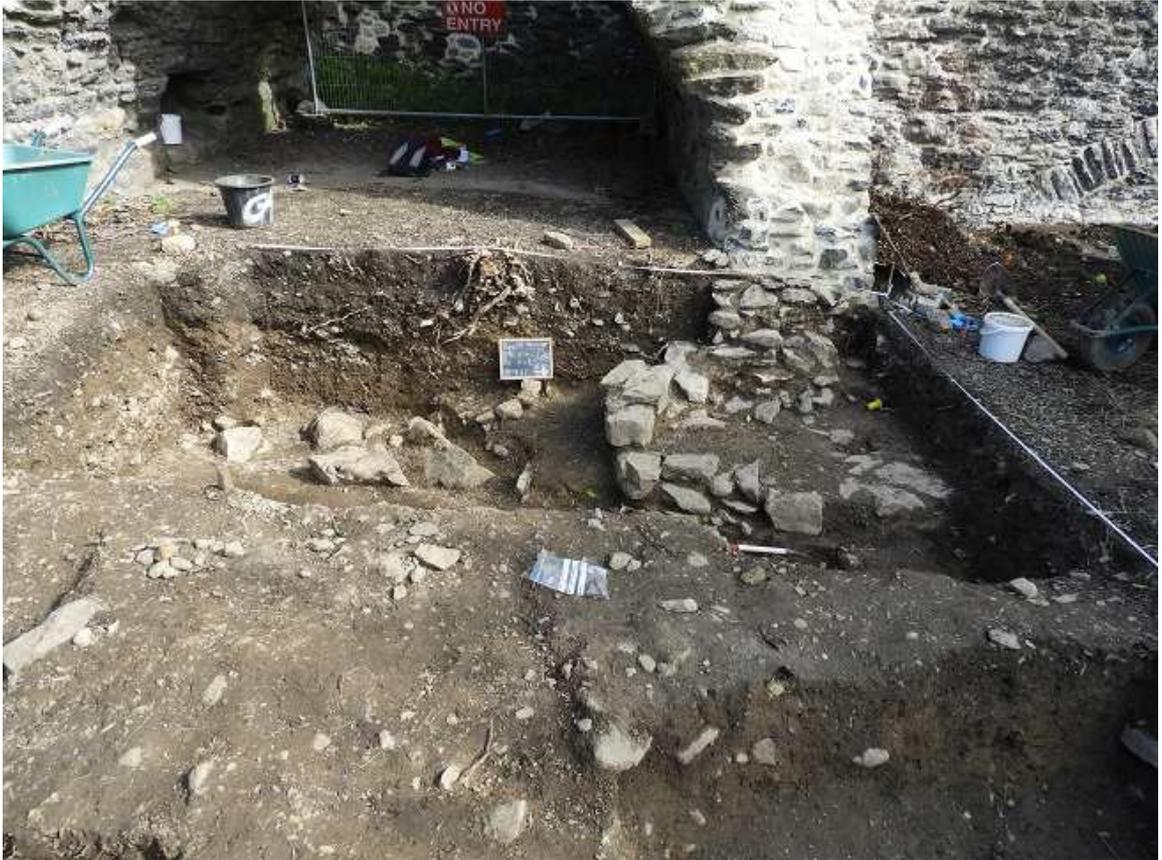
Natural subsoil was not attained with Trench 9. The maximum depth of excavation was 0.64m below ground level. To the east of the trench the wall associated with the East Tower was uncovered (F153). There were two distinct horizons of soil (F163 and F127) both of which contained burials. Two pits (F122, F128) post-dated the burials above which were the remnants of topsoil (F1) and sod.

*Plate 17: Trench 9, Post-excitation, facing east*

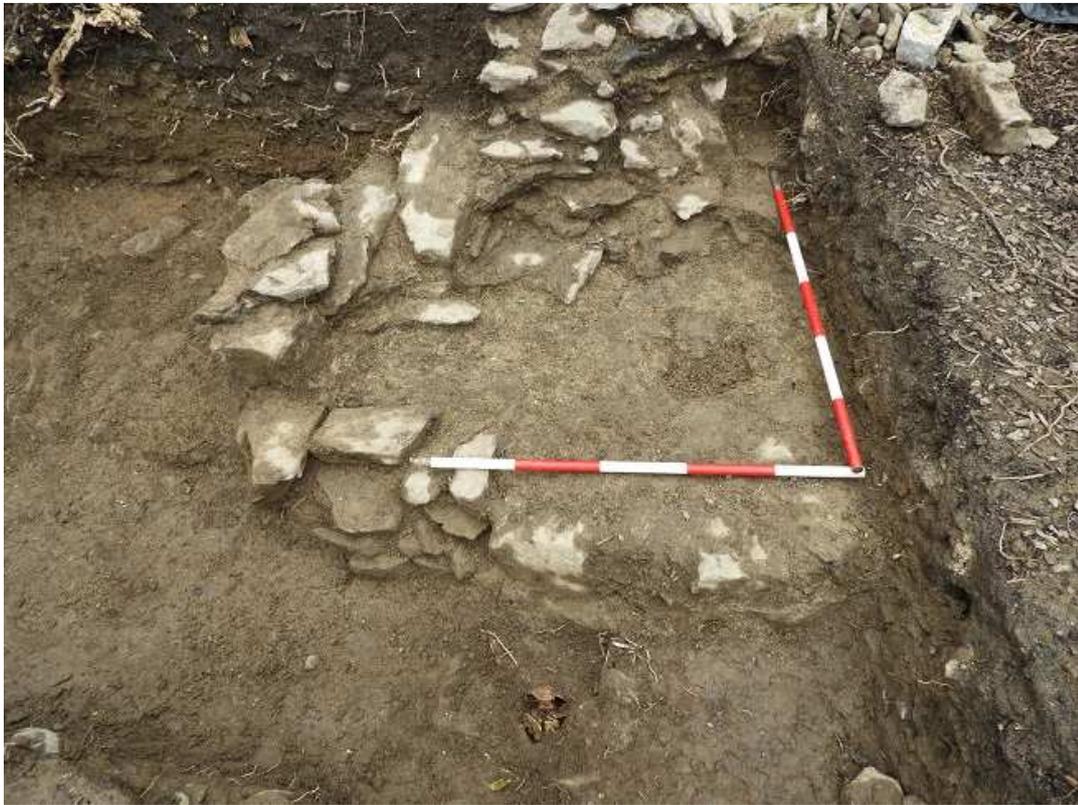
The foundation stones of the west wall of the East Tower were exposed for 2.2m north-south within Trench 9. Apparently robbed out the remaining large (0.4m-0.7m diam.) unshaped limestone within compact orange brown stony clay, c.1.2m in width. Abutting F153, it was overlain by mortar-rich F153.

*Plate 18: Wall junction F154, mid-excavation, facing east*

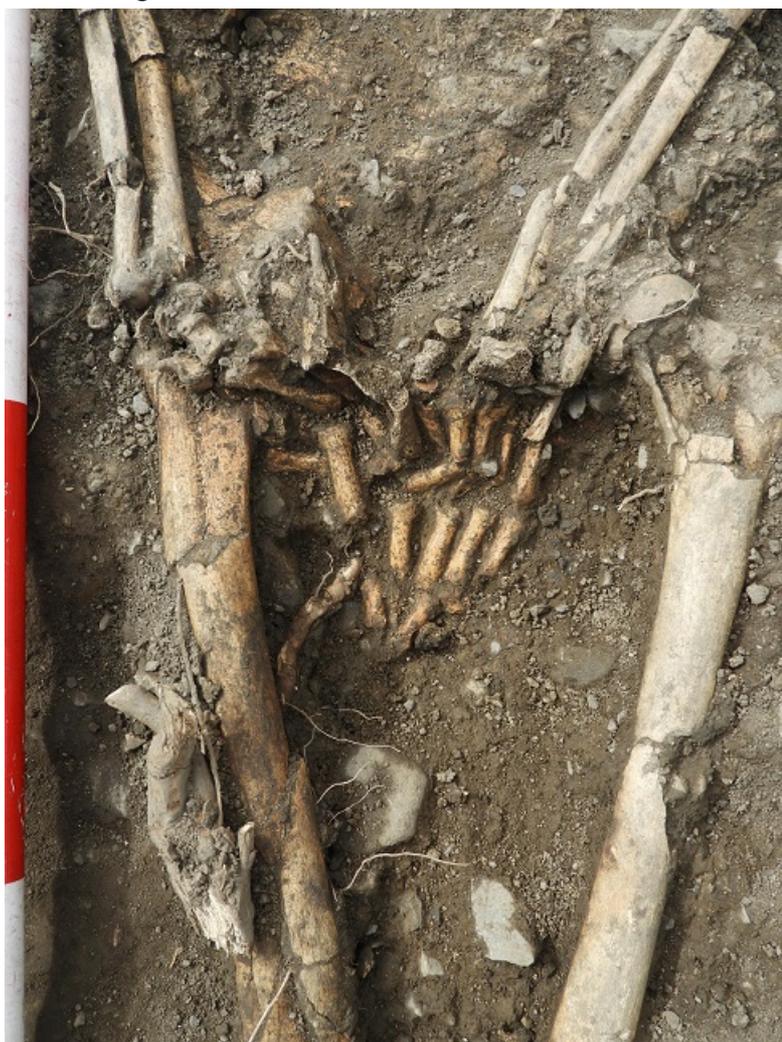
*Plate 19: Sk.02, facing west*

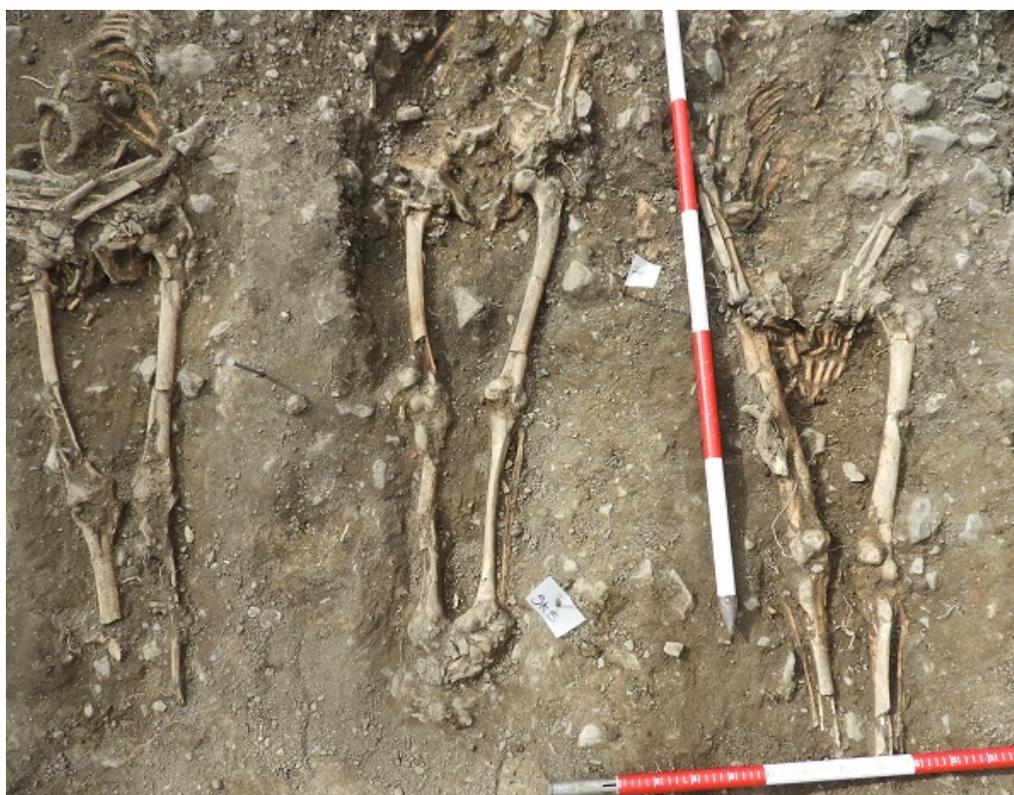
*Plate 20: Sk.01, Sk.05 and Sk.02, mid-excavation, facing west*

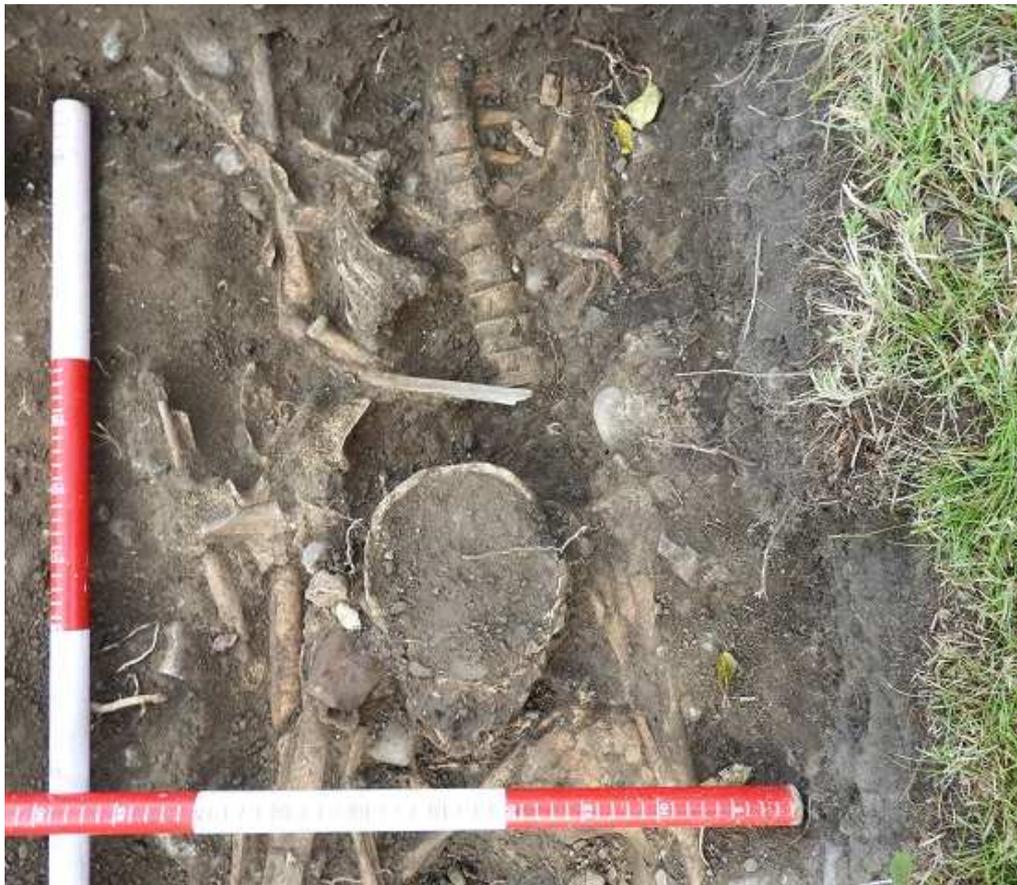
*Plate 21: Sk.09 and Sk.14, facing west*
