**Archaeological Excavation  
Preliminary Report**

**Season 3: August-September 2017  
Swords Castle  
Swords  
Co. Dublin**

**Consent no.: C450  
Excavation ref: E004619**

By  
Christine Baker  
Community Archaeologist  
Fingal County Council

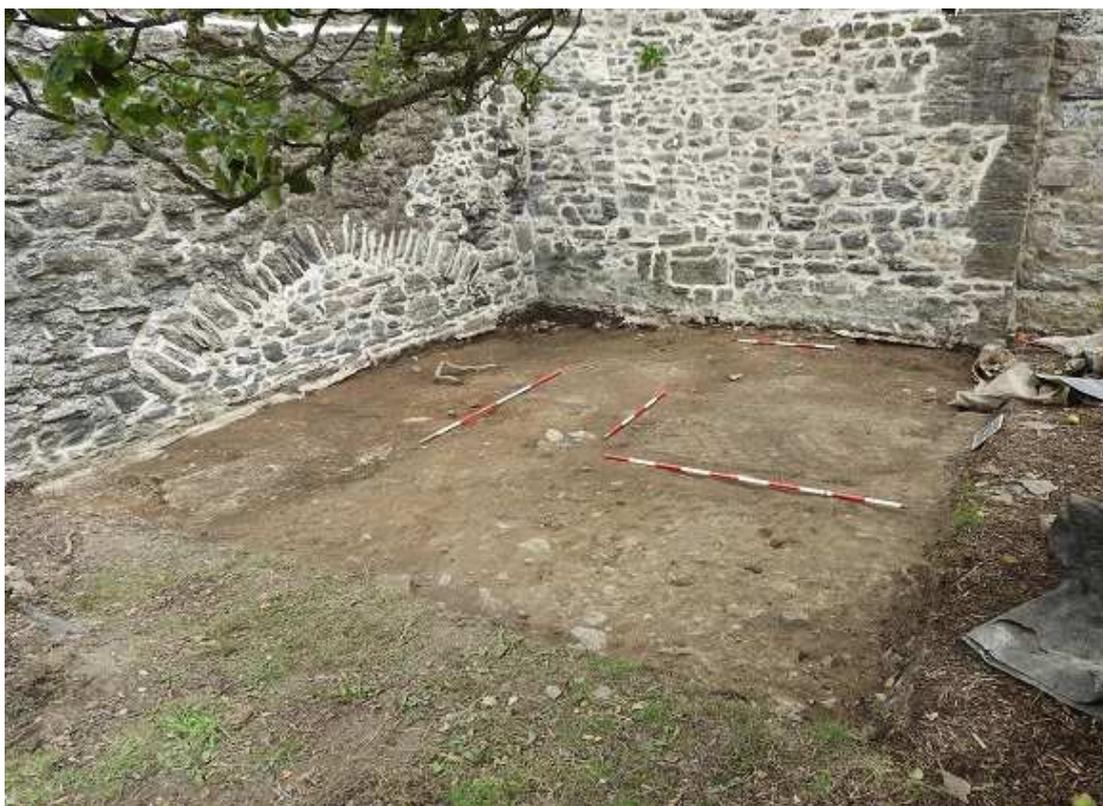
Natural subsoil was not attained with Trench 10 which was excavated within the southern quadrant of the Archbishop's Apartments. The aim was to investigate the extent of the medieval floor tiles that had been left behind after Fanning's 1971 investigation and if the burials identified during that excavation were possibly reburied here. Removal of 0.08m-0.3m of overburden (F119) which had been covered in patchy sod and woodchip was onto 1971 plastic. The relationship at the corner of the Archbishop's Apartments and the Chapel was investigated.

*Plate 22: Trench 10, Post-excitation, facing south-east*

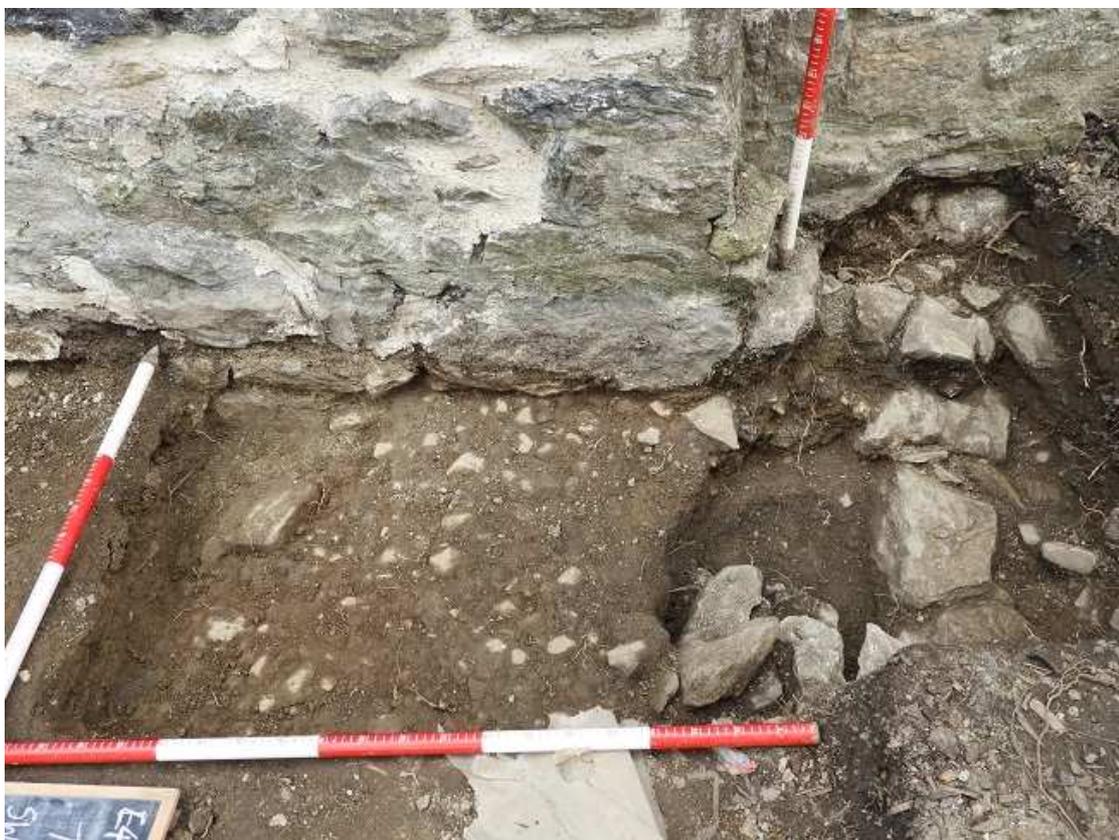
This was a compact metallised surface of angular and sub-angular stones (0.02m-0.06m diam.) set into orange brown clay. It was exposed for 0.8m EW x 0.65m NS within the exploratory cut in the south-west corner of Trench 10.

*Plate 23: F165, F167, post-excavation, facing south*

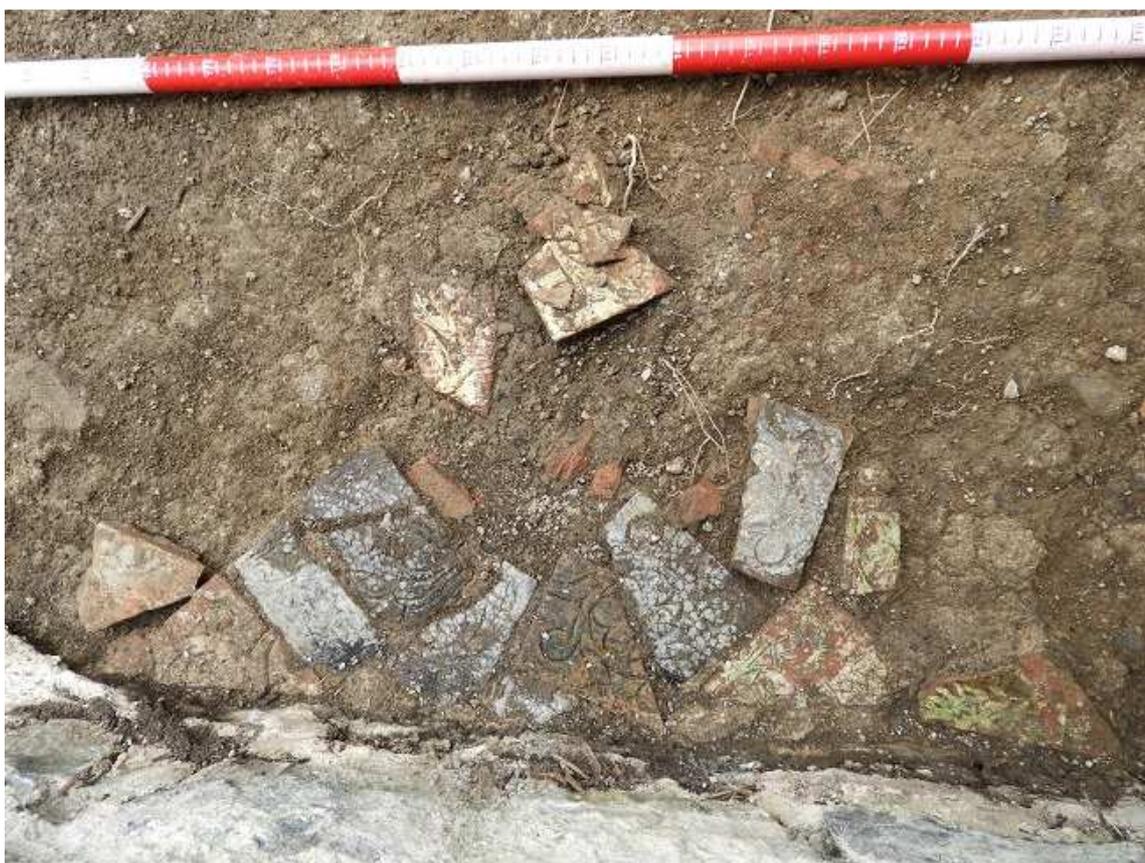
The majority of the medieval tile pavement had, following recording, been removed by Fanning to the National Museum of Ireland. However a number of tile fragments had been uncovered just 0.08m below ground level.

*Plate 24: F151, post-excavation, facing north*

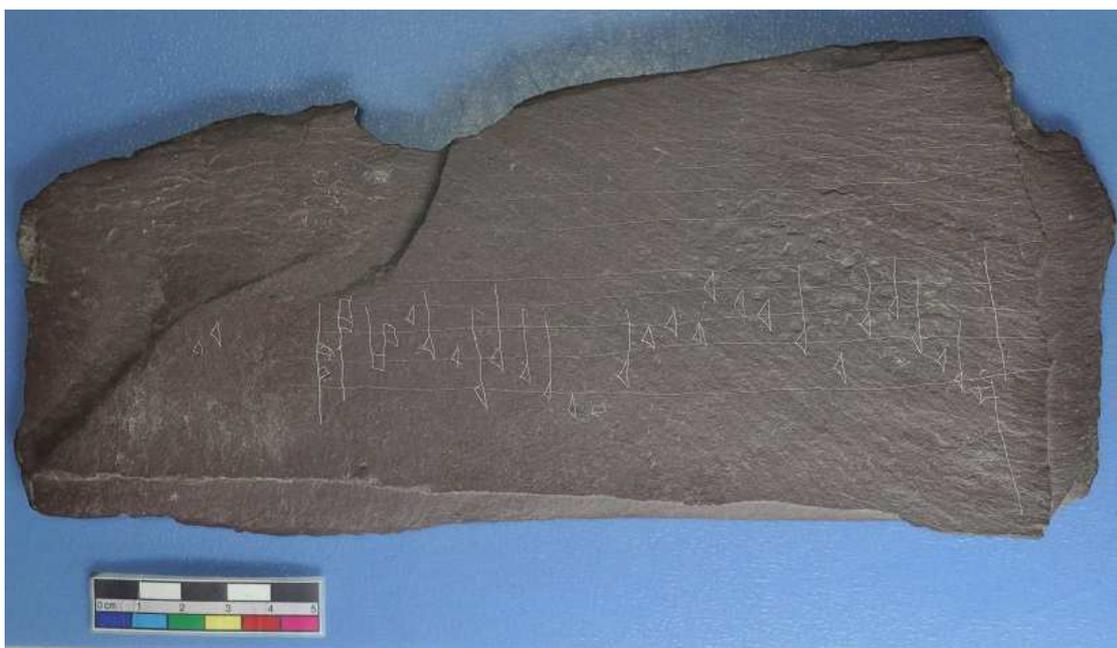
*Plate 26: Slate inscribed with musical notation, courtesy of Siobhan Duffy*

A total of 1295 artefacts were registered. This can be divided into pottery (330), tile (569), clay pipe (108), stone (2) and bone (8) artefacts. Metal finds were divided into iron nails and objects, copper alloy pins and a lead seal. A silver groat was recovered from Trench 7 and an inscribed slate from Trench 8. The latter is unusual in that musical notes were inscribed on one. The slate has been subjected to reflectance transformation imaging by Gary Devlin of The Discovery Programme in order to ensure the musical notation has been recorded which will be further analysed.

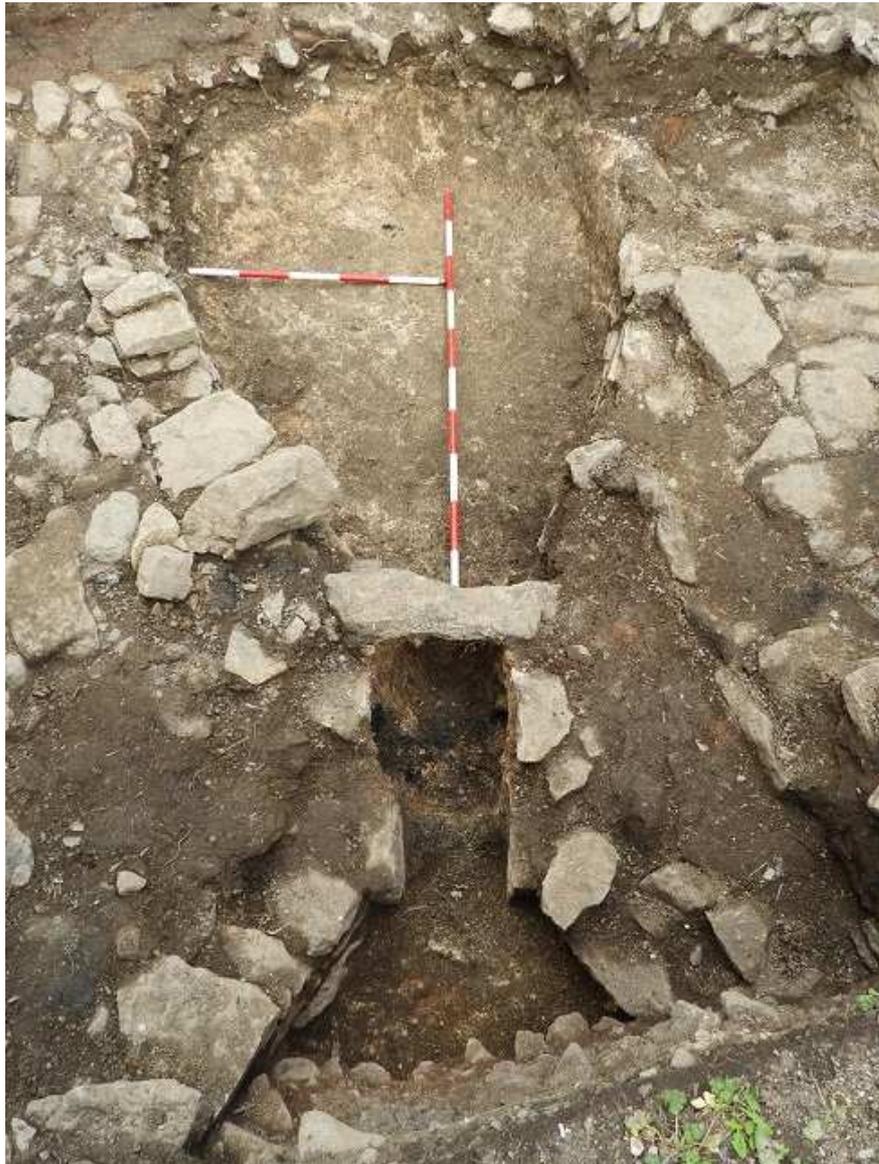
*Plate 28: Kiln, Trench 7, facing north*

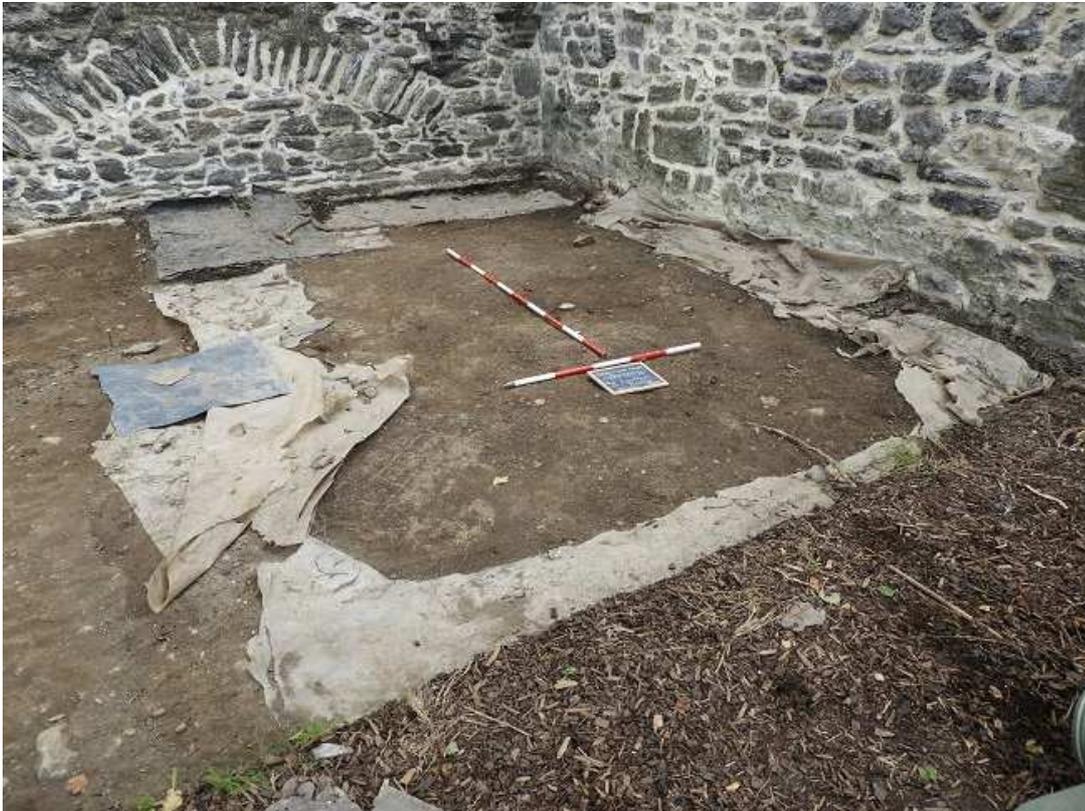
plastic that had been put there to cover the remains in 1971. The uncovering of the mortar beds was assumed to reflect the removal of tiles by Fanning. However an examination of his site notebook found that he had encountered 'a mortar bed, traces of which remain in the area where the tiles are missing'(Fanning 10-11/11/71).

*Plate 30: 1971 plastic, Trench 10*
