**STRUCTURAL ASSESSMENT AND PROPOSALS FOR REPAIR,
CONSERVATION AND PRIORITIZATION OF URGENT
WORKS
FOR
FIFTEEN ARCHAEOLOGICAL MONUMENTS
IN
FINGAL COUNTY COUNCIL OWNERSHIP**

**Dermot Nolan & Associates
Historic Buildings Consultants
& Consulting Engineers
'Claremount'
Meath Road
Bray
Co. Wicklow
Tel: 01-276 2626
Email: dnolanconservation@eircom.net**

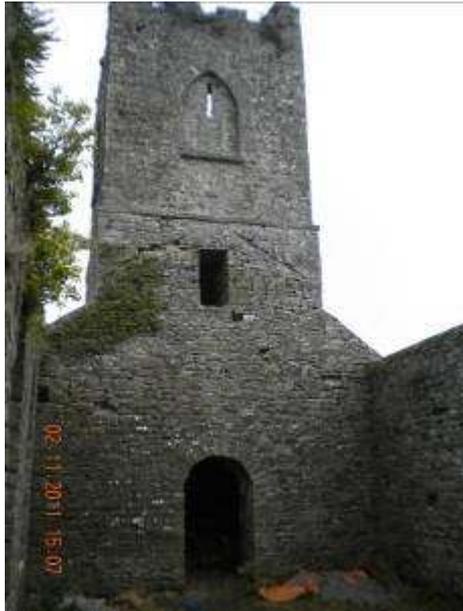
East wall of tower

The cills and gable copings have been removed from the nave. The walls are generally in good condition with no bulges or out-of-plumb. However there are areas of voiding where interior mortar has been washed out – for example, along the base of the south nave wall. There is some vegetation growing at the parapet in the tower on the east and south sides, on the tops of the south and north nave walls and on the east gable. There is a very thin timber head over the first floor opening on the east side of the tower.

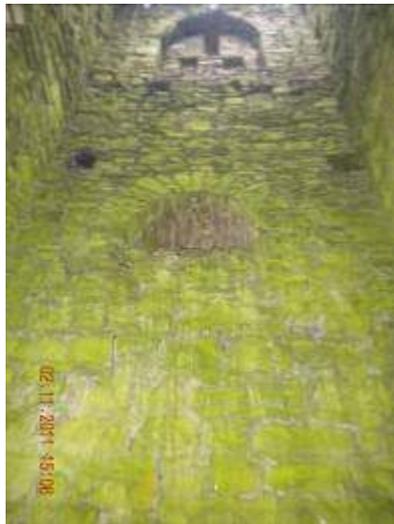
The tower walls appear to be damp and there is a covering of green mould on the interior walls. There is some masonry disintegration at high level on the west and east sides of the tower. There is vertical cracking for virtually the full height of the tower on the west side and a diagonal crack over the entrance door on the south side. These cracks may be connected and may be caused by subsidence at the south west corner. There is also cracking and voiding near the east end of the tower north wall. An area of wall below the string course on the east side of the tower requires to be pointed.

Green mould on the interior of the tower wall

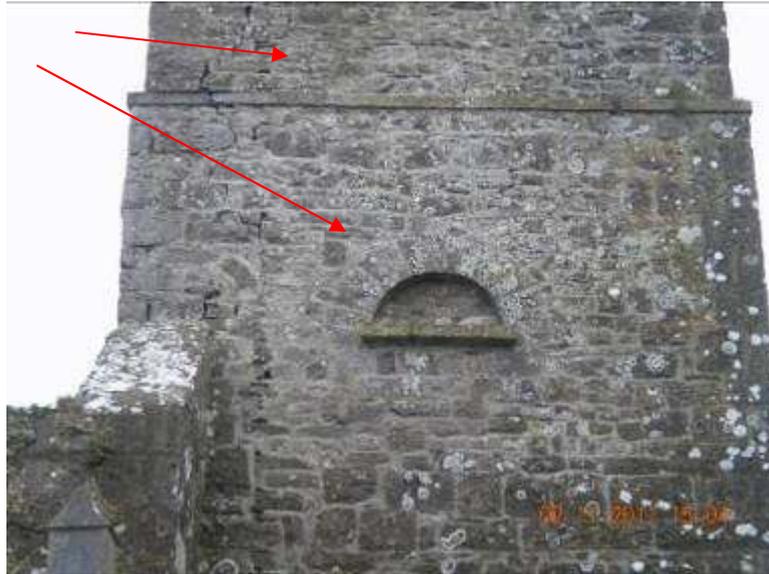
Detail of North tower wall lower level

Most of the cracking and minor disintegration in the masonry is probably due to vegetation growing in the wall in the past. Where this occurred and the vegetation was removed or died off, the resulting disruption of pointing and mortar would have permitted ingress of moisture. This, in turn, can lead to washing out of mortar and voiding and disintegration of the masonry. The solution is to point the walls and to fill voids as far as possible. As noted above, the profile of the cracking at the south-west corner of the tower indicates possible foundation subsidence in this area.

**Note
cracking**

- 5.1 An exploratory trial pit should be opened at the south-west corner of the tower to determine the subsoil conditions. The trial pit must be inspected by an engineer to determine what action might be required. The trial pit location (and that of any subsequent works) must be carefully chosen to avoid disturbing graves.

The outcome of this investigation may be a recommendation to underpin part of the tower foundation. Alternatively, or perhaps additionally, there may be a recommendation to install a 'French' drain around the tower. Where soil in the vicinity of a foundation becomes saturated it can become soft and cause subsidence. A 'French' drain can assist in drying the soil and preventing future saturation.

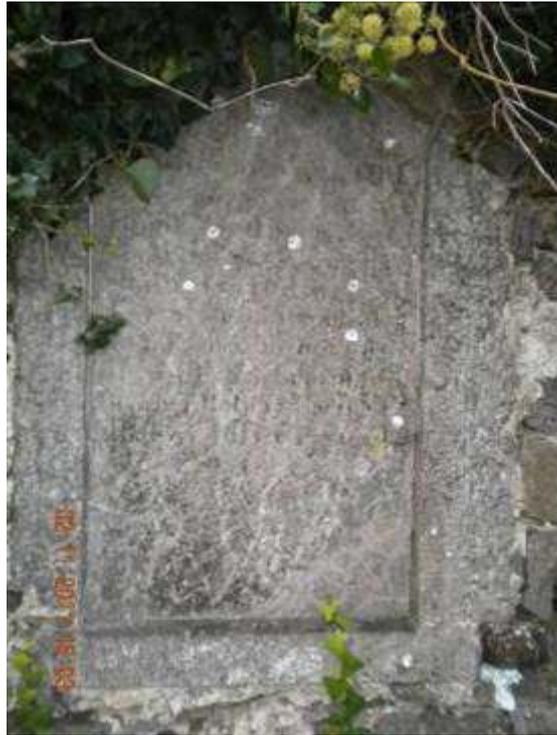
19th century grave marker fixed to the West wall

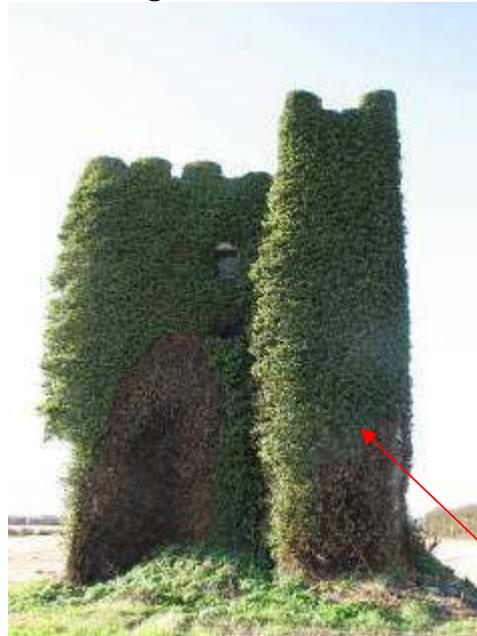
Stair
tower

The south and east sides, including the stair tower, are entirely covered in ivy and could not be examined. Parts of the west and north sides are also covered in dense ivy. The castle was plastered in lime but much of the plaster is now degraded or lost.

- 5.2 The ivy should be removed from the building. This should be done on a phased basis. The walls should be sprayed with 'Roundup' or similar appropriate biocide which can destroy the roots. This application may have to be repeated several times. The vegetation should then be cut off as near the roots as possible and be allowed to decay. Finally the vegetation should be carefully removed from the wall without pulling which can dislodge mortar and stones.

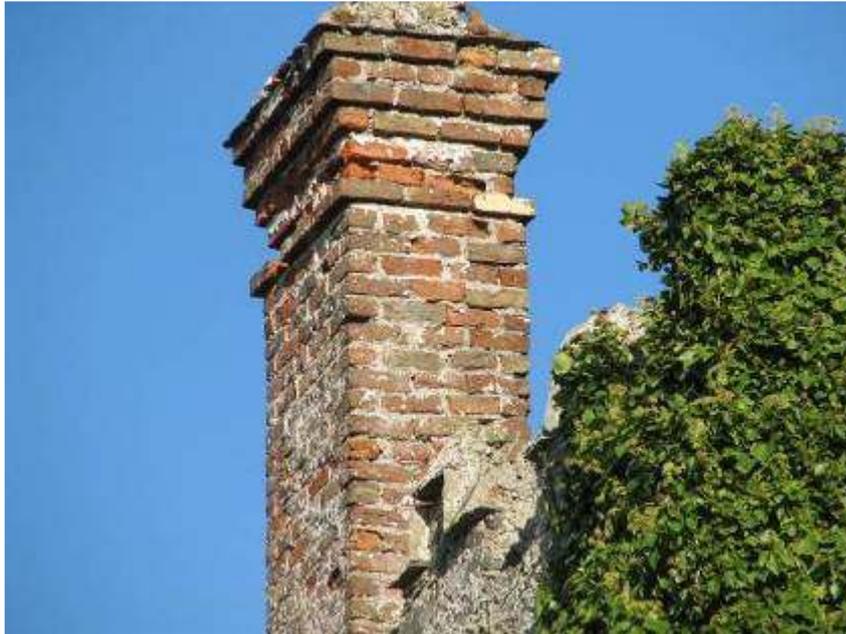
The chimney from the South

The brick chimney is a very large and impressive structure and an important example of how such buildings were modified in the seventeenth and early eighteenth centuries to improve living conditions and convenience. The chimney is off-centre on this wall. It appears to be about 3.0 metres high and has a broad stepped crown. It is unclear whether the chimney was plastered.

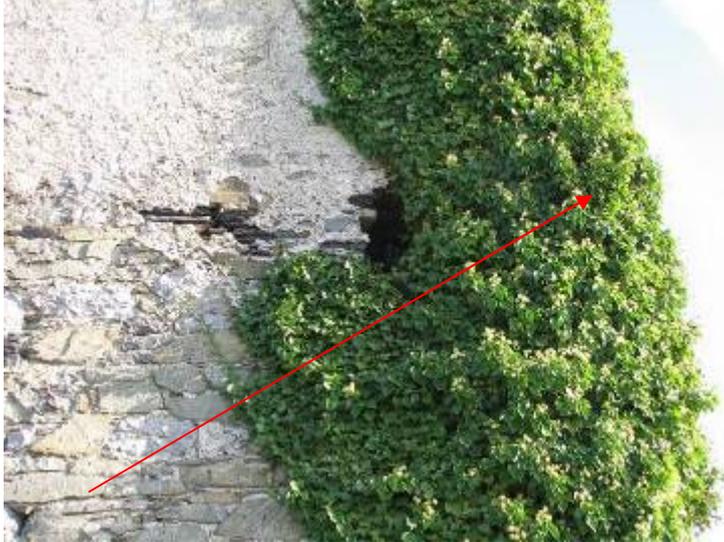
Hole

Hole in south-west corner partly hidden by ivy

- 5.4 All areas of weak or collapsed masonry on the exterior walls should be made good and filled in. This will include holes in the wall where masonry has disintegrated and degraded window and door surrounds. In some cases re-pointing will be adequate. In others it will be necessary to take down and re-build areas of masonry. Where this is necessary a careful photographic and measured record should be made prior to the work and used in re-building. Where stone has to be imported to site the source should be approved by the conservation consultant responsible for the works.

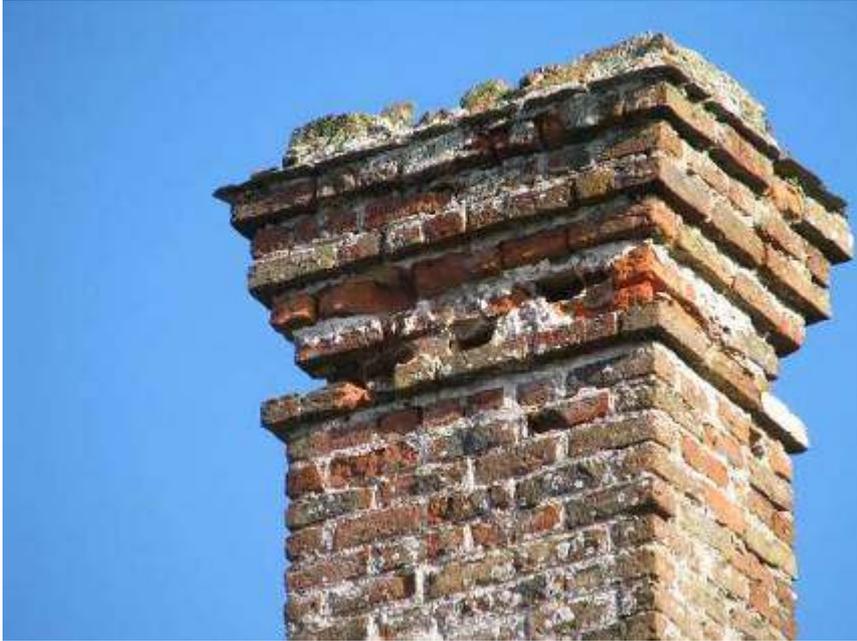
The chimney has long been considered a cause for concern by the technical staff of the County Council. The capping is badly damaged and the brick crown assembly has also been badly affected by water. The north east corner of the chimney shaft above the battlements has collapsed. In its present condition the chimney is extremely vulnerable to rooting vegetation, mortar washout, brick erosion, ice action and wind loading. There is no doubt that the degradation of the chimney is on-going and that there is a real risk of sudden collapse of sections of it or of the whole chimney.

The brick chimney is in a very precarious state. There is a serious danger that it could blow down in strong winds if remedial action is not taken. It is impossible to predict when this might happen but there is no doubt that degradation and weakening of this feature is on-going.

- 5.6 When access is available and the brick chimney is stabilized it should be carefully measured and recorded. The mortar should be analysed. An appropriate conservation and repair strategy should be devised by an experienced conservation engineer. This may involve stabilizing the structure as is or possibly re-building the lost and damaged sections using appropriate materials.

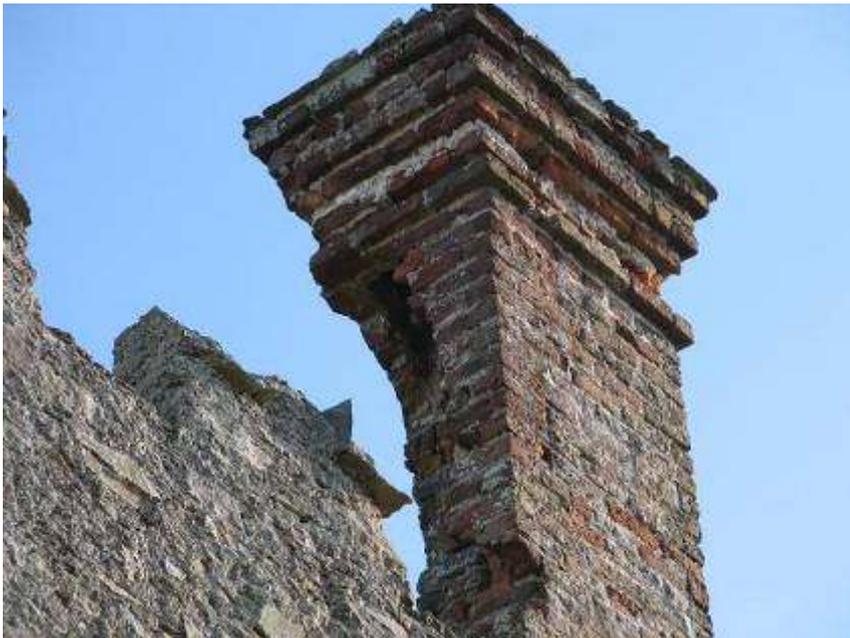
View of the chimney from the north

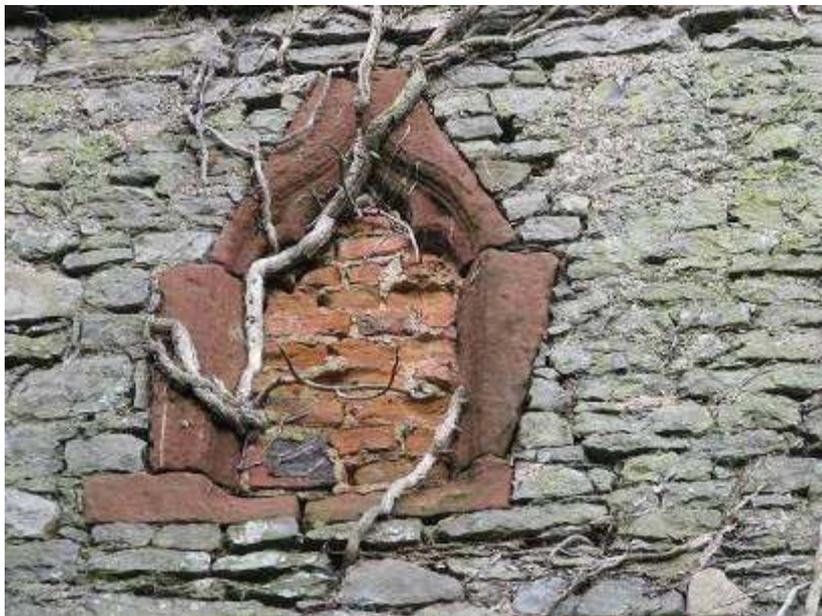
Sandstone Ogee window on south wall

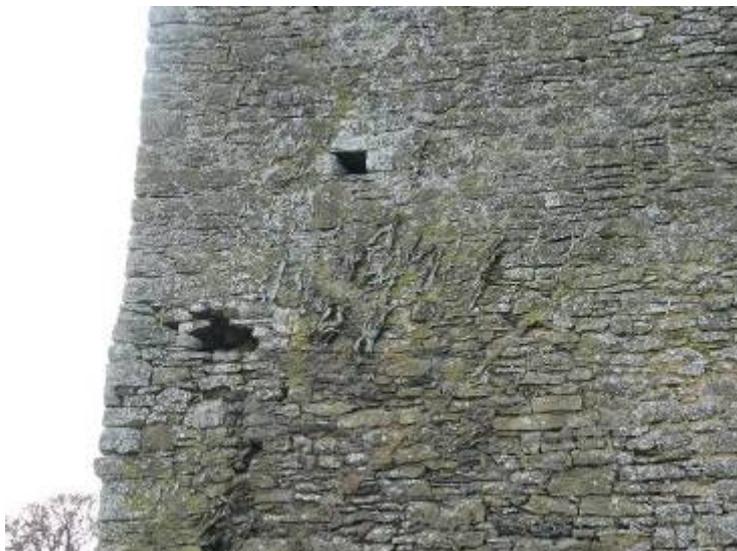
On the north elevation the failure and bulging of the stairwell wall at the northeast corner is obvious. There is a hole in the wall at high level on the west side, just under the battlements. There is a small tree growing out from the interior through a partially blocked up window beside the chimney.

North-East corner bulge and hole – north side

- 5.4 The areas of damaged and holed masonry identified in the condition section should be repaired, filled and pointed. In particular, all window reveals and the holes in the exterior walls at high level on the north and south walls and at the northeast corner.

- 5.5 The bulge in the wall at the northeast corner should be fully investigated. It may be necessary to take down and re-build a section of wall masonry. This corner appears to contain a spiral stair and any re-building will involve temporary propping of the stair and may require repairs to the stair as well as to the wall. The procedures listed in 5.3 above should be followed in any re-building works.

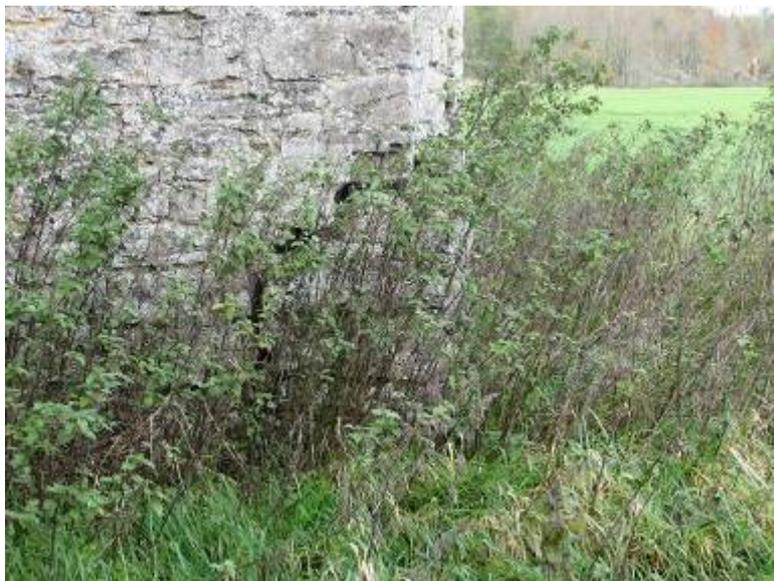
On the south elevation there is a hole in the wall at high level on the east side, just under the battlements. There is degradation of masonry at the cill of the brick-lined window. The subsidence at the southeast corner has resulted in cracking at this wall also.

Subsidence at South-East corner

- 5.8 The ground conditions at the subsided area at the southeast corner should be investigated by digging a trial hole. Underpinning or similar remedial work may be necessary. Consideration might have to be given to providing land drains around the building. All excavations would have to be supervised by a licensed archaeologist.

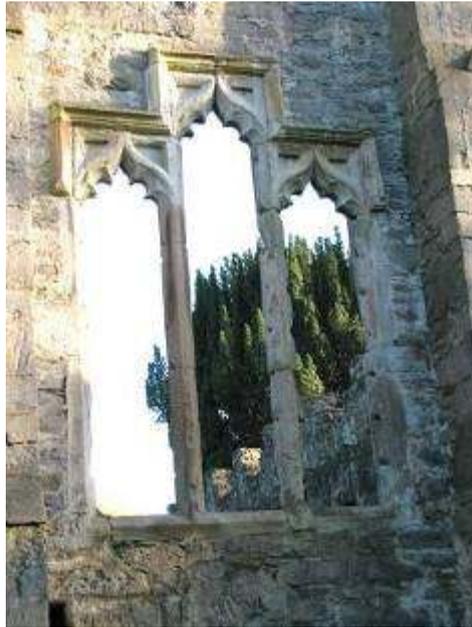
Detail of west window – note damage to mullions

- 5.4 The mullions of the west window tracery should be appropriately repaired by stone grafts, mortar repair or other methods. This work would have to be carried out by specialist masonry contractors.

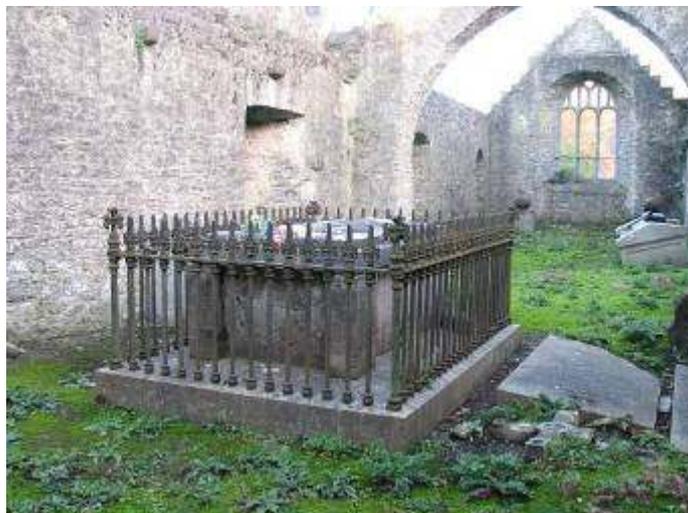
Maud's tomb

Maud’s tomb has suffered damage over the years and one end has been supported by brickwork posts at each side. The sandstone sheela-na-gigs are badly eroded.

- 5.6 Consideration should be given to repairing Maud's tomb by re-attaching pieces of masonry which have broken off and repairing cracks in the ashlar. This work would have to be carried out by stonemasons experienced in conservation work.

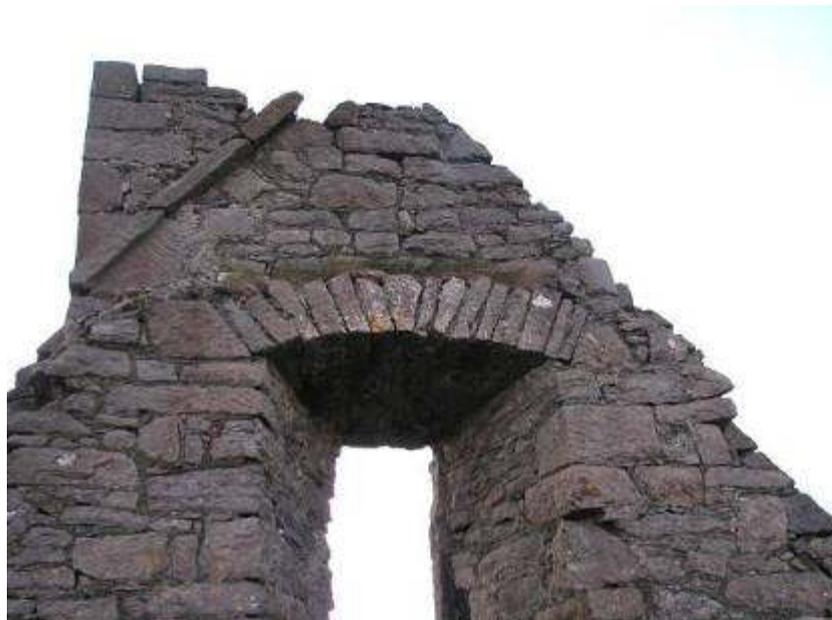
West gable – window detail

- a) Much of the structure is now effectively dry stone as the mortar has been washed out.
- b) Vegetation at the east end of the building is causing further disintegration of the masonry.
- c) The lintel over the window ope in the west gable appears to be cracked and disintegrating.
- d) The site is entirely open with ready access for removal of stone. (This would be facilitated by the gathering of stone into identifiable heaps in several places).
- e) The west gable, which contains good examples of 13th century carved masonry has lost some stones at the south end and is gradually disintegrating.

- 5.2 The broken lintel over the west window should be repaired by a mason experienced in conservation work.
- 5.3 When the vegetation is removed all the walls should be pointed. Remnants of the original mortar should be identified and analysed so that a matching mortar can be designed. A relatively weak lime putty mortar should be used in this case. In re-pointing it may be necessary to take out and re-set some stones. Masonry which has to be disturbed should be carefully recorded by photography and if possible by numbering and the records used in the re-building.

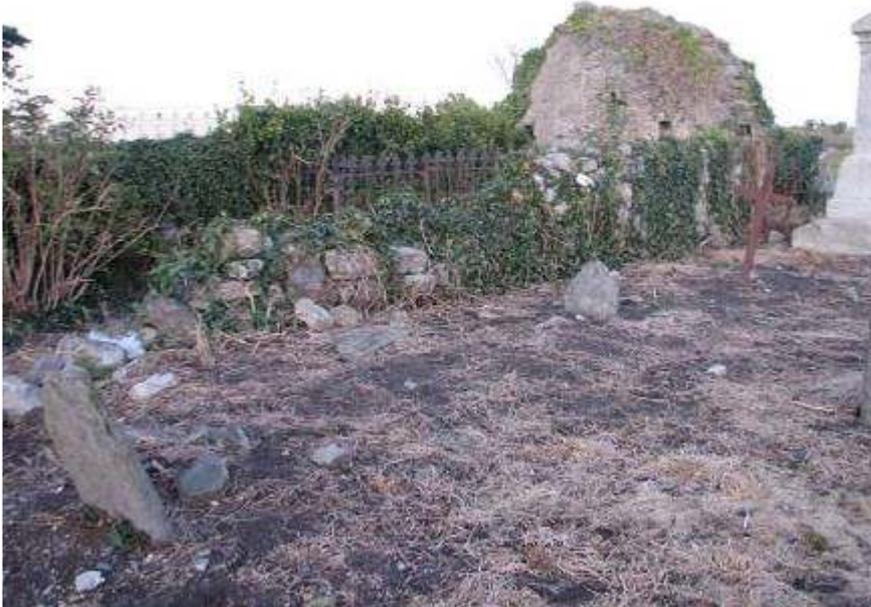
The west end of the south wall is ca 1.3 metres high and has been repointed relatively recently using cement mortar on the inner and outer faces. The interior comprises loose dry stone. This section of the wall may have been partially rebuilt. The rest of the south wall is very degraded with a collapsed area near the east end and all the mortar washed out. The east end of the wall is covered in ivy.

South wall

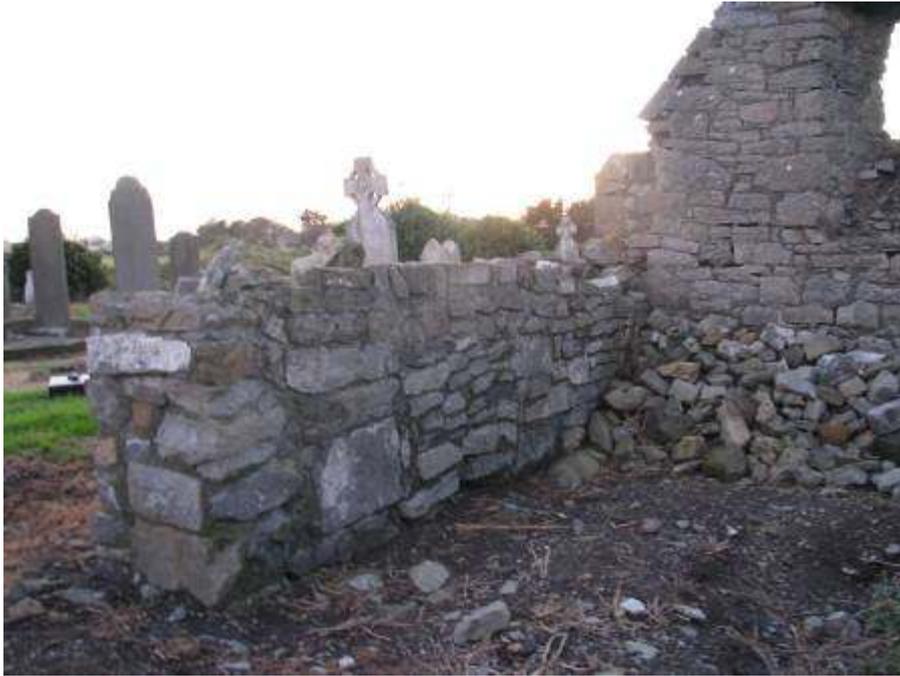
South wall, west end

- 5.1 All vegetation should be sprayed with biocide and removed. The vegetation should be carefully cut away at the face of the masonry. It should never be pulled as this could destabilise remaining mortar and masonry.

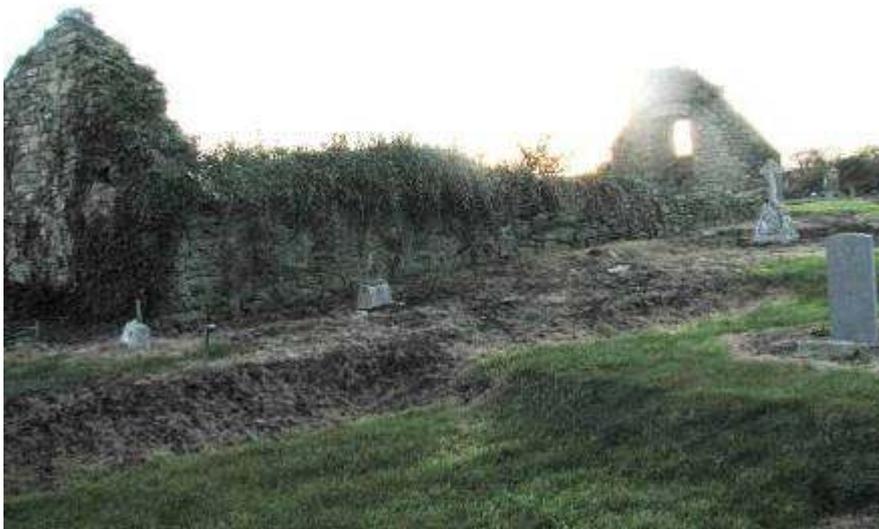
North wall

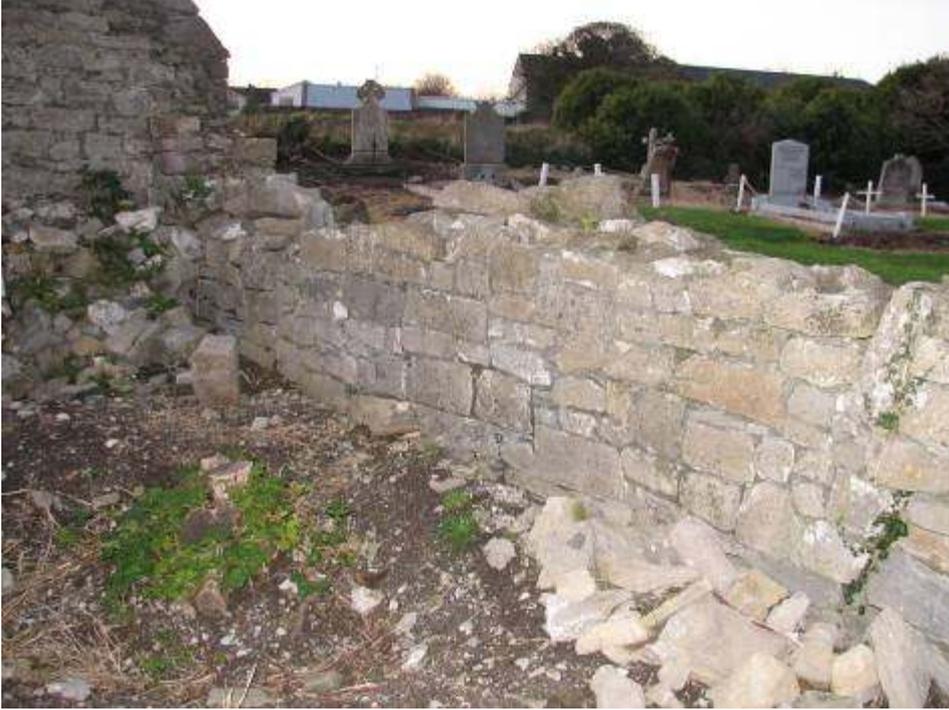
The north wall is in somewhat better condition but at the west end the mortar appears to be entirely washed out. There may have been some rebuilding in dry stone at this end. The east end is covered in ivy and retains some mortar.

North wall, west end

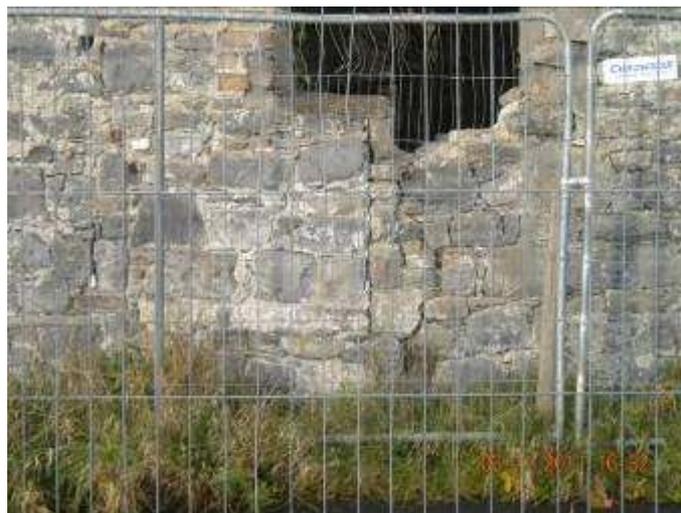
Detail of wall on south side – note construction joint

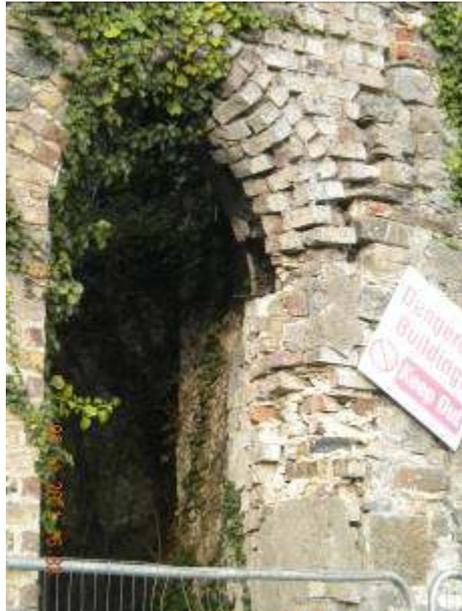
Detail of window head

This structure is in very poor condition primarily due to the action of rampant vegetation. The brickwork lining in the window surrounds, the eaves course and on the barges has been severely damaged. Mortar has been washed out in many places and there are local bulges in the walls which may be evidence of interior voiding. As noted above, the west, east and north walls are obscured by vegetation at present and it is possible that there are serious structural defects in these walls. The plaster on the outsides of the walls has been almost completely lost.

- 5.3 Loose and fallen bricks should be re-set and re-pointed on the barges and eaves and around the windows. Appropriate matching replacement bricks should be sourced and used to replace missing bricks. In particular the arches above the windows on the South wall require to be re-made. It will be necessary to provide temporary arched shutters to make the repairs to the window heads.

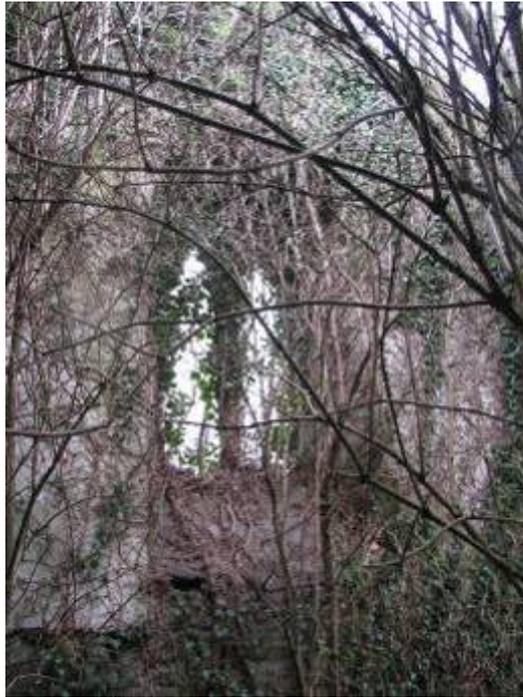
There are flues just inside both gables. At the west end the flue is an asbestos cement pipe. At the east end there is what appears to be a galvanized steel flue. There is a large tree growing inside the building. The interior ground level has been noticeably raised by fallen masonry, plaster and vegetation.

View of the interior – note tree growth

The ground in the interior of the building should be investigated by an archaeologist to determine the original ground level and to find any remains of historic flooring. It may also be possible to retrieve fallen masonry and bricks which could be used in the repair of the structure.

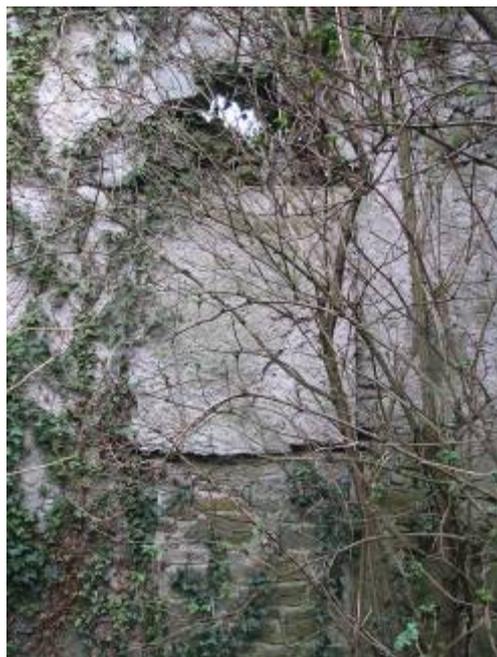
The interiors of the walls were examined on the 23rd of February during the second visit to site. The walls generally retain a thick coating of lime plaster except at low level (up to ca 750 mm above ground level). This may be evidence of a former finish of timber wall paneling up to dado level. There are four niches or small recesses just above the entrance door (two at each side) which may have been support points for a former internal timber porch. There is clear evidence of a blocked up former door opening with a pointed arch at the east end of the north wall. The cills of the windows on the south elevation are badly degraded and bricks are missing from the arch soffits.

Interior – note lime plaster on north wall

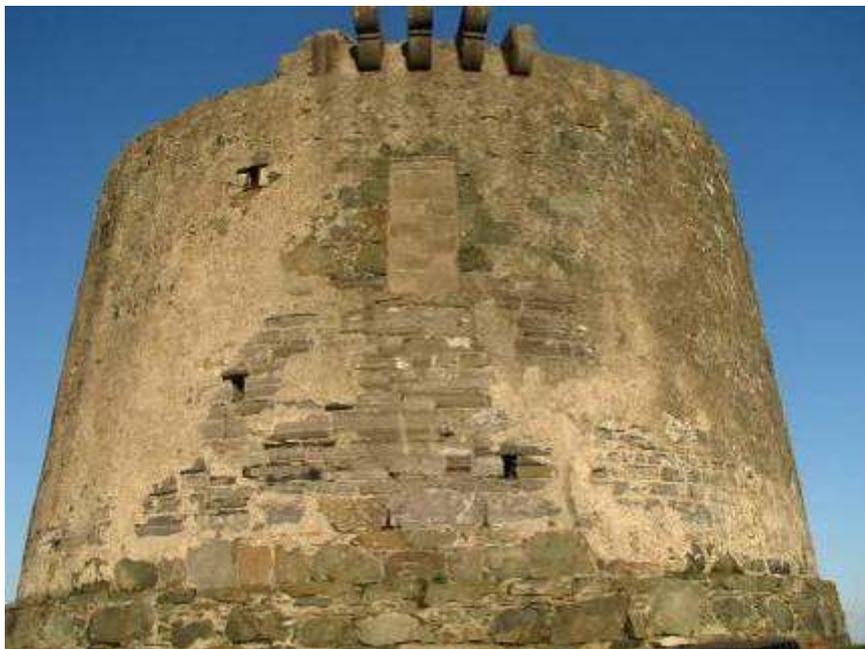
Tower former entrance

Most of the tower is intact although the upper section has been entirely removed. The brackets which supported the defensive machicolation over the entrance door remain, although two of them are damaged. The upper section (which would have been about 1.0 m high) was removed to salvage the masonry. The entrance door at first floor level is blocked up with concrete blocks.

- 5.1 Access should be provided to the interior of the structure by breaking out the blocked up door opening. Access should also be provided to the roof.

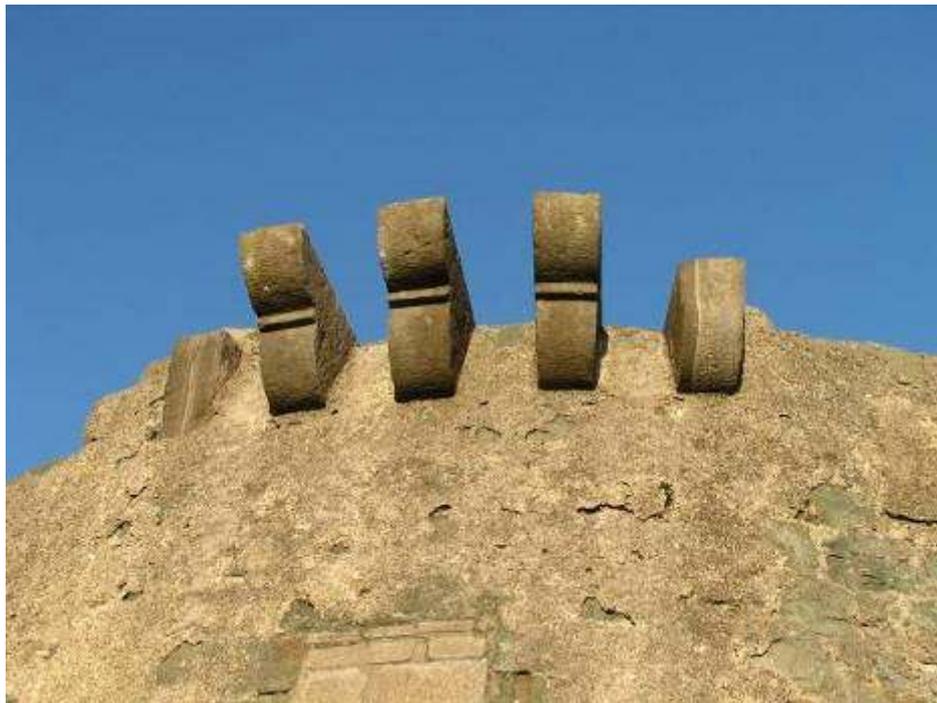
There is no evidence of subsidence and no structural cracking. The removal of the upper part of the structure may have left the tops of the walls unprotected. It would be necessary to gain access to the top of the wall to examine the condition. As noted above, the machicolation brackets have been damaged.

Detail of machicolation brackets

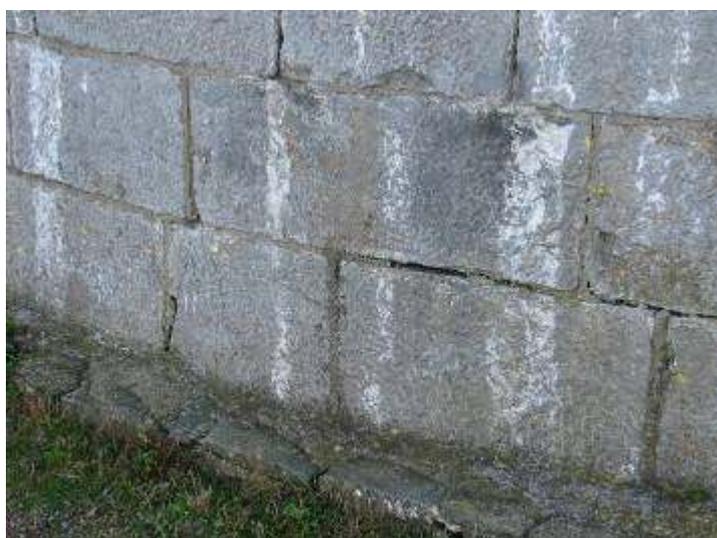
On the exterior there is no evidence of subsidence and no structural cracking was noted. However the brackets supporting the machicolation appear to have been damaged, probably when a structure was erected against the tower. There is extensive loss of mortar from the masonry joints. In some areas, the mortar has been replaced by inappropriate cement pointing, which may result in moisture retention in the masonry. At high level there is moss growing in the joints which is evidence of dampness in the wall. At low-level, mortar has been completely washed out of the joints. There appears to be virtually no ventilation of the interior.

Evidence of mortar washout at low level

- 5.5 The entire exterior should be treated with biocide and re-pointed.
- 5.6 When access to the first floor is provided the head details of each opening in the wall should be carefully examined by an appropriately experienced engineer. Where necessary lintels should be provided.

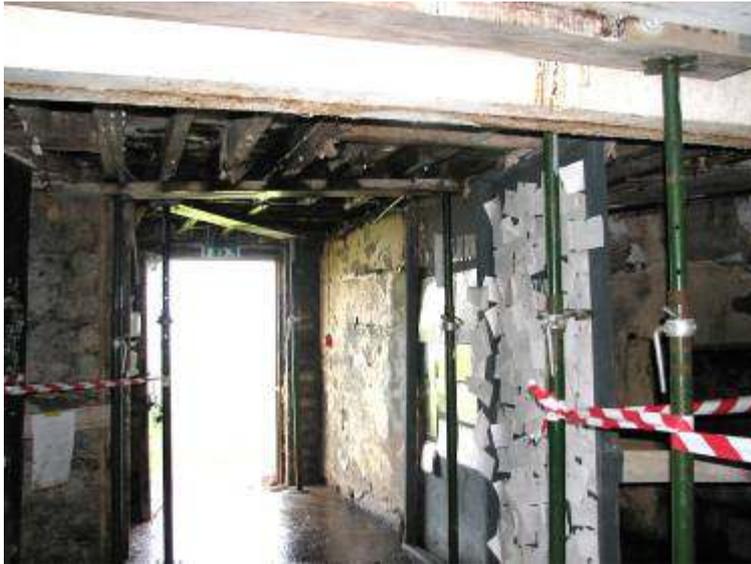
are also two steel beams carrying the floor. The floor is supported in several places by by 'Acrow' props. There are remnants of timber paneling on the ceiling soffit. The first floor is in a dangerous condition and it was not possible to walk on it to examine the upper parts of the building.

Interior – ground floor – note propping of floor over

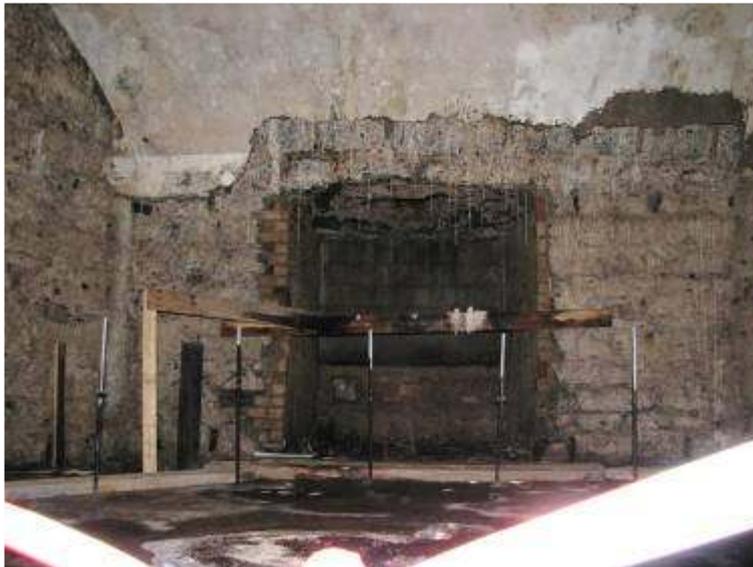
The interior of the building is very damp. The floors and walls are palpably wet and there are 'stalactites' suspended from all the soffits above the first floor. The timber elements in the building are very badly affected by wet rot which makes it unsafe to access the first floor as noted above. The first floor steel beams are badly corroded.

First floor interior – note lime ‘stalactites’

- 5.2 The first priority in this case is to provide access to the roof and to carry out waterproofing works to stop the ingress of moisture through the roof which is obviously on-going. The necessary details cannot be elaborated until access is provided.

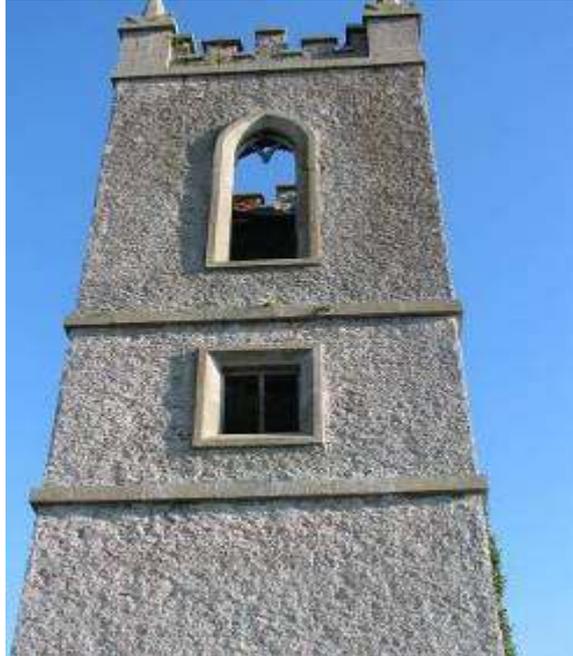
West elevation - upper

The roof has entirely collapsed and it is likely that the interior timber work such as bell supports, floors and ladders has also collapsed. The lead gutters can be seen through the louvre openings hanging from the walls as their timber supports have completely decayed. Some vegetation is growing in the parapets and there is some damage to merlons. The mortar joints in the parapet ashlar blocks appear to be completely washed out. One crocket (at the north-west corner) has fallen and one other is leaning. The timber framing is gone from three of the louvre openings and one of the windows. Some of the exterior plaster has been washed off the walls.

- 5.2 The parapet requires to be completely refurbished and repaired. This will require scaffolding the building on all sides and providing access to the inside faces of the parapet walls. Loose remnant timbers and lead flashings should be removed. The vegetation growing from the parapet should be sprayed with biocide and removed. Damaged and dislodged stones should be re-set. The parapets should be re-pointed and flashed. The pointing should be carried out using hydraulic lime (NHL 3.5) and fine sand in a 1 : 2.5 mix. All of the work should be specified by an experienced conservation professional.

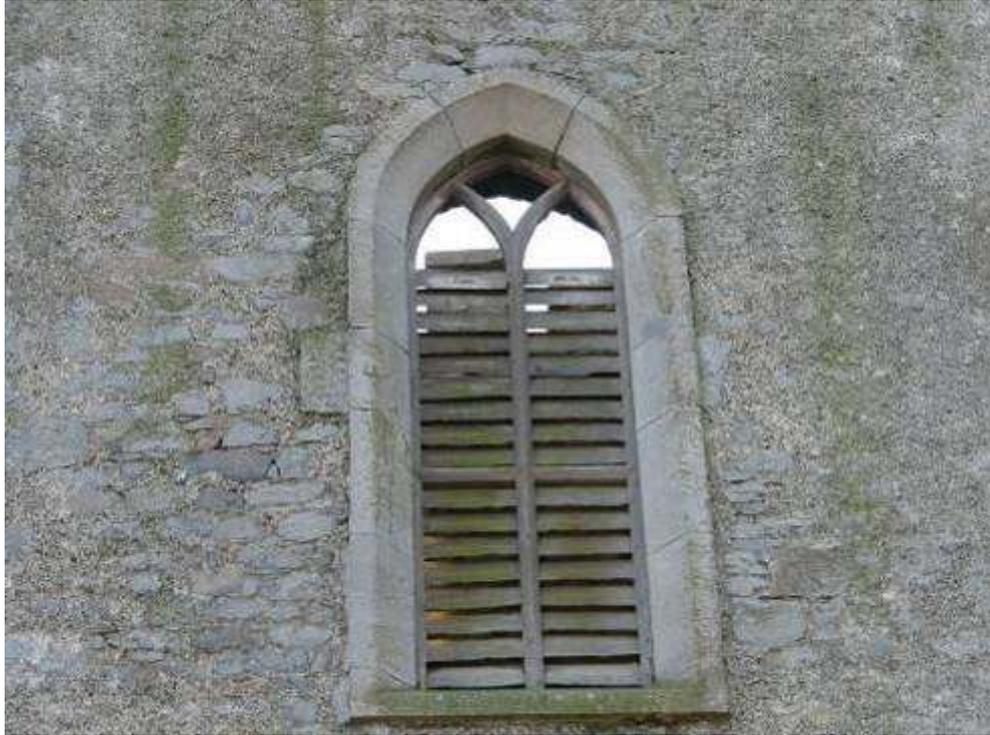
Louvre – north elevation

The tower is square (4.6 m. side) almost symmetrical and ca. 16 metres high. It was finished in lime harling with very finely carved limestone ashlar string courses and window surrounds. The entrance door is round-headed with chamfered reveal. At first floor level, there are square window openings on each side except the east (which abutted the Church). The window frames were casement shaped and two of these survive. There are string courses above and below these windows. The belfry level has high, pointed louvre openings on all four sides. The timber louvre on the north side is largely intact.

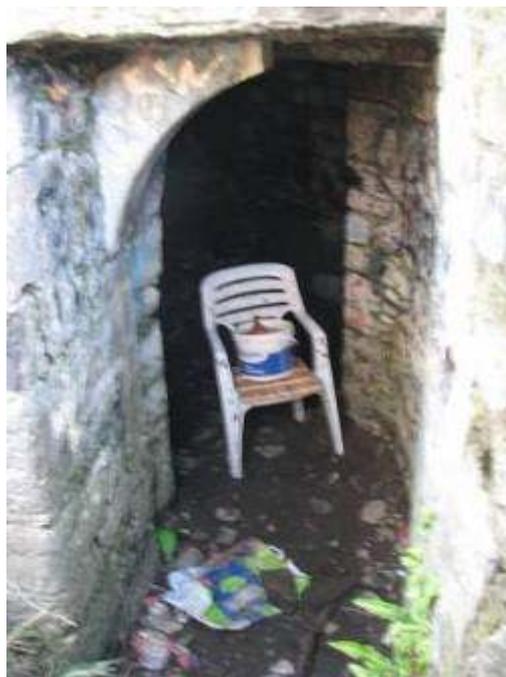
area of collapsed wall facing ca. 800 x 300 on the west wall and the masonry around the chimney has disintegrated. The lintel over the door into the undercroft is badly cracked. There was formerly a pointed architrave at the door but

one half of the arch is gone. The lintel over the window on the north side of the north-east tower is cracked. The ivy growth on the exterior is quite heavy and undoubtedly is harming the masonry. The grass and soil on top of the monument may be protecting the masonry to some extent (by absorbing rainfall rather than letting it percolate through the masonry of the barrel vault), but in the long term it is likely to cause damage.

Entrance to undercroft (note damaged arch)

- 5.4 The cracked lintels over the entrance door and over the north window in the north-east tower should be repaired. This

work should be executed by a mason experienced in conservation. The work may involve stitching with stainless steel pins.

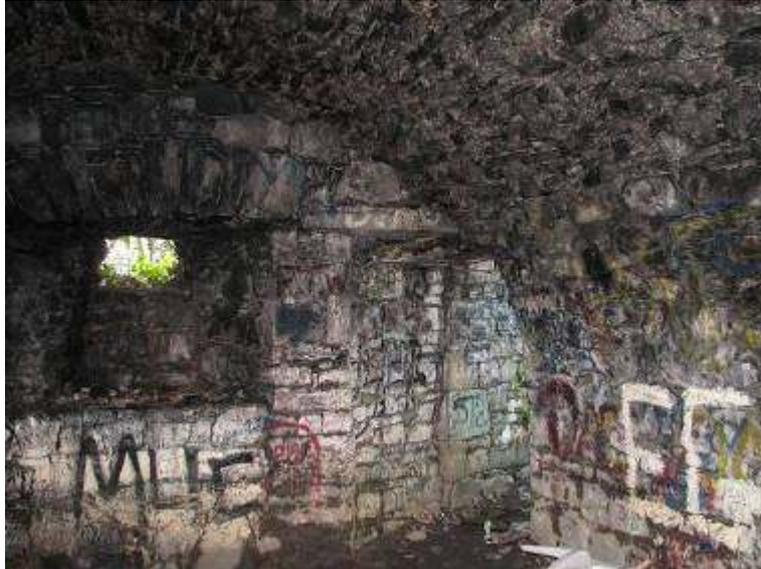
Undercroft – view from entrance

Viewed from the inside, the walls and roof of the undercroft are generally in quite good condition although very damp. There is an

- 5.6 The damaged interior masonry in the undercroft on the west wall and at the chimney on the east wall should be rebuilt by a mason experienced in conservation work. Fallen stones in-situ and stone recovered from around the site should be used in rebuilding.

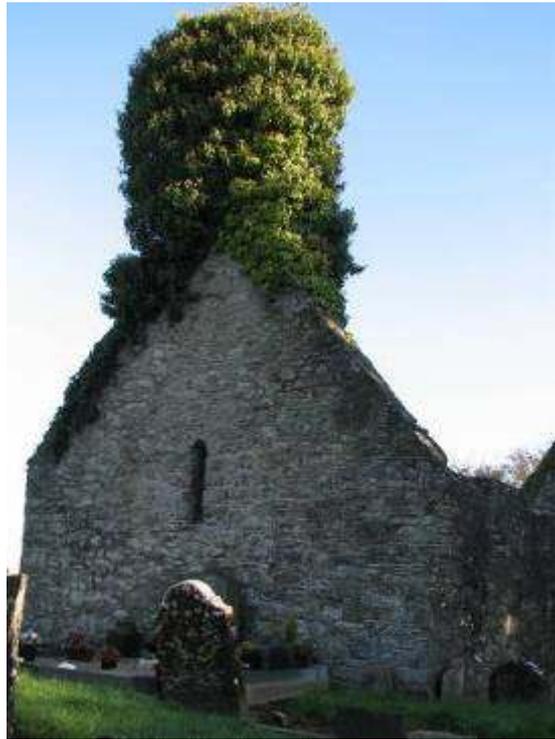
West gable

The vegetation on both gables may be causing damage – particularly on the west gable but this can only be determined by removing it. There is evidence of a small area of wash out of mortar at the base of the north wall. There is quite extensive cracking on the west gable wall which is probably due to subsidence caused by the proximity of graves. The north wall has a wavy profile with bulges which is probably historic and not of concern.

The problem of subsidence on the west gable is potentially serious in the medium term. In the long term the cement pointing may cause damage to the masonry but is not a matter of immediate concern. The vegetation, particularly on the west gable will cause disintegration of the masonry if it is not removed.

- 5.3 The cracking in the west gable should be monitored over ca two years by attaching tell-tales to the wall in selected locations. Should it become clear that the movement in the wall is on-going, measures will have to be taken to address it. This would involve digging trial pits to examine the soil under the wall. This will be a difficult operation because graves have been dug directly against the outside of the wall. It might be necessary to work from inside the wall. All excavation work will have to be supervised by a licenced archaeologist. The investigation work should be supervised by a conservation engineer. Should remedial works be considered necessary some form of underpinning may be required.

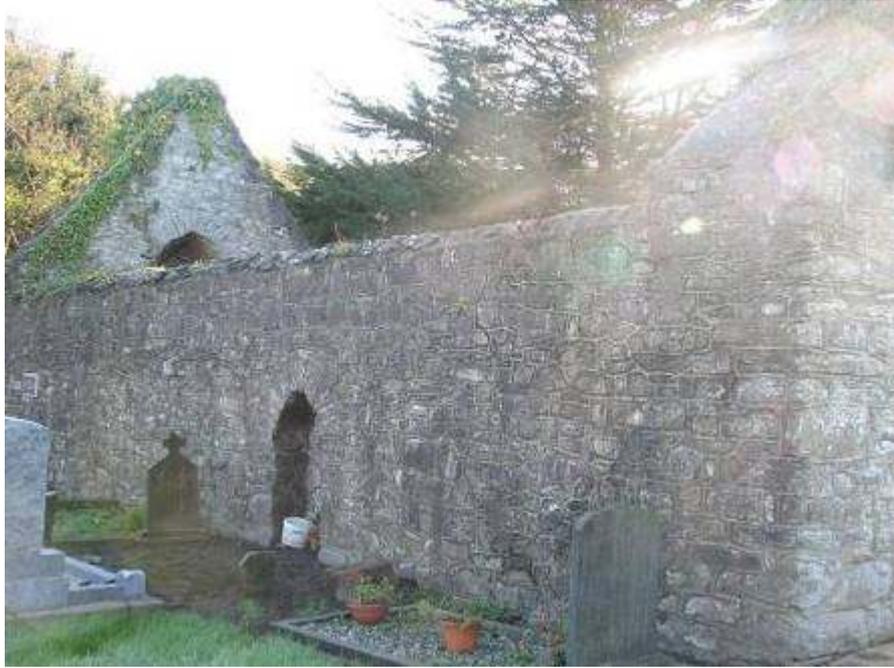
North Wall

There are graves dug very close to the walls on all sides. There is a plaque on the north wall commemorating local cholera victims who died during the Famine.

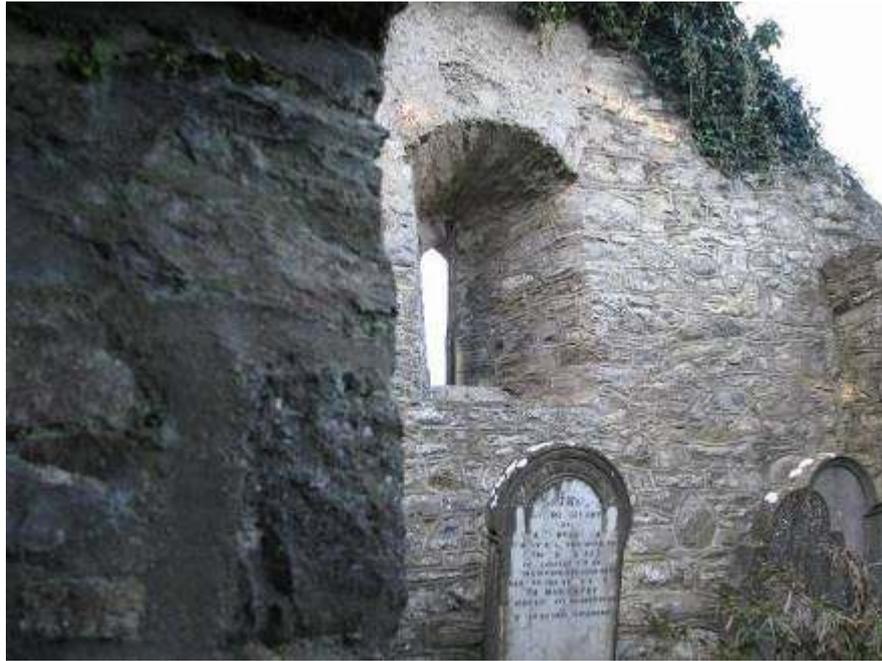
West gable interior (note plaster remnants)

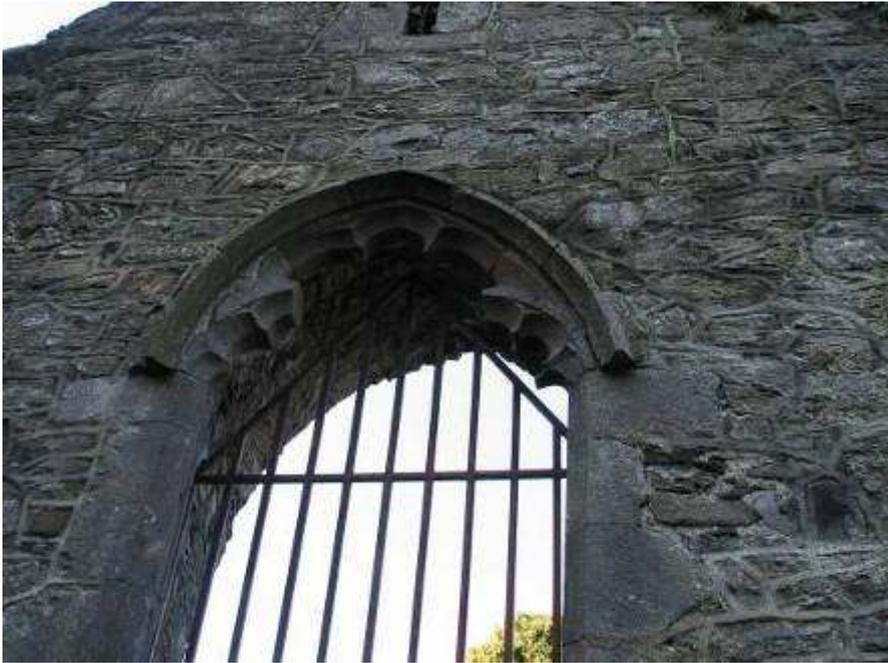
Tracery remnants at east window.

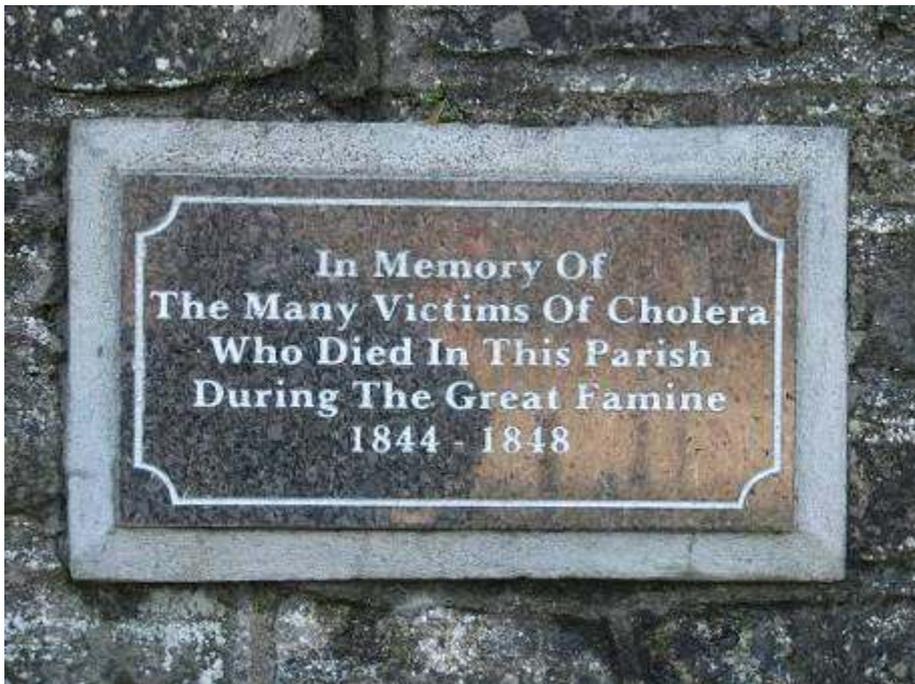
Famine memorial plaque
