**STRUCTURAL ASSESSMENT AND PROPOSALS FOR REPAIR,
CONSERVATION AND PRIORITIZATION OF URGENT
WORKS
FOR
FIFTEEN ARCHAEOLOGICAL MONUMENTS
IN
FINGAL COUNTY COUNCIL OWNERSHIP**

**Dermot Nolan & Associates
Historic Buildings Consultants
& Consulting Engineers
'Claremount'
Meath Road
Bray
Co. Wicklow
Tel: 01-276 2626
Email: dnolanconservation@eircom.net**

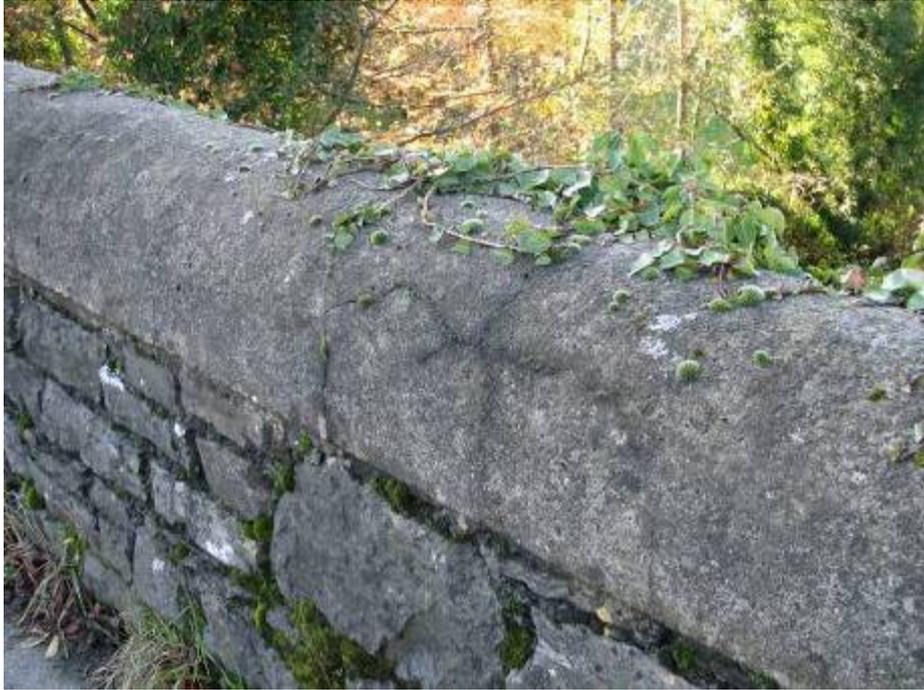
Detail of parapet

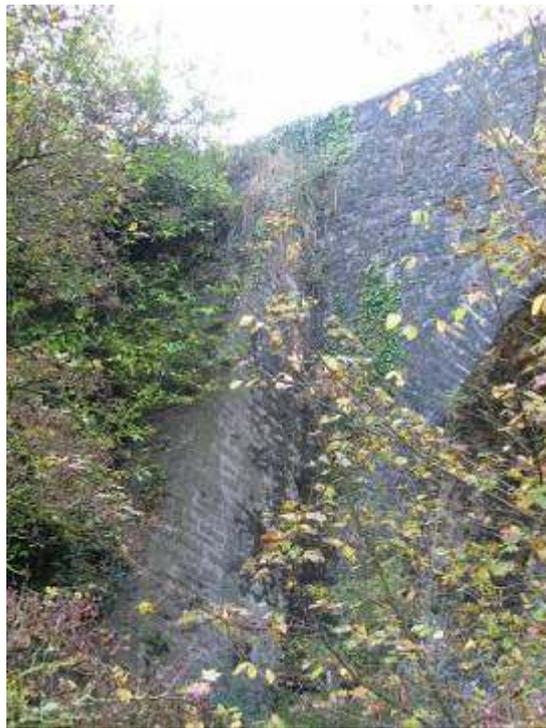
Buttress at south-east corner

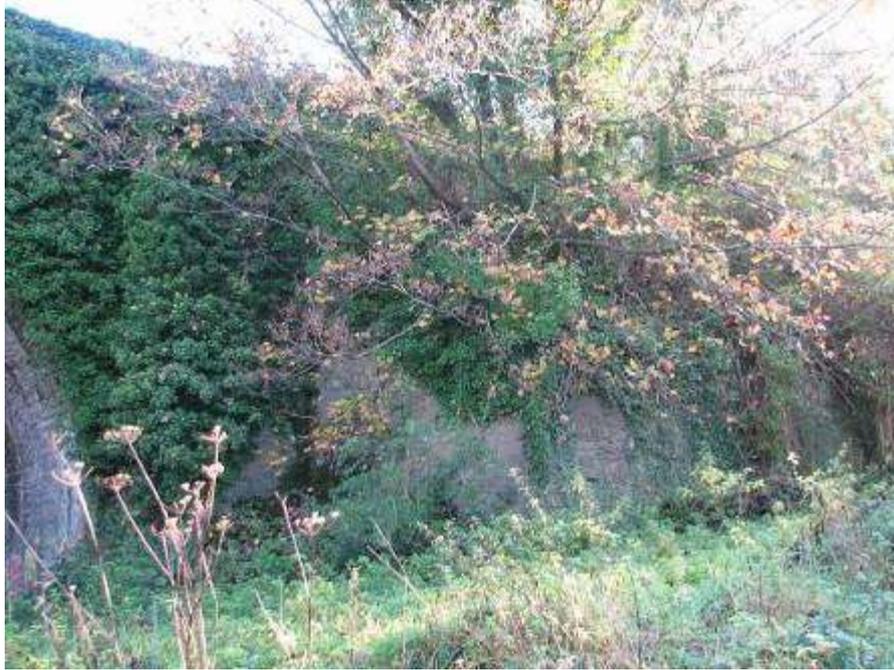
Buttress at south-west corner

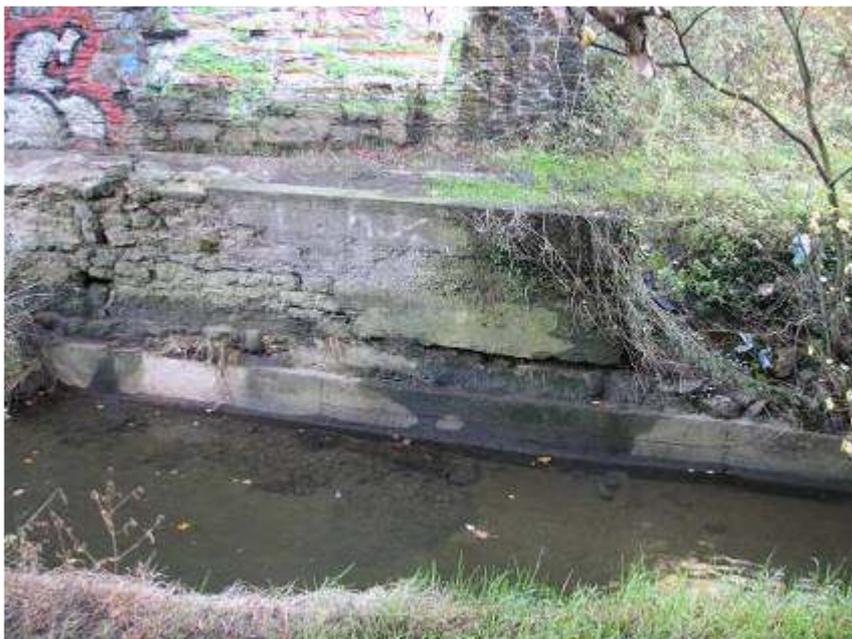
- g) A section of wall circa 7 metres long has been knocked out (presumably by vehicle collision) on the east side, south of the bridge.
- h) There is evidence of undermining of the walkway on the north abutment of the bridge.
- i) There appears to be at least one hole in the bridge soffit which could permit washing out of mortar from above the arch.
- j) There are small lime 'stalactites' on the bridge soffit – particularly at the arch edges which indicate that washing out of lime from the arch interior has occurred.
- k) The road drainage holes in the bridge parapets discharge directly over the bridge masonry and have damaged the pointing on the spandrels.
- l) The very heavy vegetation growing in and on the masonry is very likely to be causing serious and on-going problems of destroying mortar, dislodging stones and blocking weepholes.

Underpinning at north abutment

- 5.4 The masonry faces of the river channel along the walkways should be pointed and repaired as necessary. This may involve some underpinning or other concrete repairs. The works should be planned and supervised by a conservation engineer experienced in bridge works. The mortar design for re-setting masonry and for re-pointing will have to be carefully considered because of the vulnerability of the structure to flooding and mortar washout.

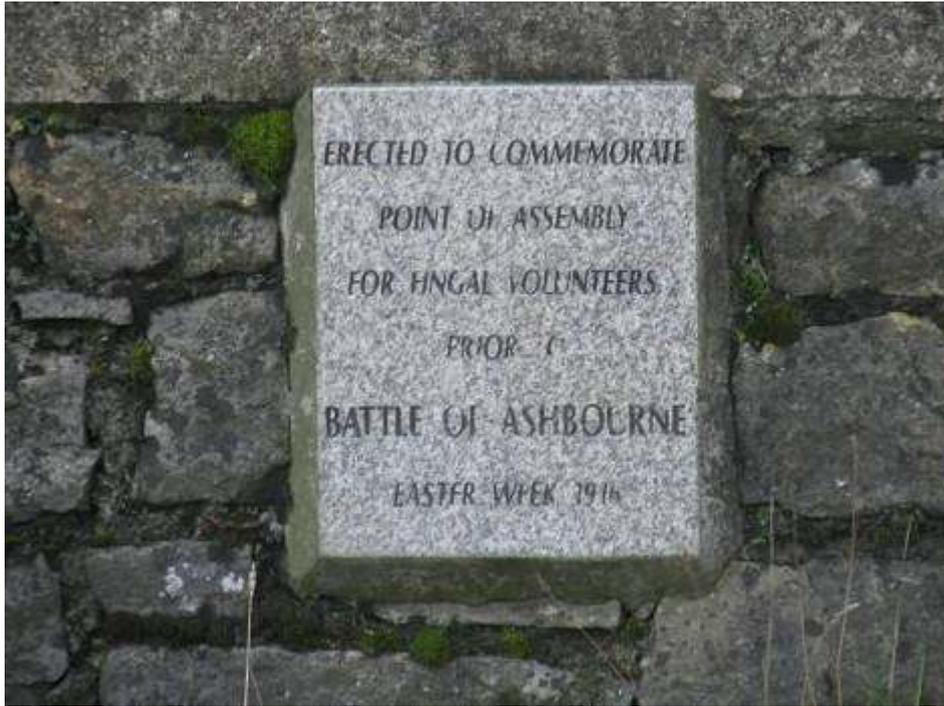
Commemorative plaque

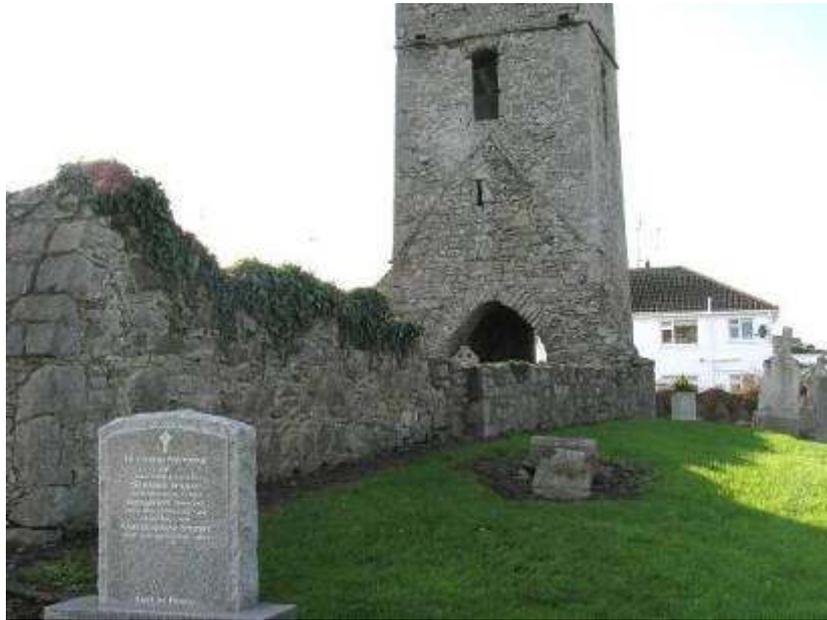
North wall

The north and south walls of the Church have generally been pointed inside and out with cement and this has protected them for the moment. However the tops of these walls do not appear to have been repaired. There is quite heavy ivy growth on the north wall and this is probably causing damage. There is also some vegetation in places on the tower walls.

- 5.1 The building should be sprayed with biocide and the vegetation should be removed. The vegetation should be carefully cut away after spraying. It should never be pulled as this could damage mortar and dislodge stones.
- 5.2 The battlements on the tower should be re-pointed as well as areas on the exteriors of the walls where mortar has been washed out. The mix used should be hydraulic lime (NHL 5.0) to sand in the proportion 1 : 3.

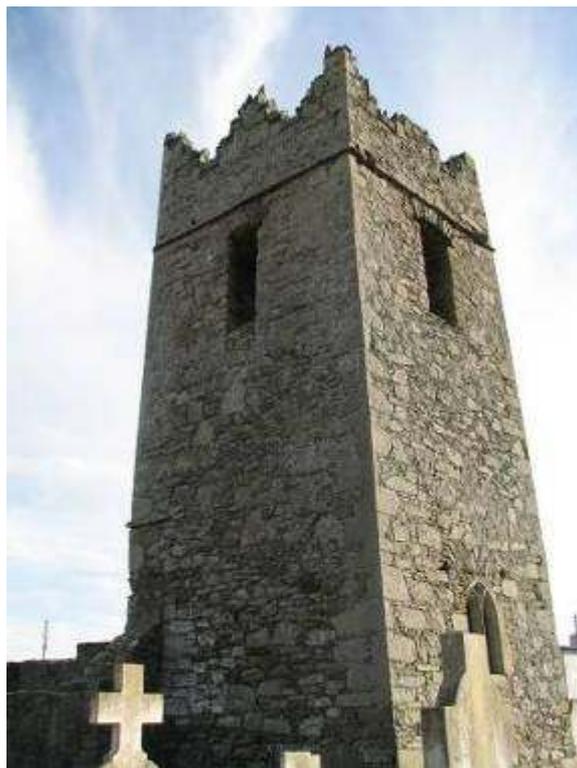
North-west view of the tower

The battlements on the tower have suffered from considerable mortar wash out and require to be re-pointed. Some areas of the exterior of the tower walls on all sides require to be re-pointed. The interior of the tower requires re-pointing of the arches generally and repair to the walls locally – in particular, to the west and east

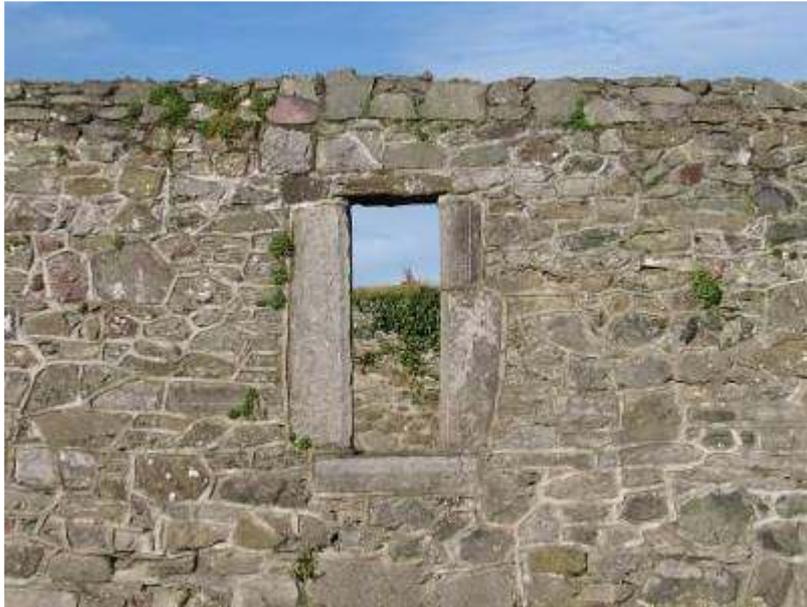
Window opening in the south wall

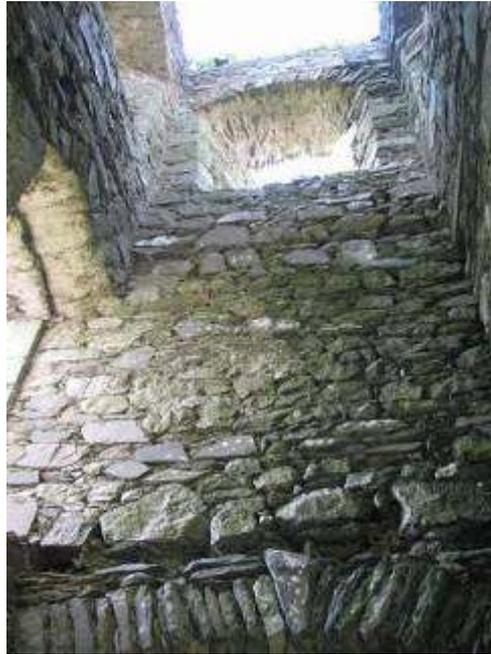
walls at first floor level where removal of the floor has created a situation of potential instability by leaving voids in the walls.

The tower interior west wall

- 5.3 Damaged masonry above the window on the west wall and the arch on the east wall of the tower interior ground floor should be filled and re-pointed. The other window heads in the tower should be re-pointed as necessary. The mix used should be as in 5.2 above.

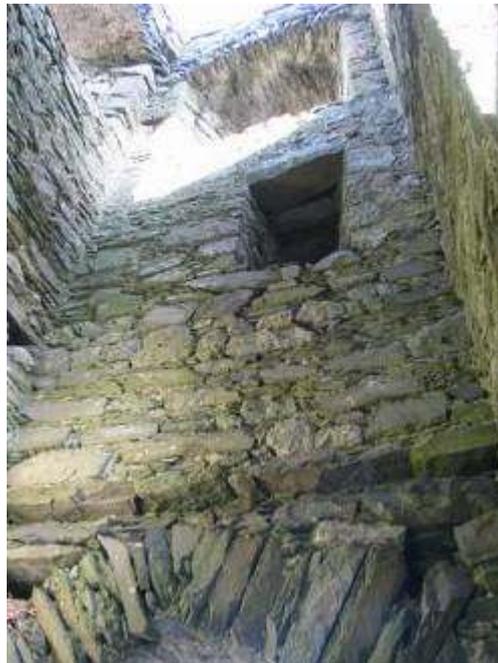
Tower interior east wall

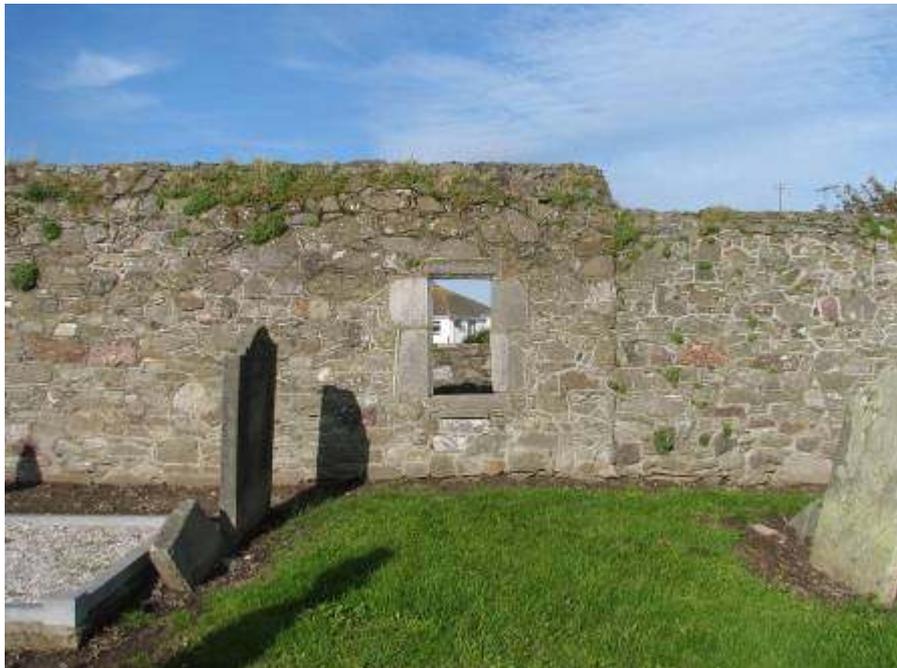
Window on the south wall

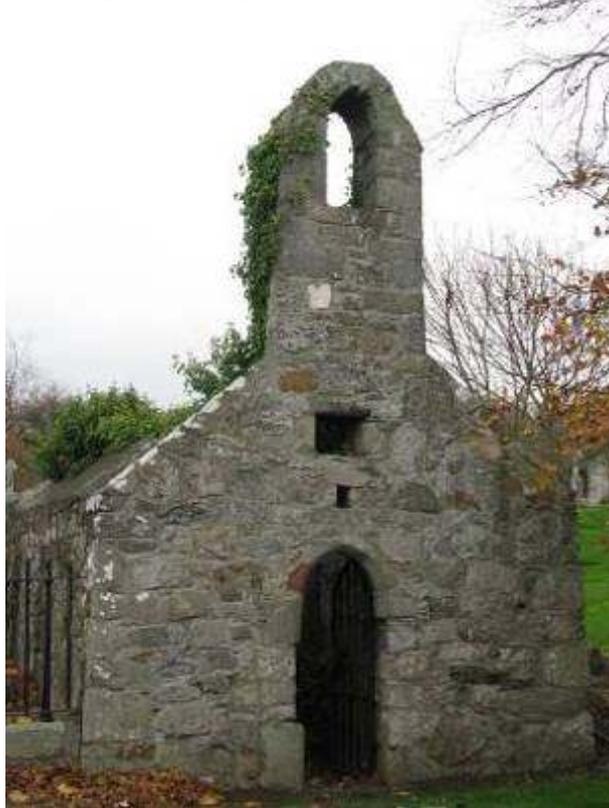
West elevation

The tops of the north and south walls have been repaired in the past and capped with cement mortar, the new construction being separated from the old by a dpc (damp proof course). The west wall and bell-cote have been re-pointed in cement mortar. The interior of the building is overgrown and ivy is growing on the east face of the bell-cote and over the north and south walls. The building has been secured by a locked steel gate and a steel caging over the interior.

- c) Much of the mortar appears to have been washed out of the south, north and east walls. (This applies to the exterior. The pointing on the wall interiors appears to be in quite good condition).
- d) The cement pointing of the west wall is inappropriate and may eventually cause damage to the fabric.
- e) The infill in the east window appears to be unstable.

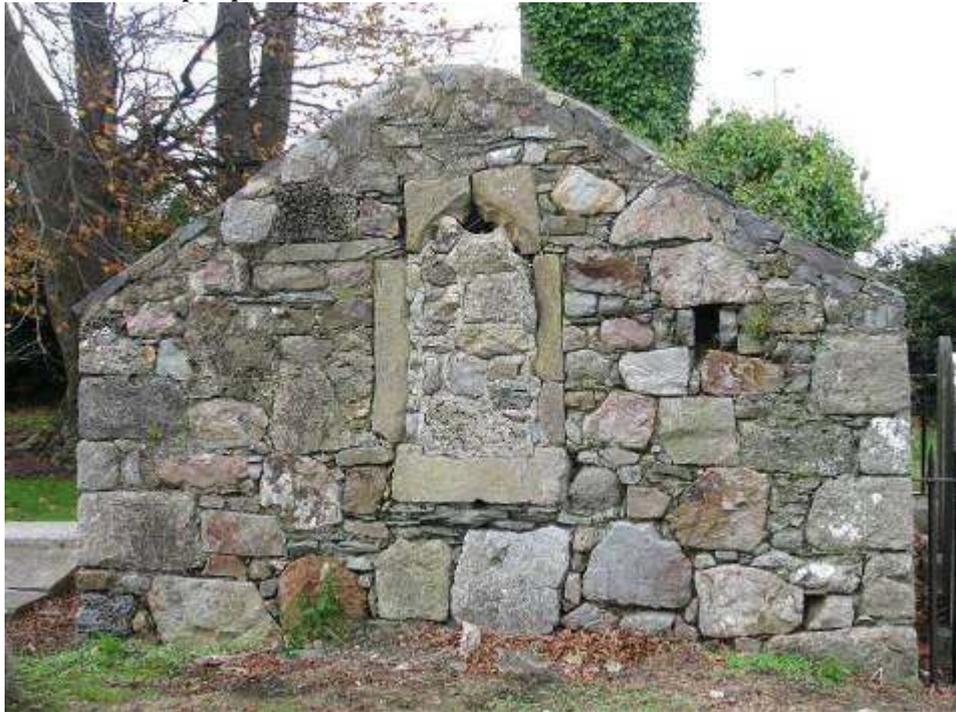
East elevation

The east wall had a sept-foil tracery sandstone window which is roughly blocked up. In contrast to the entrance door, the east window is proportionally quite large for the size of the building.

- 5.5 The infill in the east window appears to be quite old and lime mortar was used. It would therefore be inappropriate to remove the infill completely and to replace it. It should be repaired to ensure the security of the building.

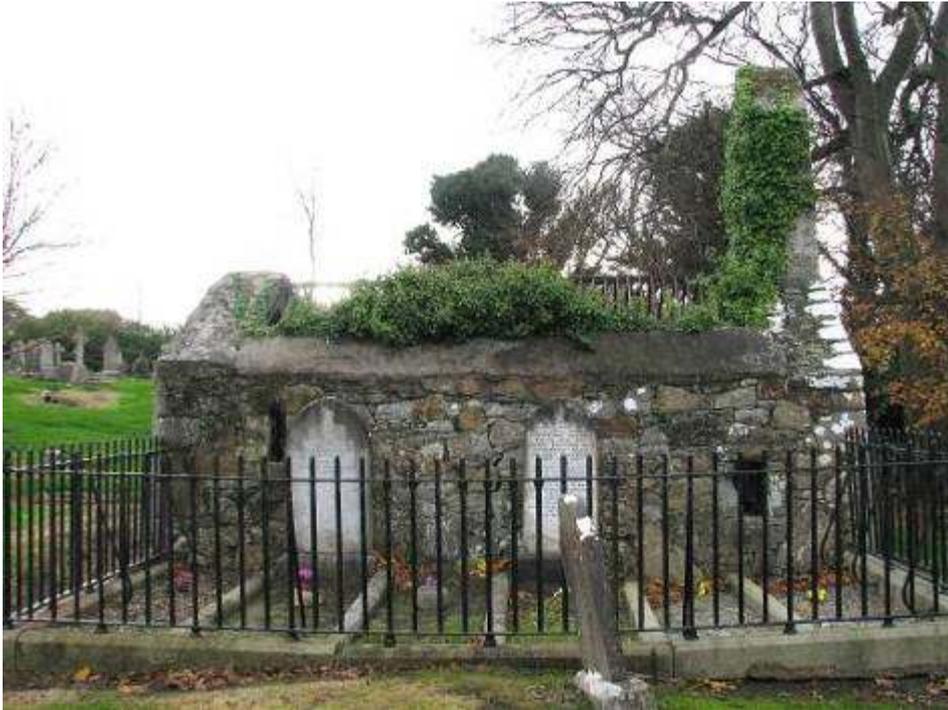
North elevation

A fenced grave plot belonging to the Bellingham family occupies the full length of the north wall.

- a) The interior is overgrown and the vegetation is beginning to cause damage to the masonry.
- b) There is some evidence of subsidence along the north wall which may be associated with the graves in the Bellingham family plot. The subsidence may be historic, as no burials have been carried out in the recent past.

- 5.2 The apparent cracking in the north wall should be monitored by inspection and photography at regular intervals. Should it get worse, it may be necessary to take action which might involve underpinning or provision of drainage in the vicinity of the wall. Any excavation would have to be monitored by a licenced archaeologist.

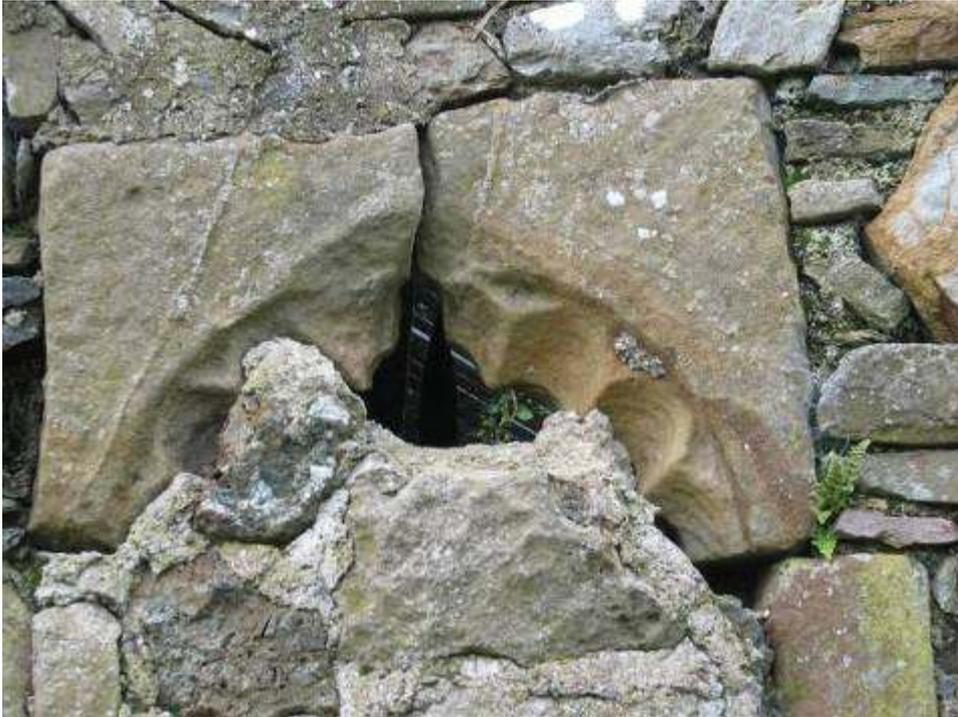
Remnant of tracery on east window

On a scale of vulnerability of 1 to 5 the monument may be considered to be at level 2. The most pressing matter is the possible collapse of the infill on the east window.

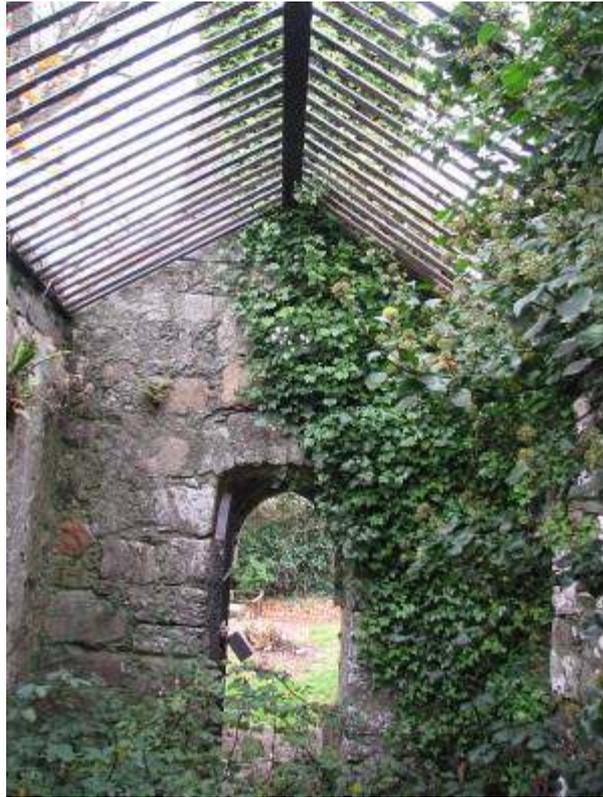
Interior looking towards the entrance (west)

- 5.1 The building should be sprayed with biocide and the vegetation removed. After spraying the vegetation should be carefully cut away. Vegetation should never be pulled from historic masonry as damage to mortar and stones could ensue.

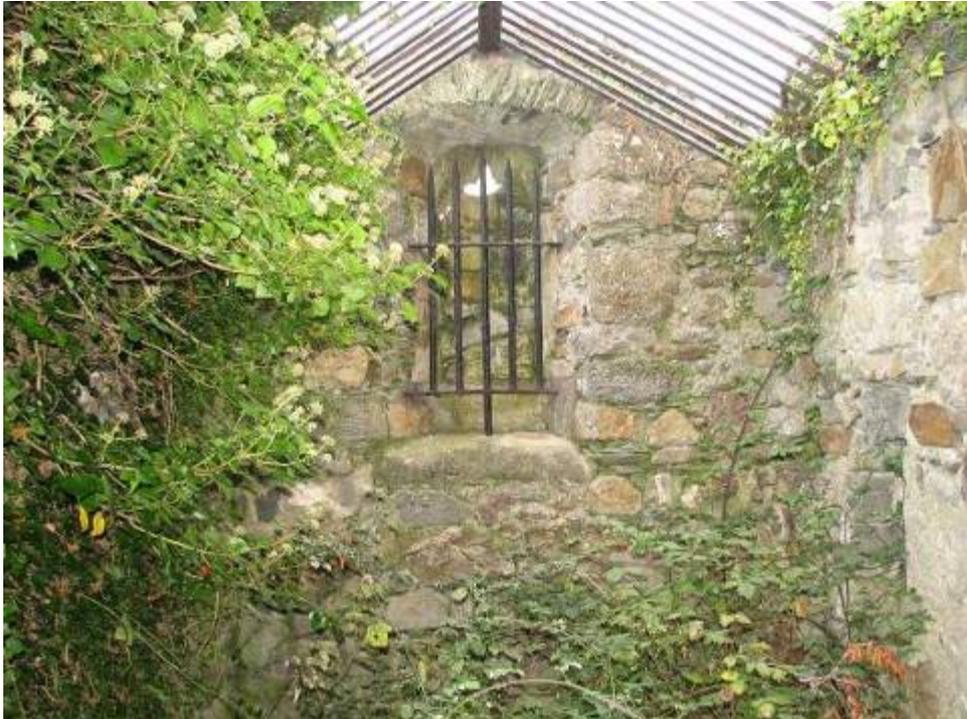
Interior showing the east wall
